Hazardous Building Materials Inspection

Cochran House Fairfield Hills Campus Newtown, Connecticut

August 2015 Revised January 2016 and December 2016

Fuss & O'Neill EnviroScience Project No. 20141268.B1E

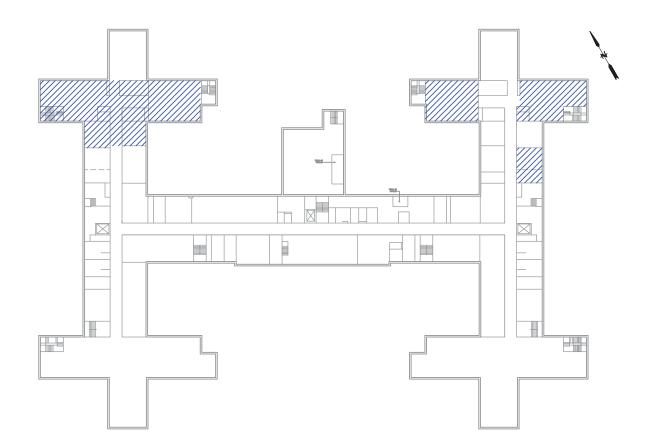
ASBESTOS CONTAINING SURFACING MATERIALS LOCATION BASEMENT — COCHRAN HOUSE

SOFT TEXTURED CEILING PLASTER

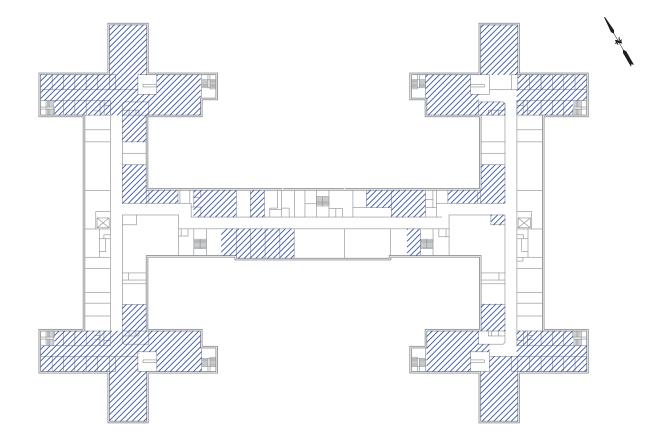
ASBESTOS CONTAINING SURFACING MATERIALS LOCATION SECOND FLOOR — COCHRAN HOUSE

SOFT TEXTURED CEILING PLASTER

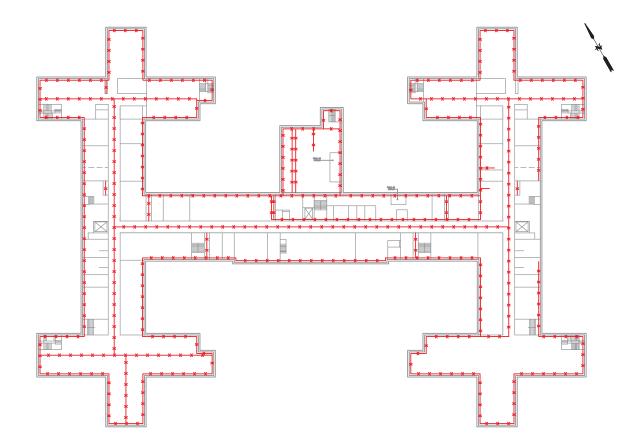
ASBESTOS CONTAINING THERMAL SYSTEM INSULATION MATERIALS LOCATION BASEMENT - COCHRAN HOUSE

1. DAMAGED TSI DEBRIS EXISTS THROUGHOUT BASEMENT LEVEL.

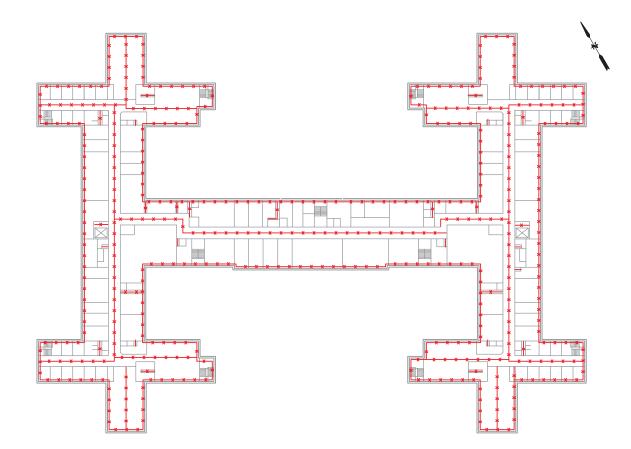
ASBESTOS CONTAINING THERMAL SYSTEM INSULATION MATERIALS LOCATION SECOND FLOOR — COCHRAN HOUSE SCALE: N.T.S.

× × × × PIPE INSULATION AND MUDDED PIPE FITTING INSULATION

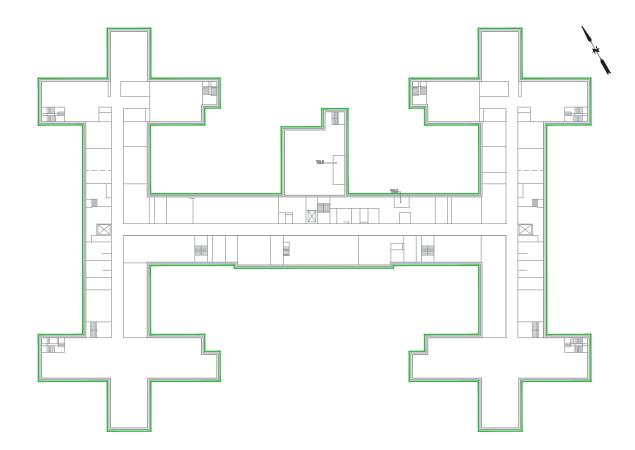
ASBESTOS CONTAINING EXTERIOR MATERIALS LOCATION FIRST FLOOR - COCHRAN HOUSE

BLACK TAR/PAPER BETWEEN BRICK AND CONCRETE FOUNDATION

EXTERIOR GRAY DOOR CAULKING COMPOUNDS
