# **Hazardous Building Materials Inspection**

**Newtown Hall  
Fairfield Hills Campus  
Newtown, Connecticut**

August 2015

Revised December 2016

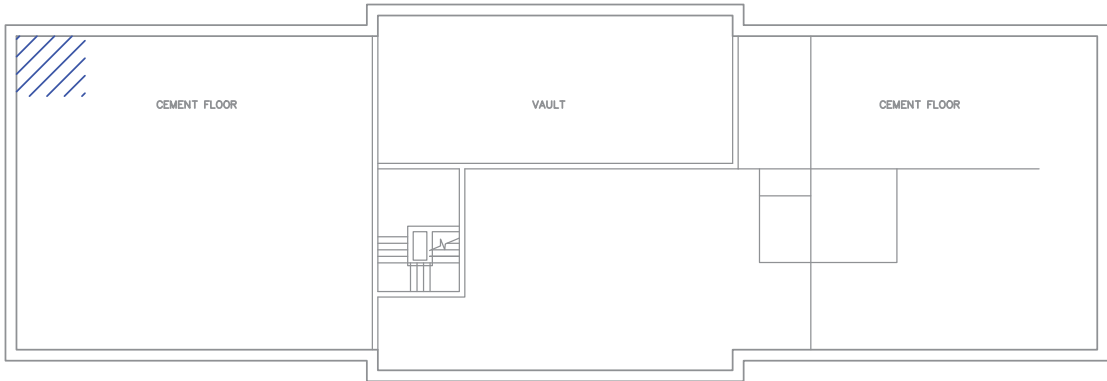
1 ASBESTOS CONTAINING MISCELLANEOUS MATERIALS LOCATION  
BASEMENT — NEWTOWN HALL  
SCALE: 3/32" = 1'-0"

FLOOR TILE & MASTIC

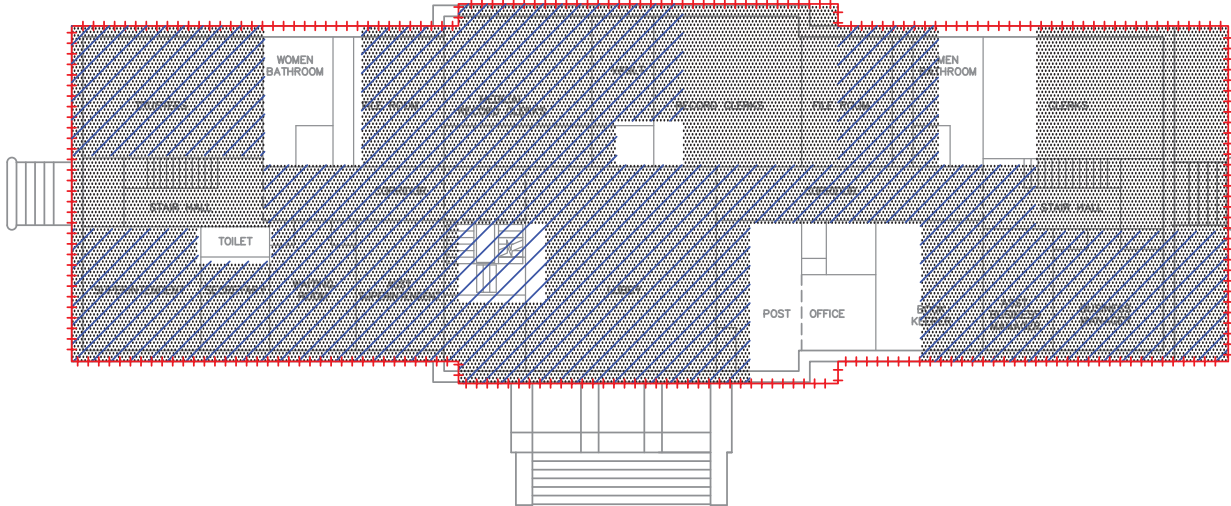
2 ASBESTOS CONTAINING MISCELLANEOUS MATERIALS LOCATION  
FIRST FLOOR — NEWTOWN HALL  
SCALE: 3/32" = 1'-0"

BROWN GLUE DAUBS ON 6"x4" CEILING  
TILES  
+++++ INTERIOR BLACK TAR/DAMPROOFING ON  
TERRACOTTA

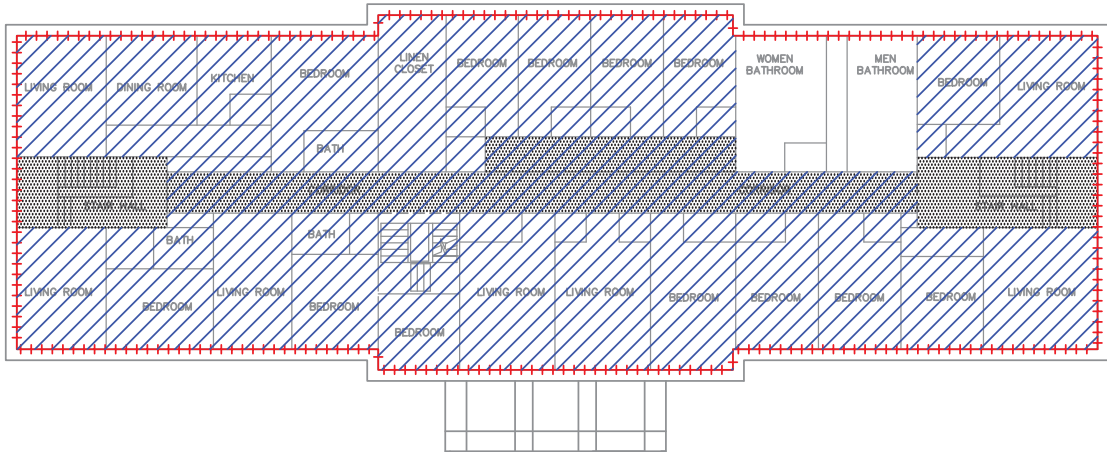
3 ASBESTOS CONTAINING MISCELLANEOUS MATERIALS LOCATION  
SECOND FLOOR — NEWTOWN HALL  
SCALE: 3/32" = 1'-0"

BROWN GLUE DAUBS ON 6"x4" CEILING  
TILES  
+++++ INTERIOR BLACK TAR/DAMPROOFING ON  
TERRACOTTA

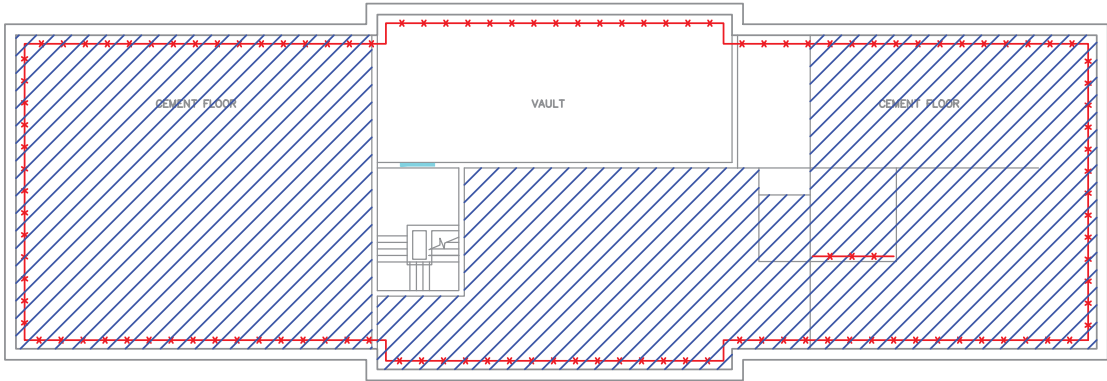
1 ASBESTOS CONTAINING THERMAL SYSTEM INSULATION MATERIALS LOCATION  
BASEMENT – NEWTOWN HALL  
SCALE: 3/32"= 1'-0"

- PIPE INSULATION AND MUDDIED PIPE FITTING INSULATION DEBRIS
- VAULT DOOR INSULATION
- PIPE INSULATION AND MUDDIED PIPE FITTING INSULATION

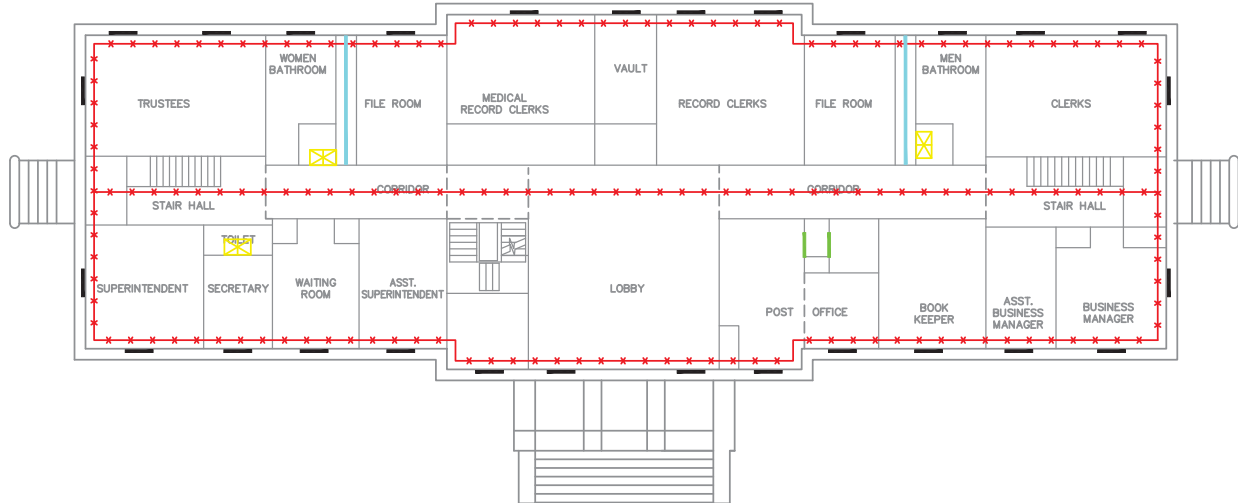
2 ASBESTOS CONTAINING THERMAL SYSTEM INSULATION MATERIALS LOCATION  
FIRST FLOOR – NEWTOWN HALL  
SCALE: 3/32"= 1'-0"

- PIPE INSULATION AND MUDDIED PIPE FITTING INSULATION
- PIPE WALL CHASE
- GRAY RADIATOR INSULATION AND INSULATION PAPER
- VAULT DOOR INSULATION
- SINK WITH PIPE INSULATION AND MUDDIED PIPE FITTING INSULATION

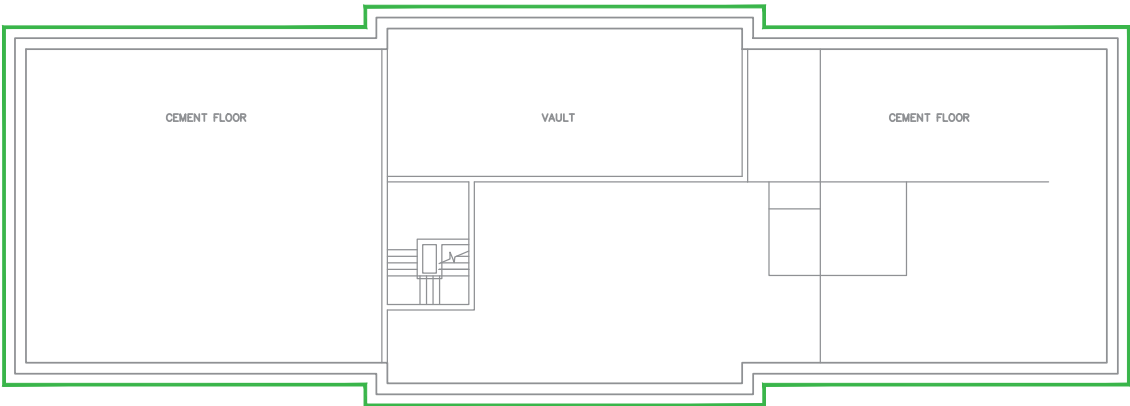
1 ASBESTOS CONTAINING EXTERIOR MATERIALS LOCATION  
BASEMENT – NEWTOWN HALL  
SCALE: 3/32"= 1'-0"

EXTERIOR WINDOW CAULKING AND GLAZING COMPOUNDS

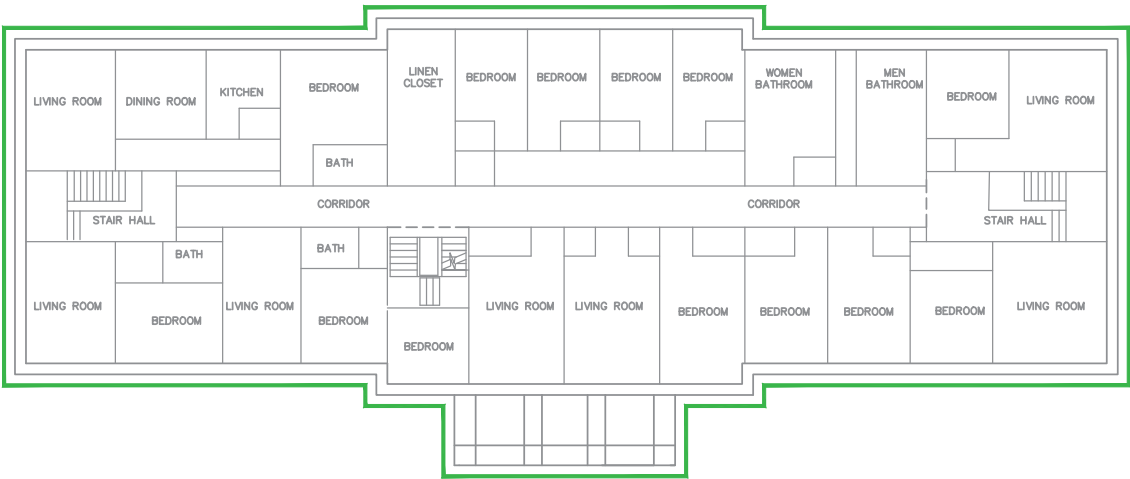
3 ASBESTOS CONTAINING EXTERIOR MATERIALS LOCATION  
SECOND FLOOR – NEWTOWN HALL  
SCALE: 3/32"= 1'-0"

EXTERIOR WINDOW CAULKING AND GLAZING COMPOUNDS

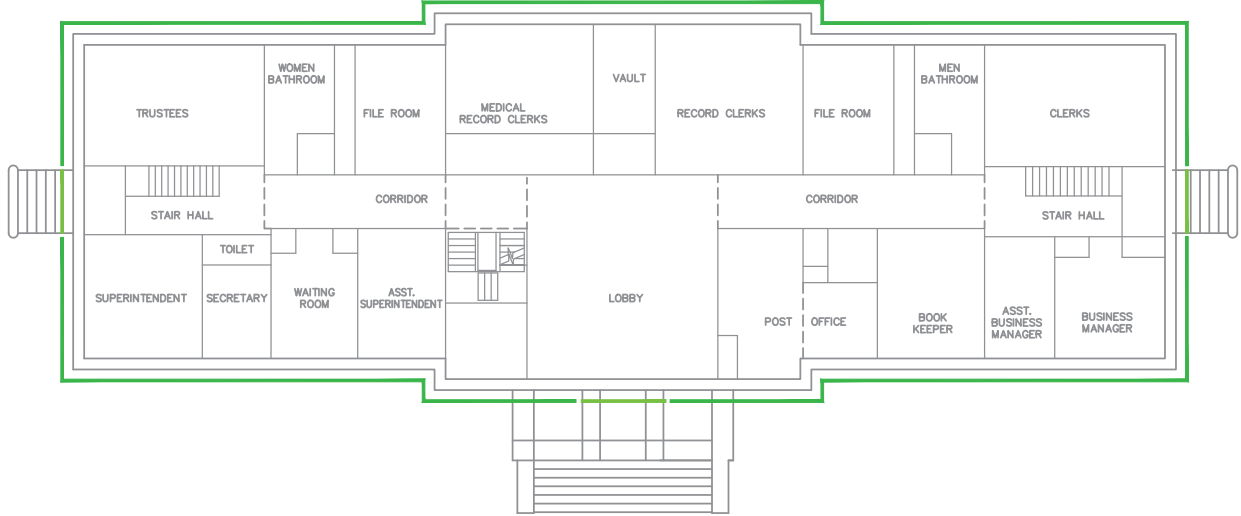
2 ASBESTOS CONTAINING EXTERIOR MATERIALS LOCATION  
FIRST FLOOR – NEWTOWN HALL  
SCALE: 3/32"= 1'-0"

EXTERIOR WINDOW CAULKING AND GLAZING COMPOUNDS

EXTERIOR DOOR CAULKING COMPOUNDS

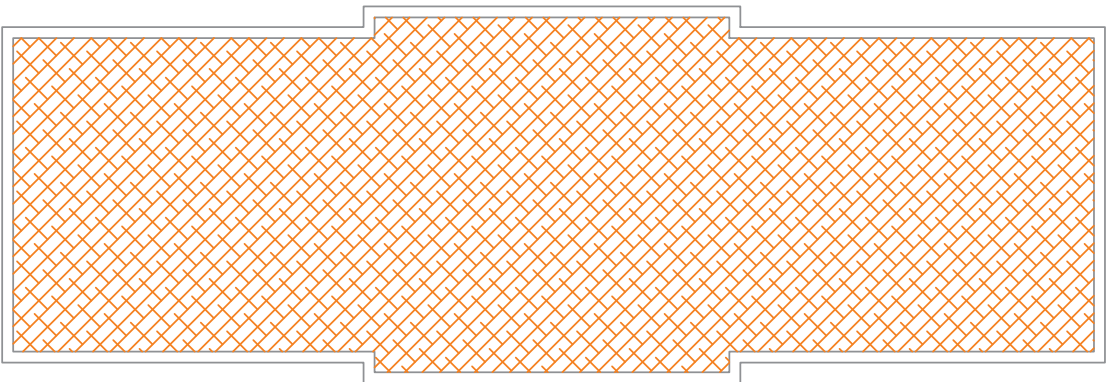
4 ASBESTOS CONTAINING EXTERIOR MATERIALS LOCATION  
ROOF – NEWTOWN HALL  
SCALE: 3/32"= 1'-0"

EXTERIOR CEMENTITIOUS ROOF SHINGLES AND ASSOCIATED FLASHING AND TARS

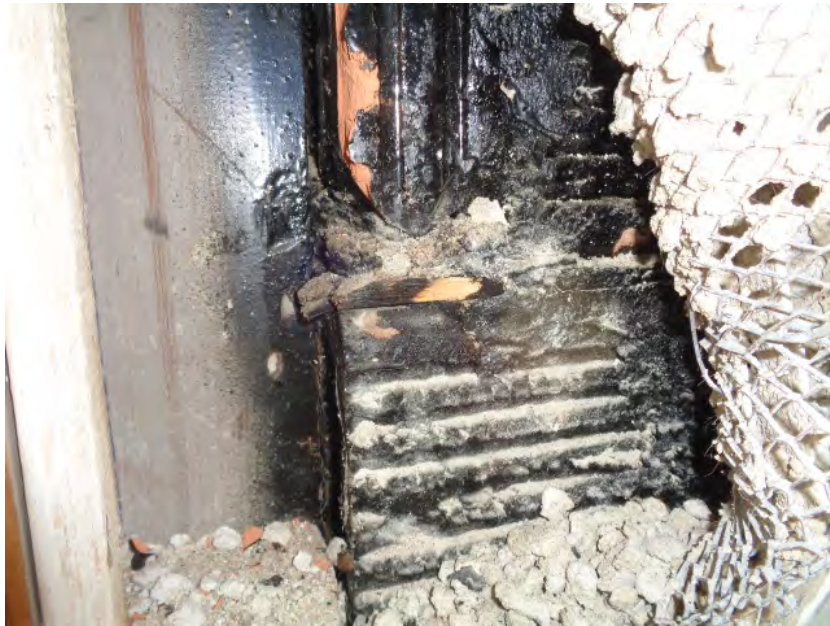
ACM Black Tar/Damproofing on Terracotta Block

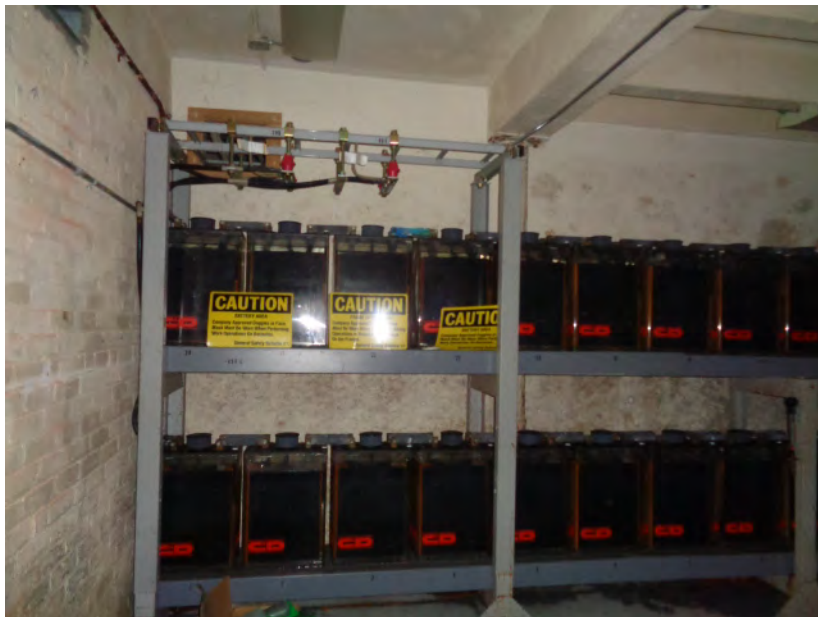
Batteries with Fluid (Corrosives) in Basement
