Hazardous Building Materials Inspection

Shelton House
Fairfield Hills Campus
Newtown, Connecticut

July 2015

Re: Hazardous Building Materials Inspection Report
Shelton House
Fairfield Hills Campus, Keating Farms Avenue, Newtown, Connecticut
Fuss & O'Neill EnviroScience Project No. 20141268.A1E

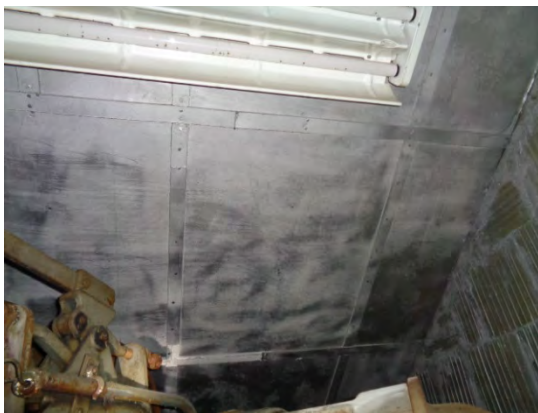
ACM Ceiling Panels, Attic Mechanical Room

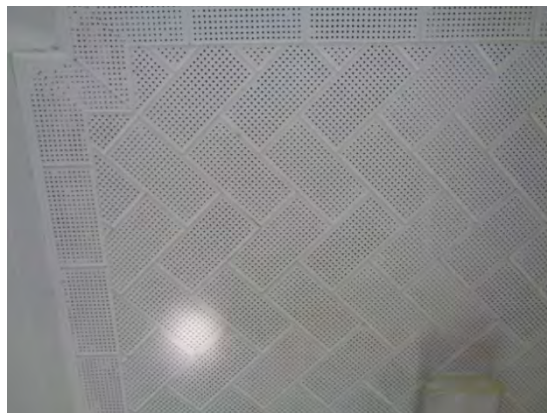
6" x 4" Ceiling Tile with ACM Brown Glue Daubs

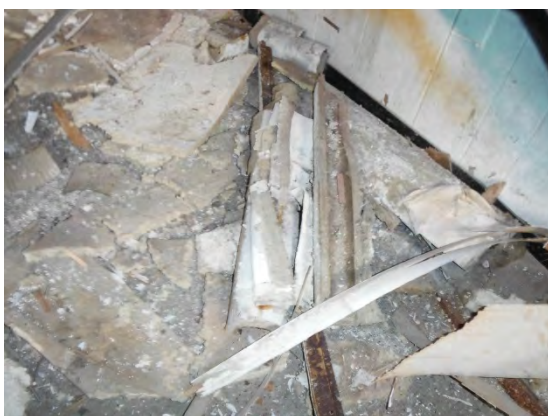
ACM Thermal System Insulation Debris

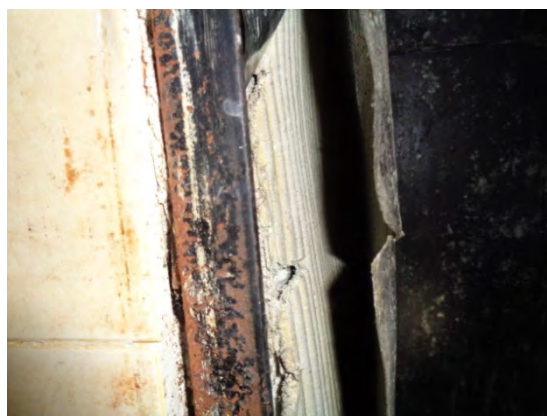
ACM Corrugated Paper behind Metal Radiator Panel

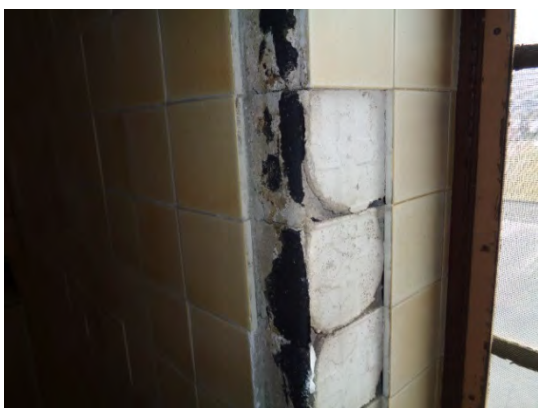
ACM Black Adhesive behind Ceramic Wall Tile

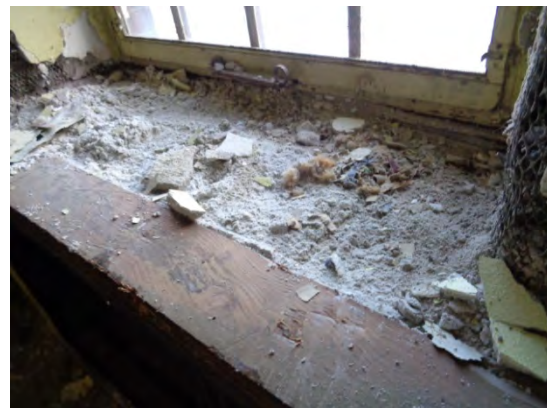
ACM Packing Insulation around Radiator

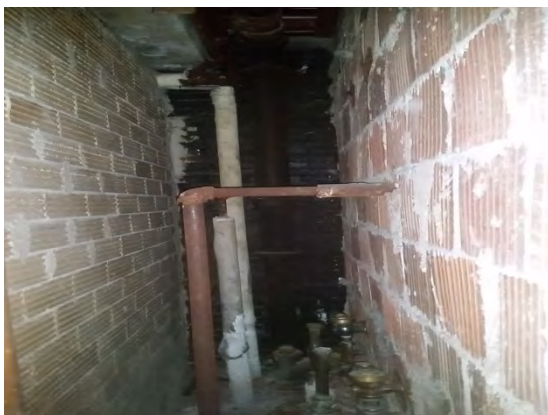
ACM Pipe and Pipe Fitting Insulations in Wall

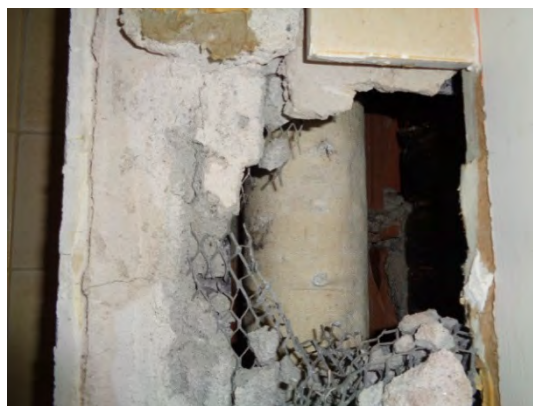
Concealed ACM Pipe Insulation in Vertical Pipe Chase

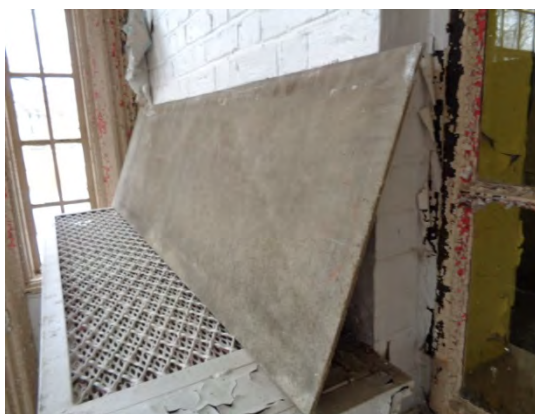
Cementitious Panel Radiator Cover

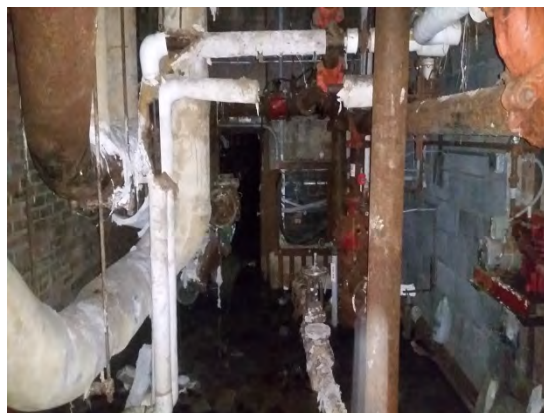
ACM Pipe and Mudded Pipe Fitting Insulations in Basement

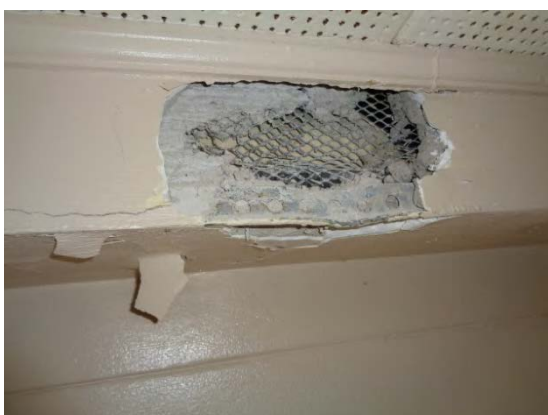
ACM Pipe Insulation in Concealed Horizontal Ceiling Pipe Chase

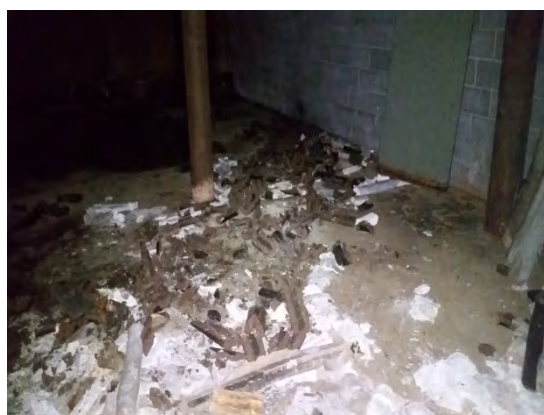
ACM Thermal System Insulation Debris on Basement Floor

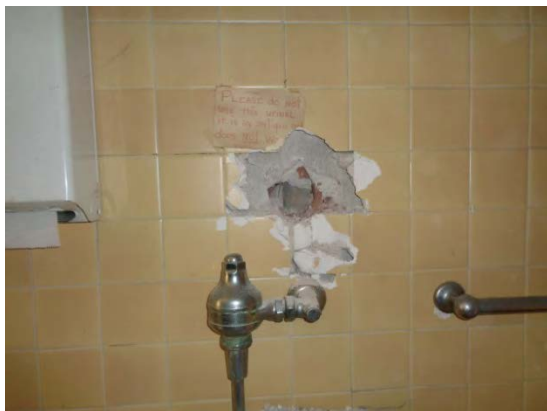
Concealed ACM Pipe Insulation in Bathroom Wall

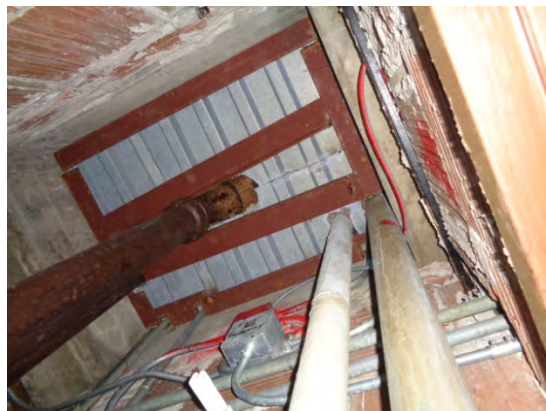
Wall Chase with ACM Pipe Insulation

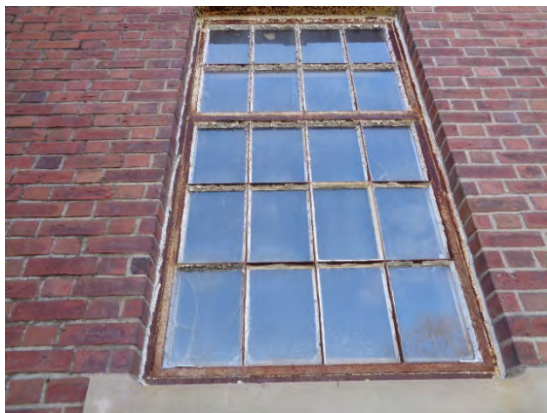
Exterior Window Systems with ACM Window Glazing Compounds

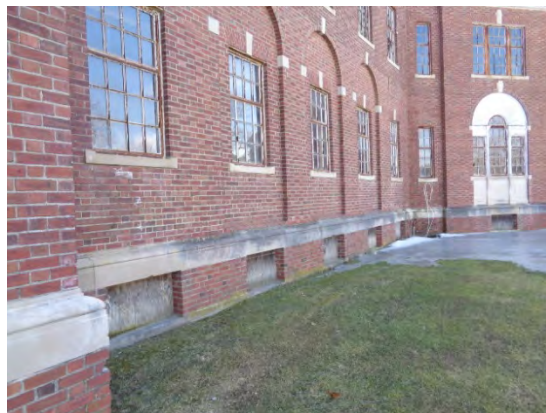
Exterior Window Systems with ACM Window Glazing Compounds

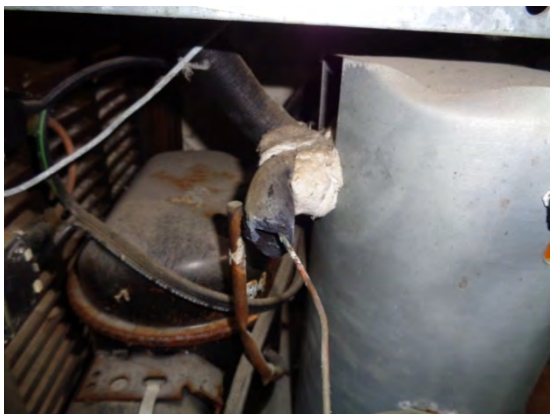
ACM White Caulking Compounds on Drinking Fountain Electrical Wiring
