Hazardous Building Materials Inspection

**Stamford Hall
Fairfield Hills Campus
Newtown, Connecticut**

Town of Newtown

August 2015
Revised December 28, 2016

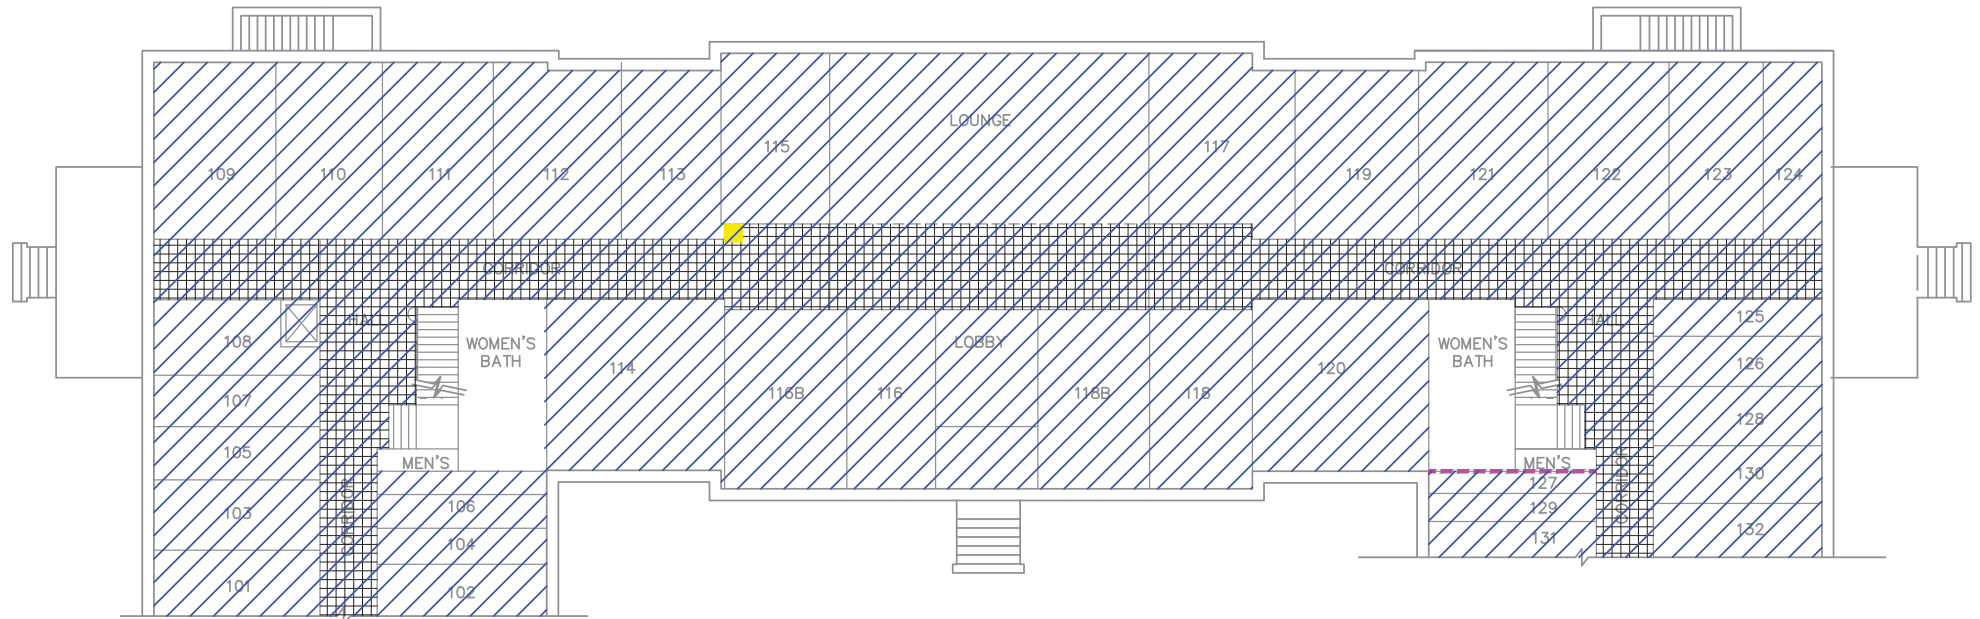
1 ASBESTOS CONTAINING MISCELLANEOUS MATERIALS LOCATION
FIRST FLOOR – STAMFORD HOUSE
SCALE: N.T.S.

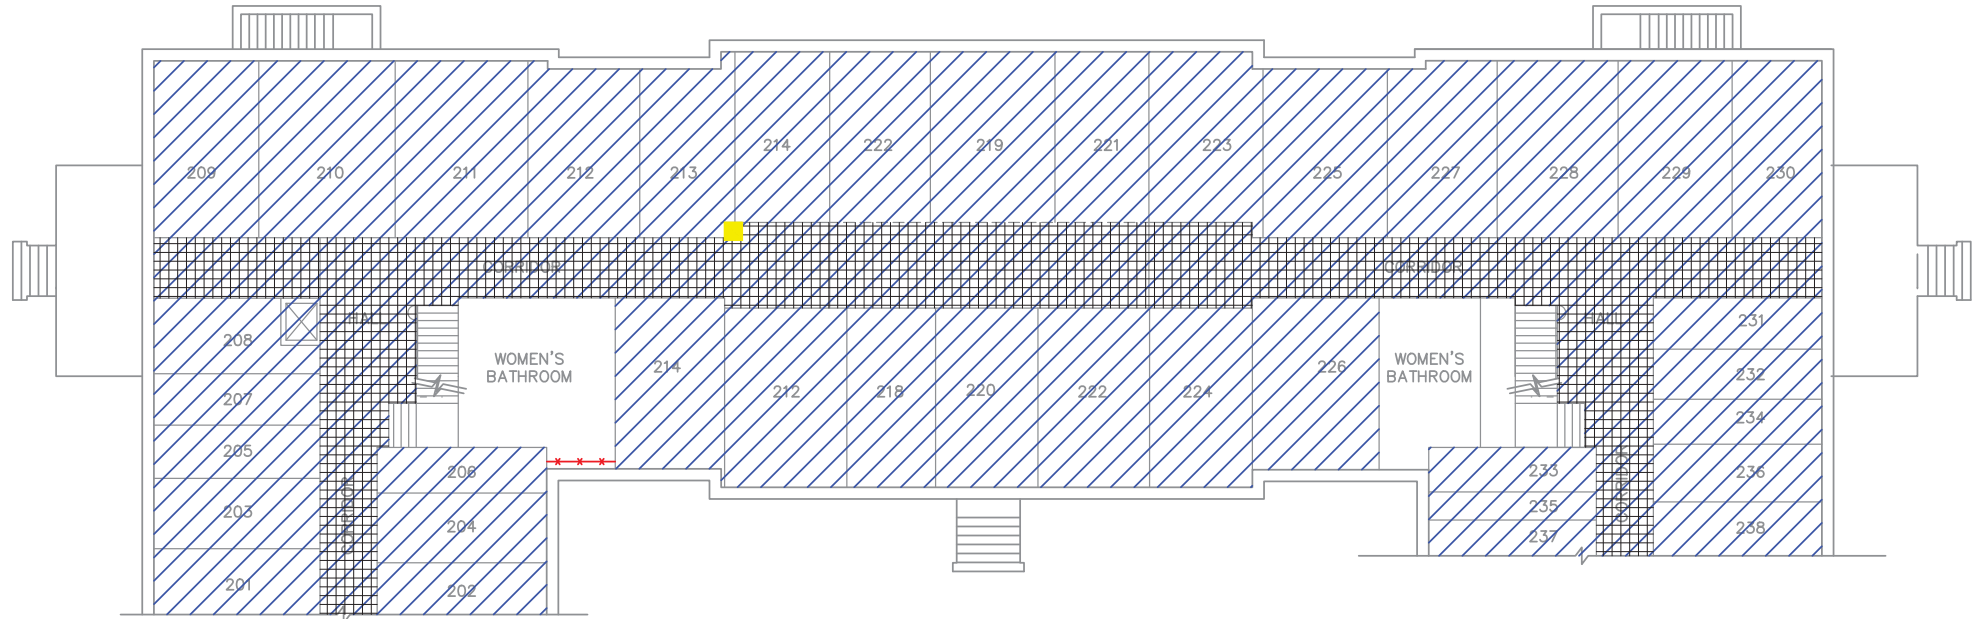
2 ASBESTOS CONTAINING MISCELLANEOUS MATERIALS LOCATION
SECOND FLOOR – STAMFORD HOUSE
SCALE: N.T.S.

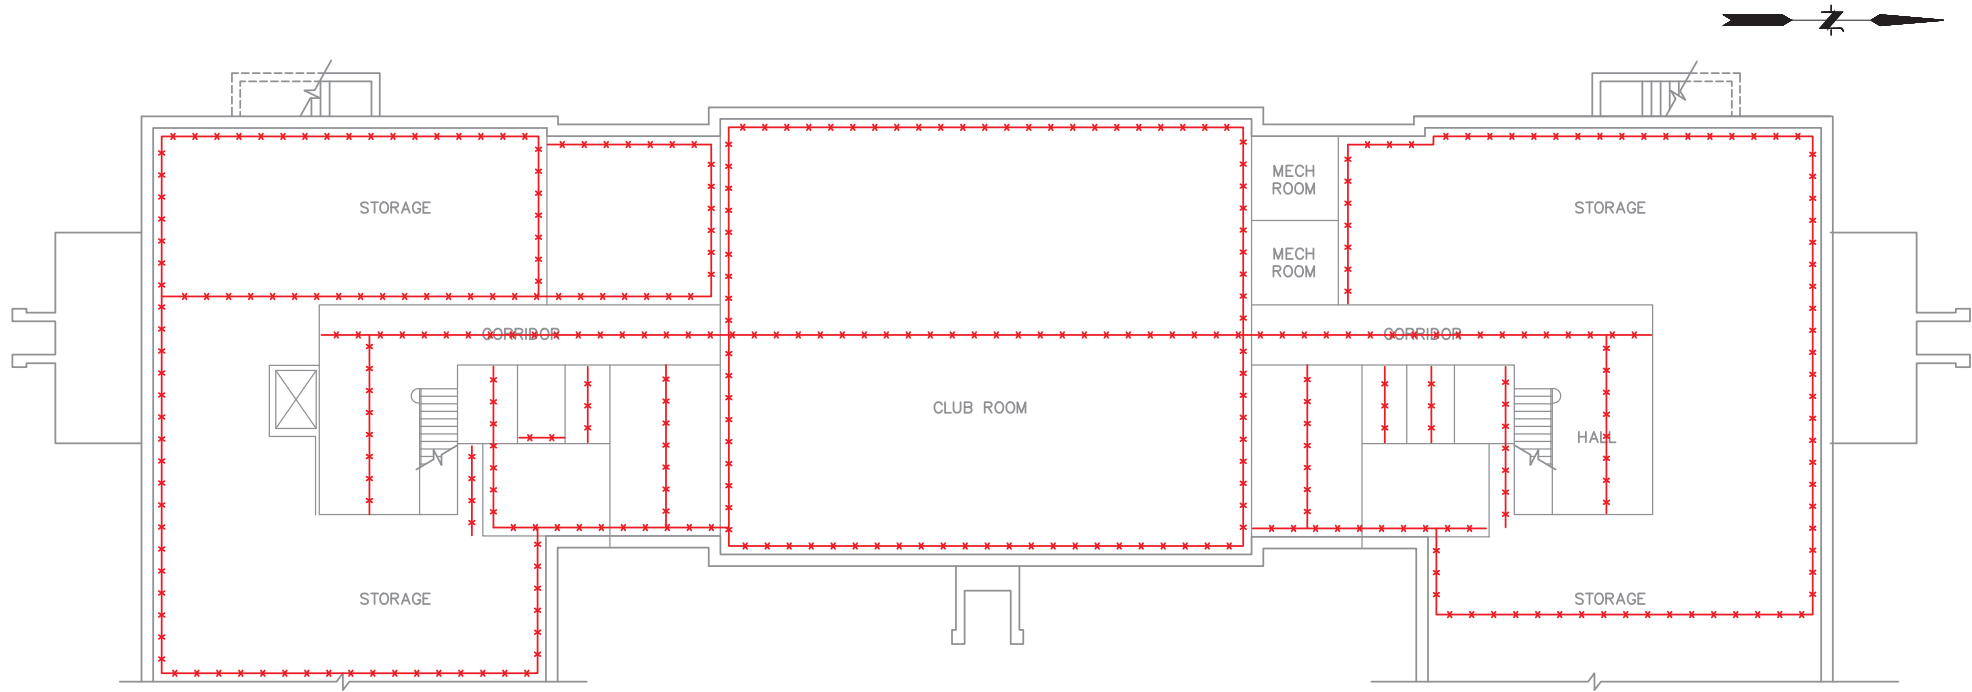
1 ASBESTOS CONTAINING THERMAL SYSTEM INSULATION MATERIALS LOCATION
BASEMENT – STAMFORD HOUSE
SCALE: N.T.S.

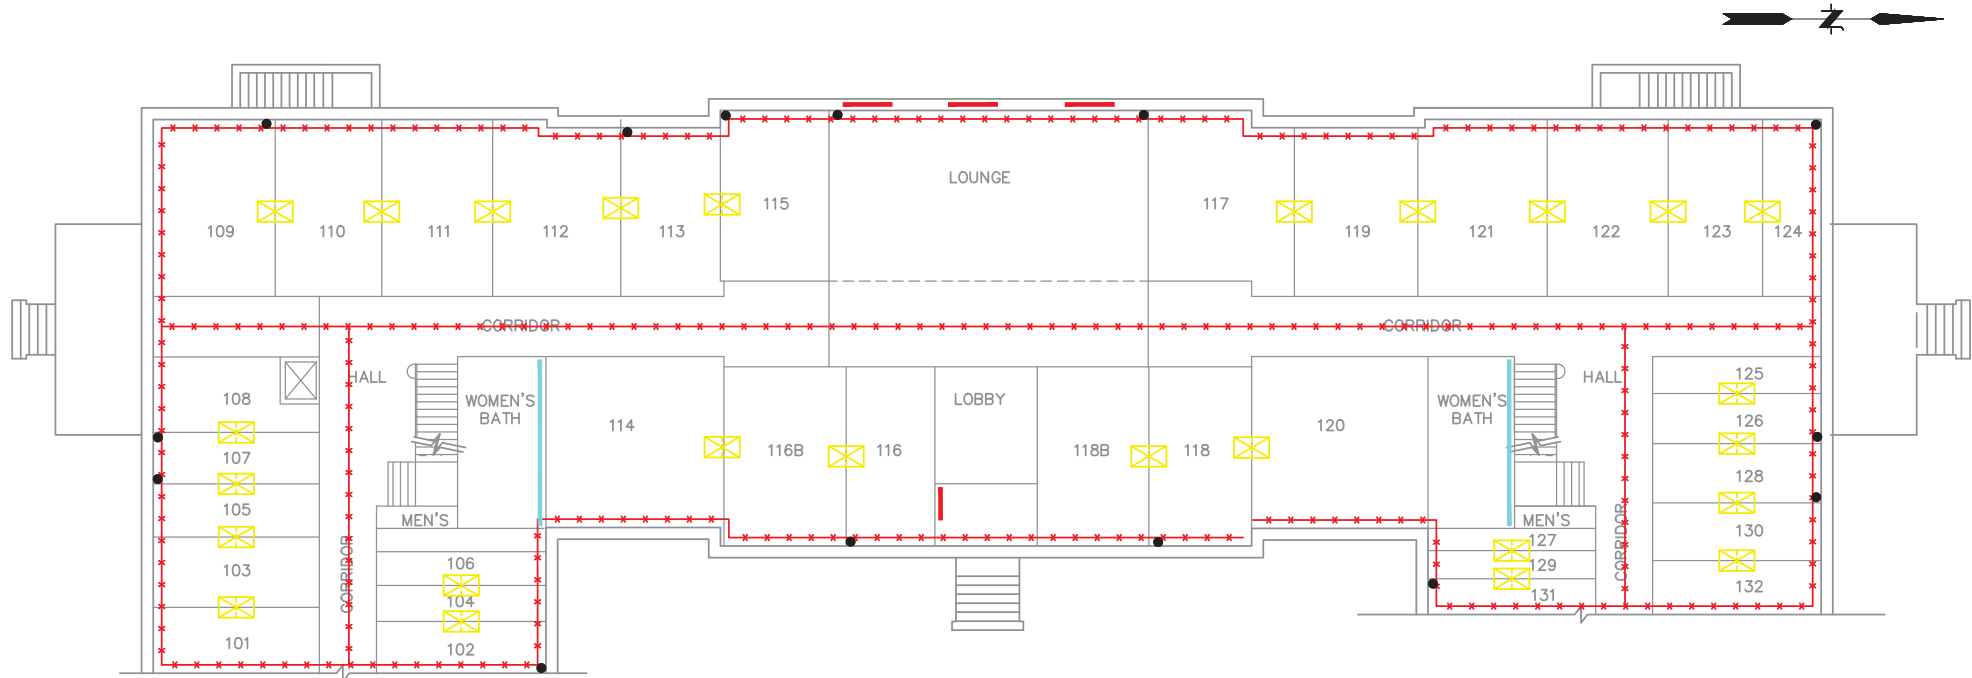
2 ASBESTOS CONTAINING THERMAL SYSTEM INSULATION MATERIALS LOCATION
FIRST FLOOR – STAMFORD HOUSE
SCALE: N.T.S.

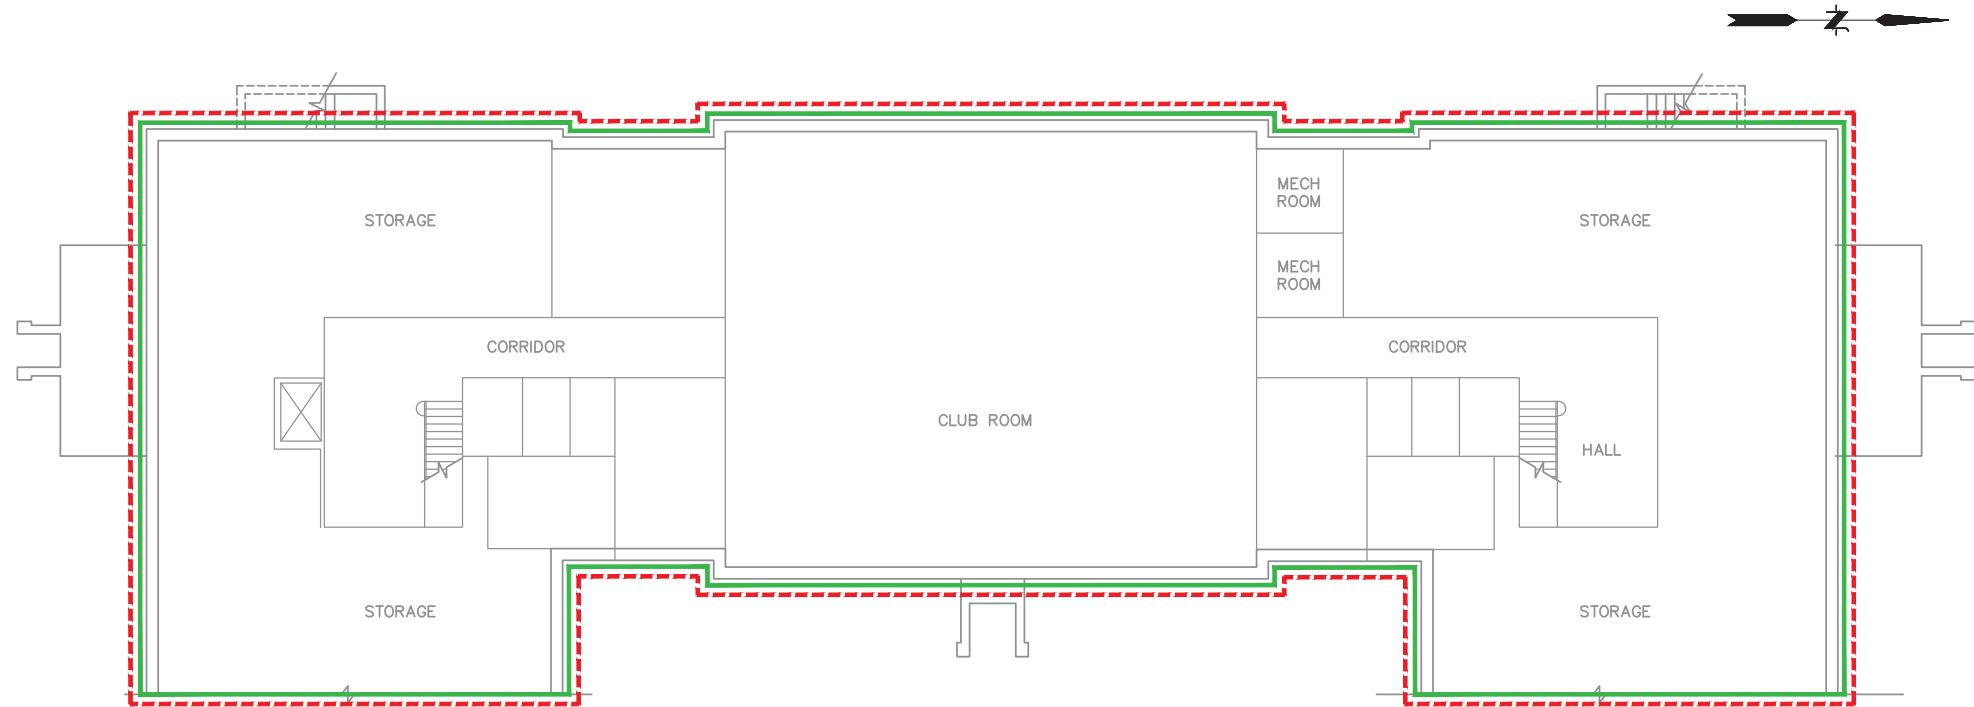
1 ASBESTOS CONTAINING EXTERIOR MATERIALS LOCATION
BASEMENT – STAMFORD HOUSE
SCALE: N.T.S.

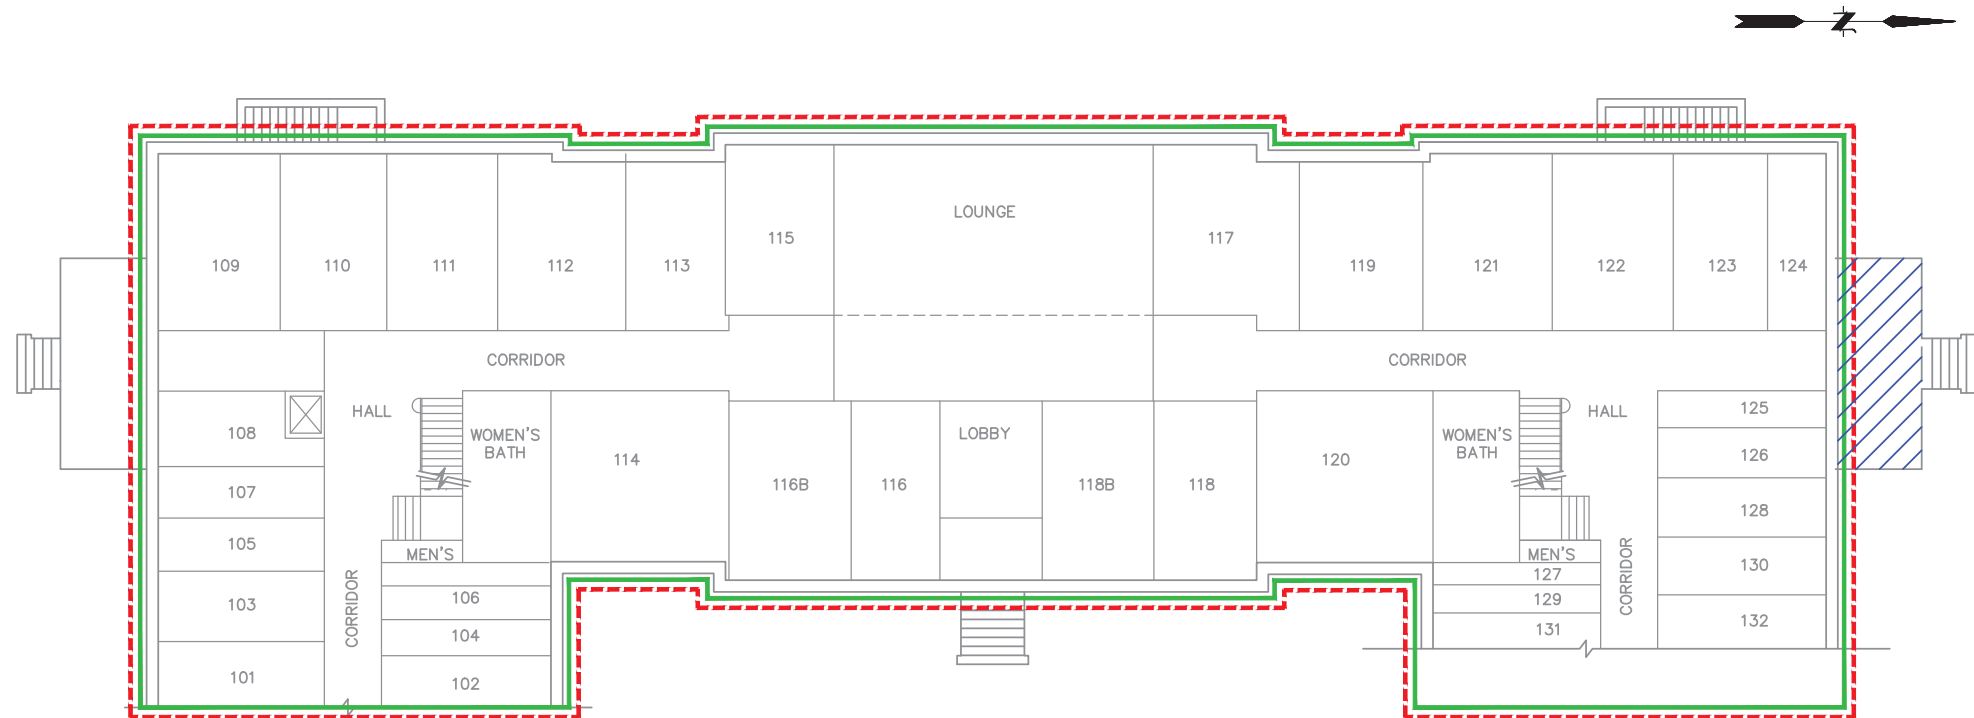
2 ASBESTOS CONTAINING EXTERIOR MATERIALS LOCATION
FIRST FLOOR – STAMFORD HOUSE
SCALE: N.T.S.

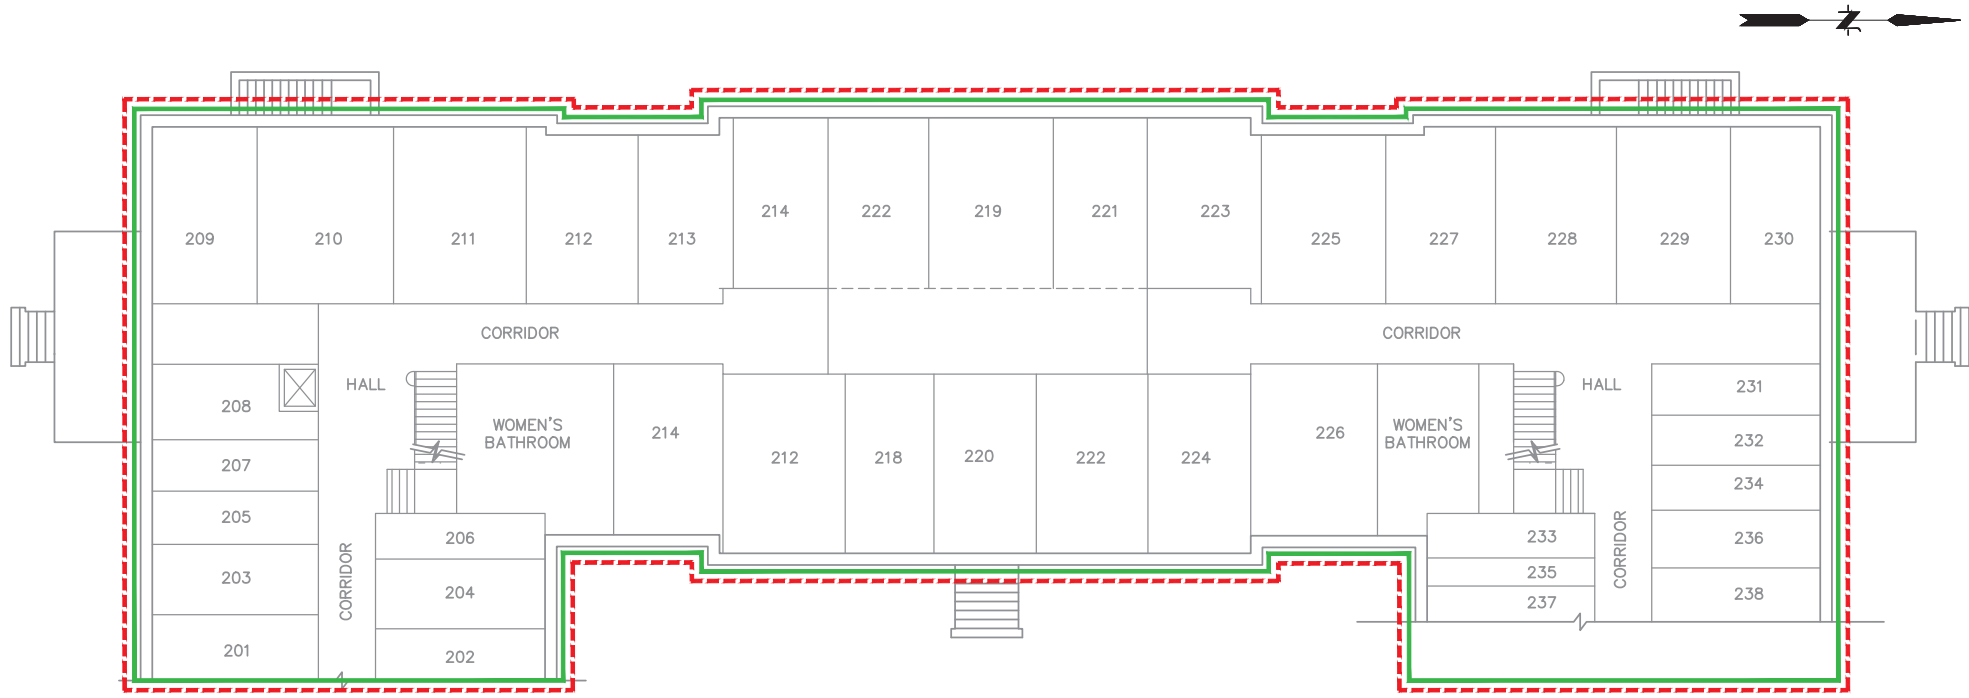
1 ASBESTOS CONTAINING EXTERIOR MATERIALS LOCATION
SECOND FLOOR – STAMFORD HOUSE
SCALE: N.T.S.

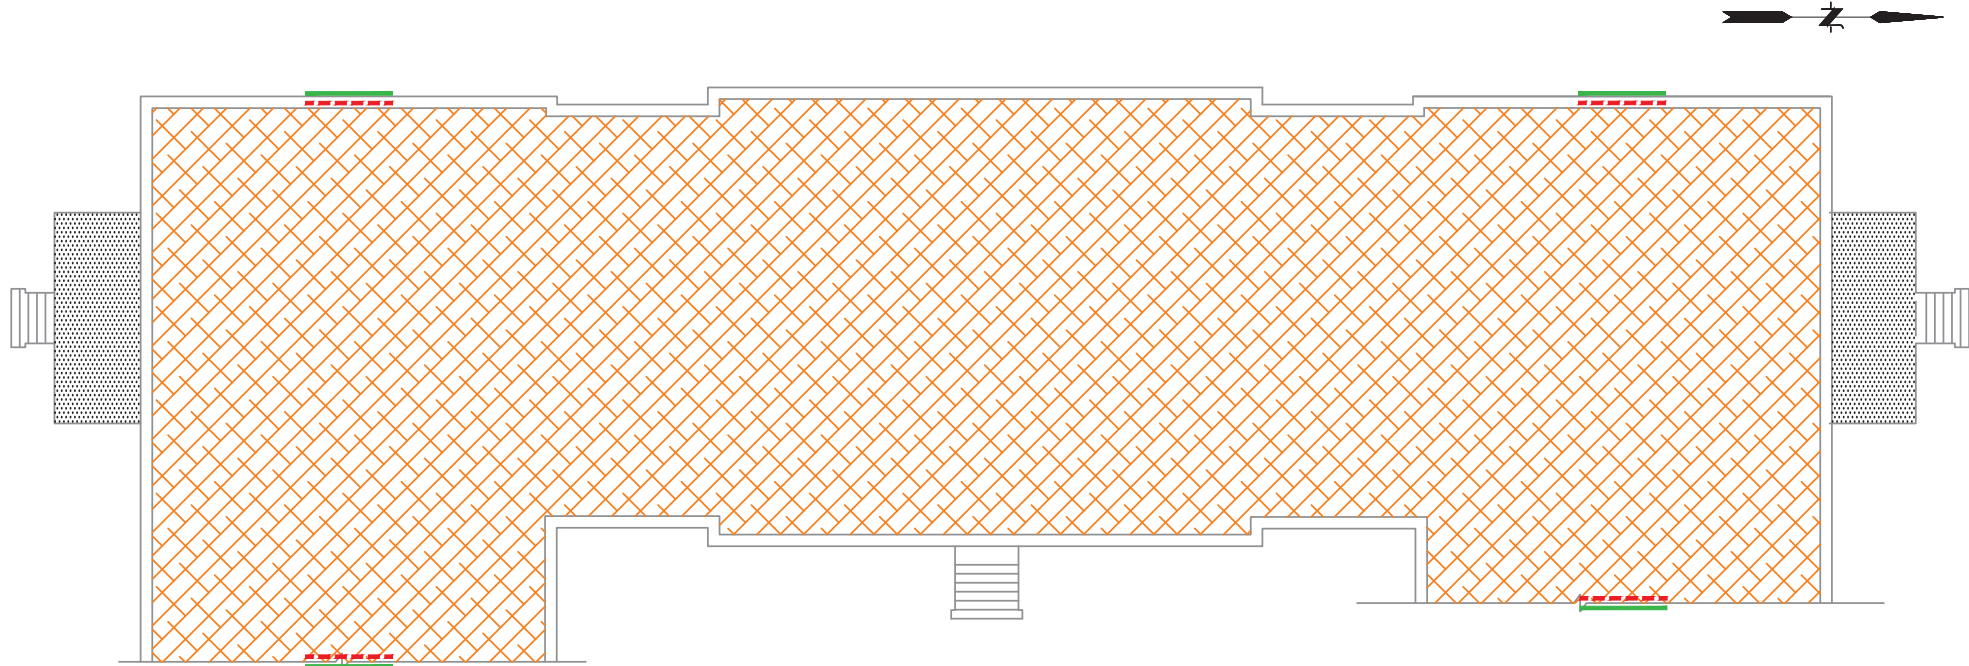
1 ASBESTOS CONTAINING EXTERIOR MATERIALS LOCATION
ROOF – STAMFORD HOUSE
SCALE: N.T.S.

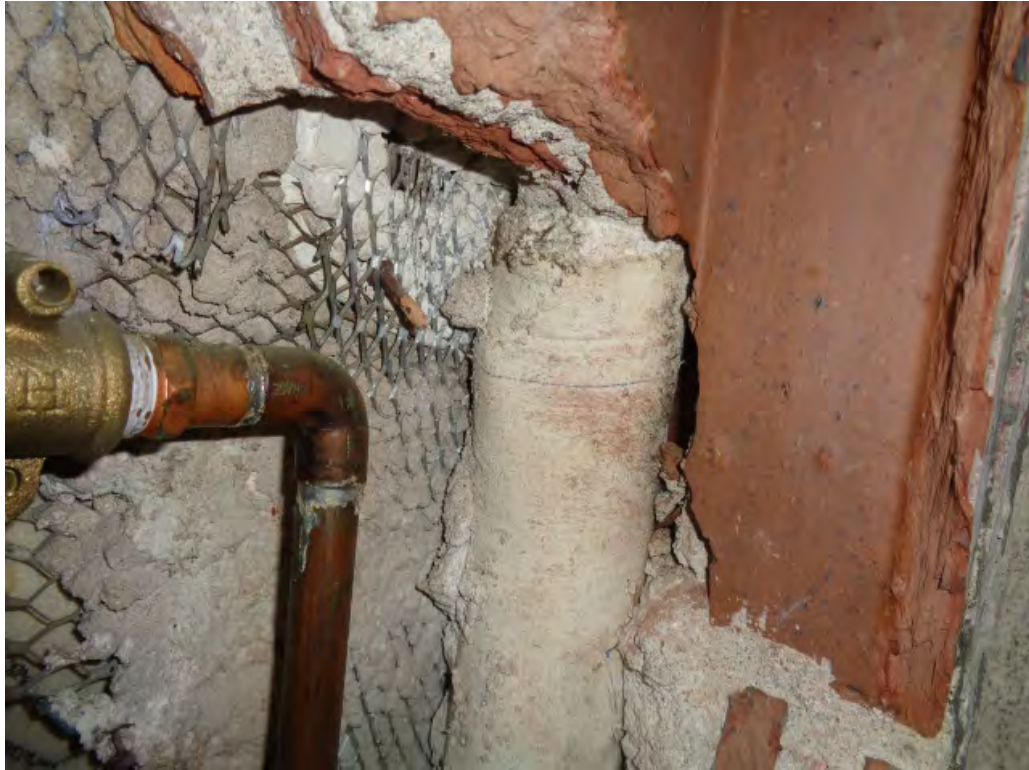
Asbestos-Containing White Solid Core Pipe Insulation

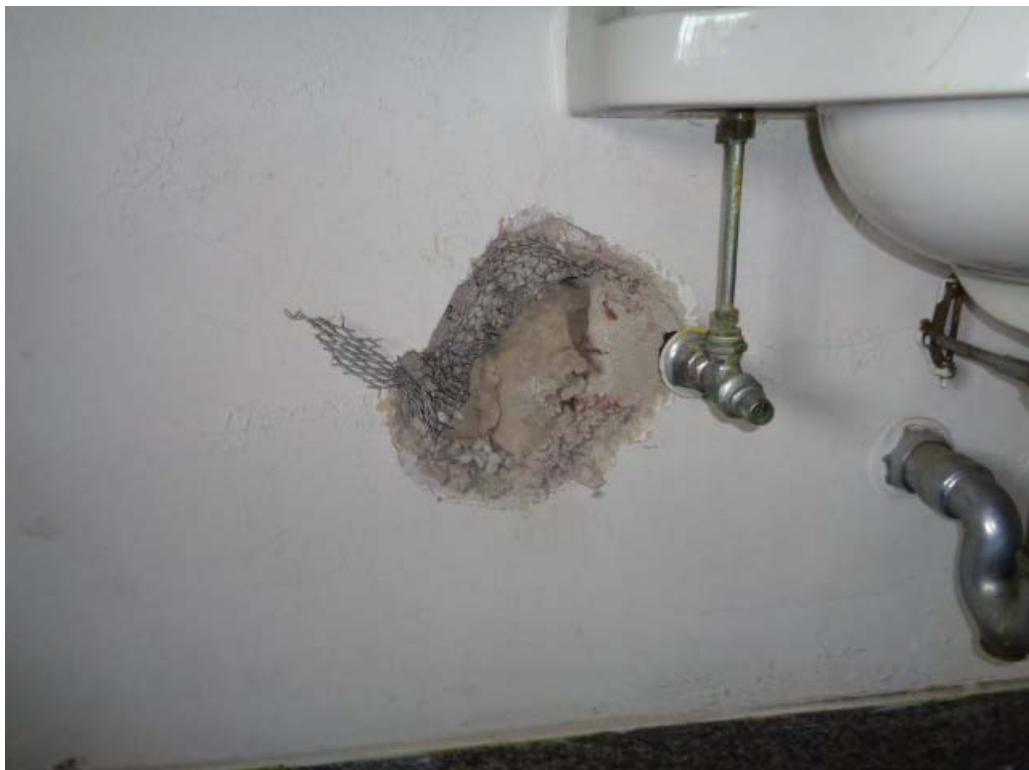
Asbestos-Containing Pipe Insulation in Wall at Sink

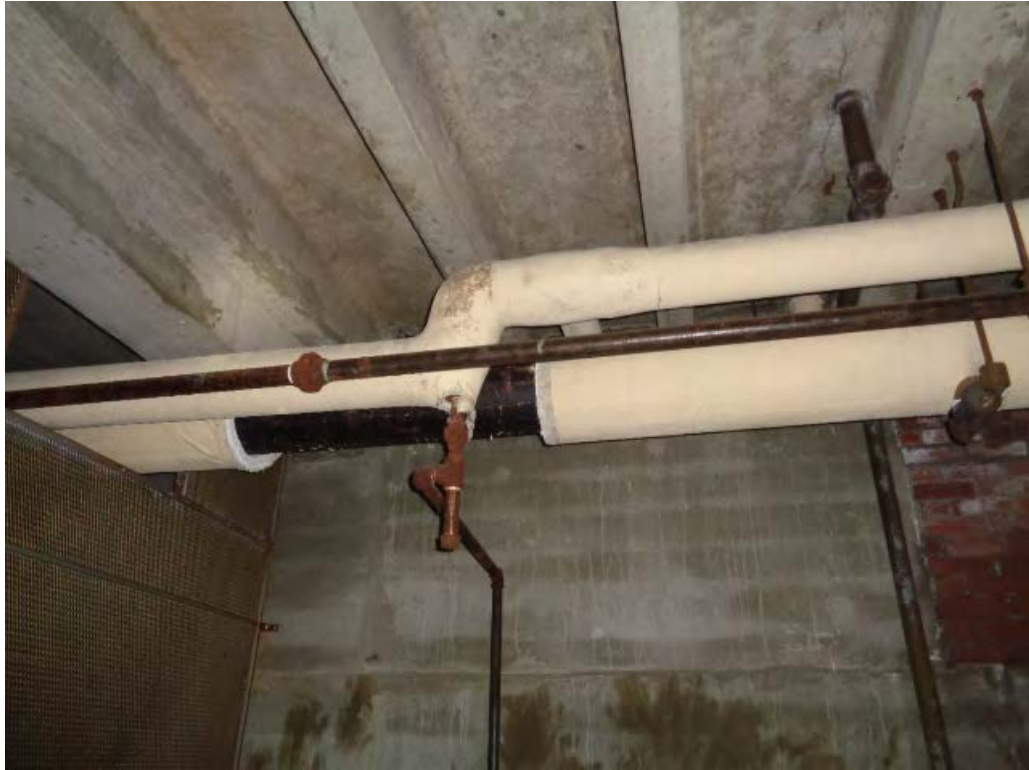
Asbestos-Containing Pipe and Mudded Pipe Fitting Insulations

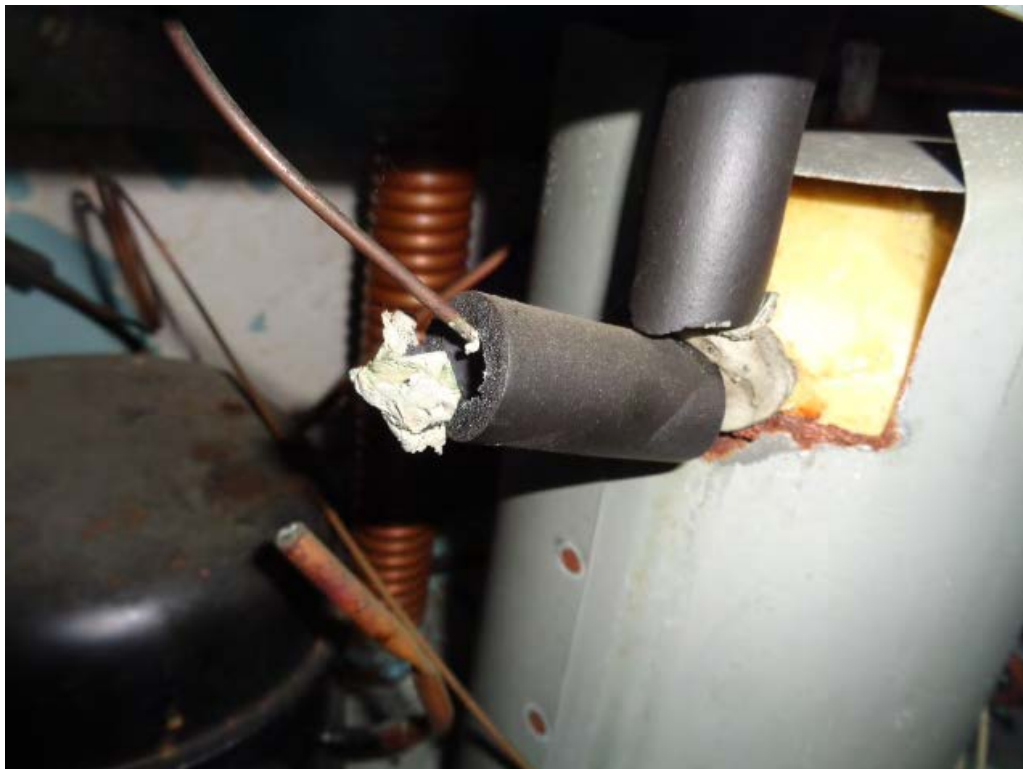
White Putty Caulking on Electrical Wiring inside Metal Drinking Fountain

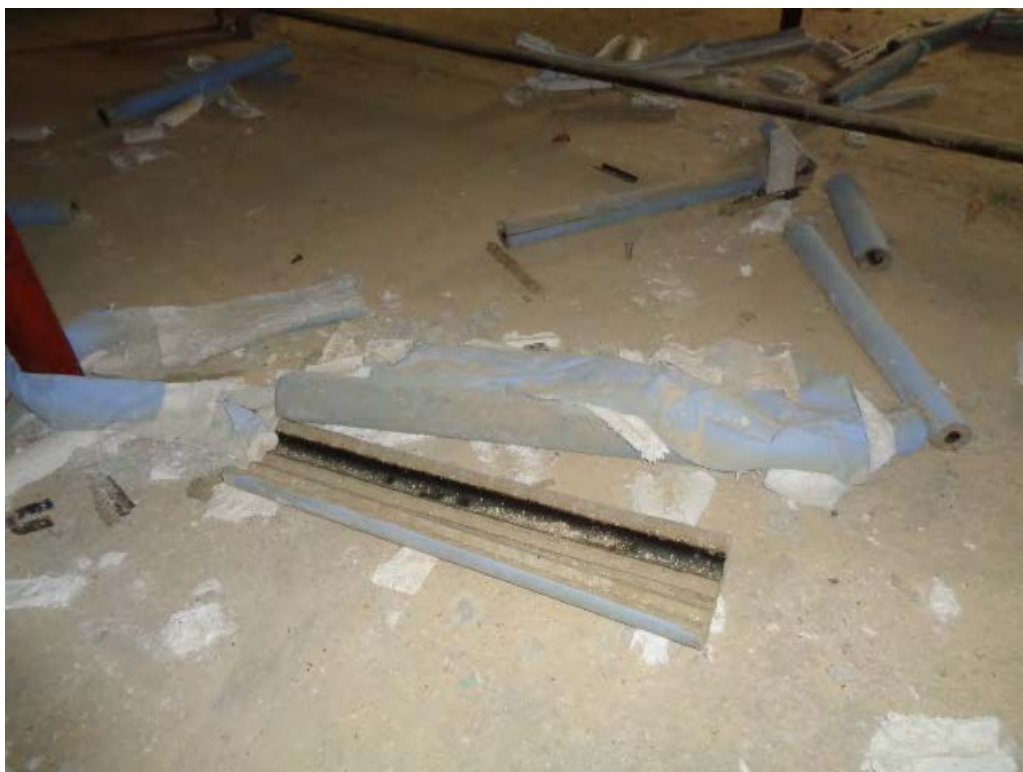
Asbestos-Containing TSI Debris on Ground in Attic

EnviroScience recommends that a comprehensive scope of work and technical specification for asbestos abatement be developed as part of Site renovation and/or demolition plans. Due to damaged ACM located throughout the Site, an Alternative Work Practice (AWP) should be developed by a CTDPH-licensed Asbestos Project Designer and submitted to the CTDPH for approval. The AWP should be developed for the installation of critical barriers, establishment of negative pressure, and construction of a decontamination unit. Once critical barriers, negative pressure, and a decontamination unit are constructed, the abatement contractor would clean all surfaces, abate all ACM, and encapsulate the work area with lockdown encapsulant.

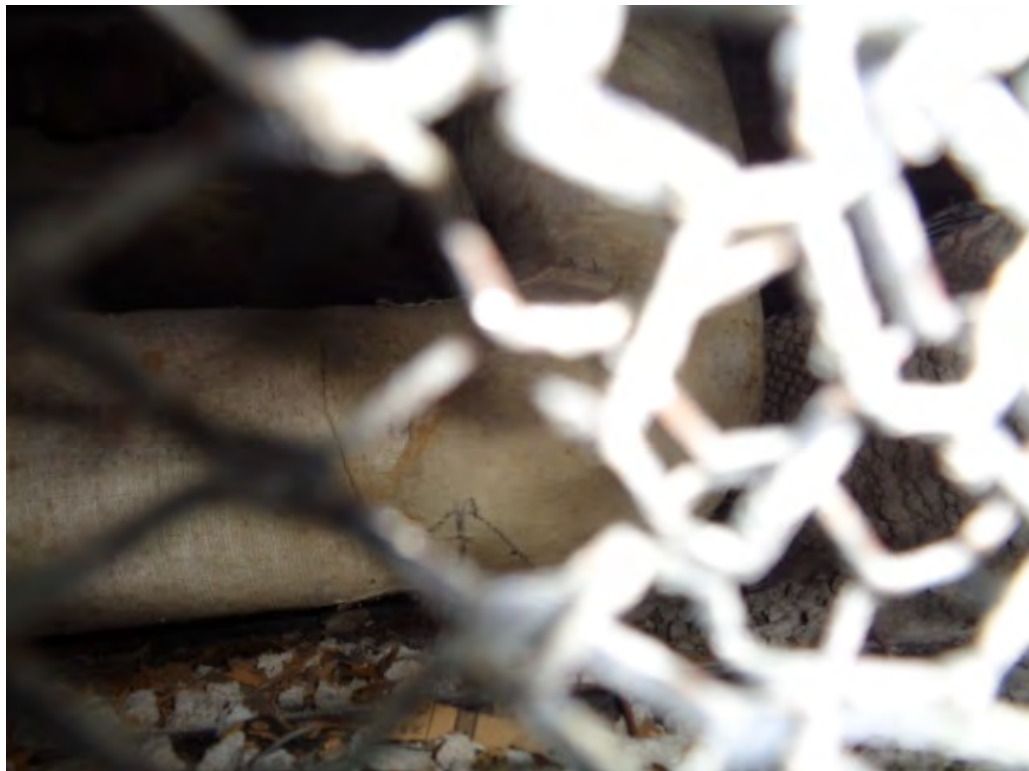
Asbestos-Containing Pipe and Mudded Pipe Insulations inside Horizontal Pipe Chase

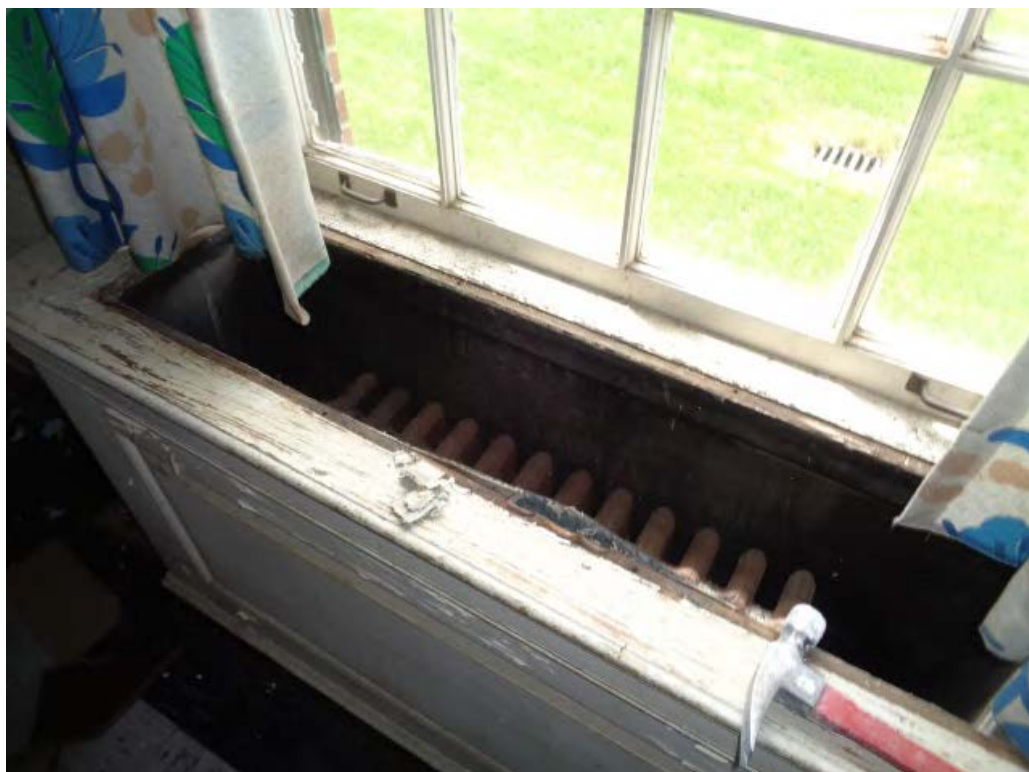
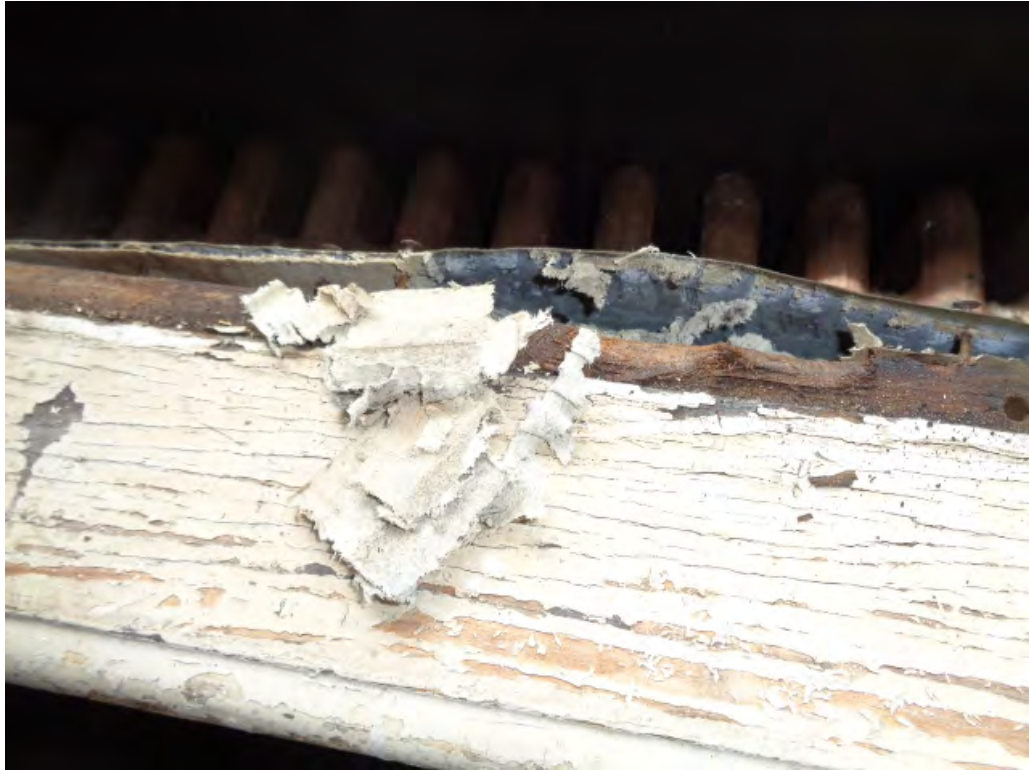
Asbestos-Containing Gray Radiator Insulation and Paper Insulation

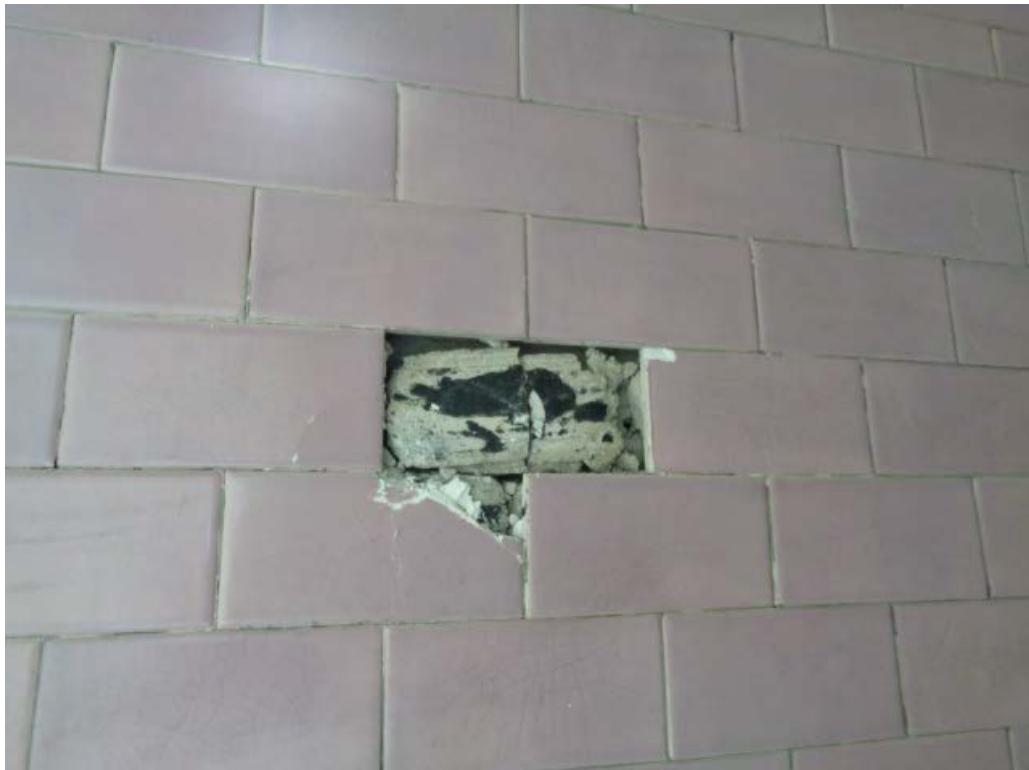
Asbestos-Containing Black Glue on Ceramic Wall Tile

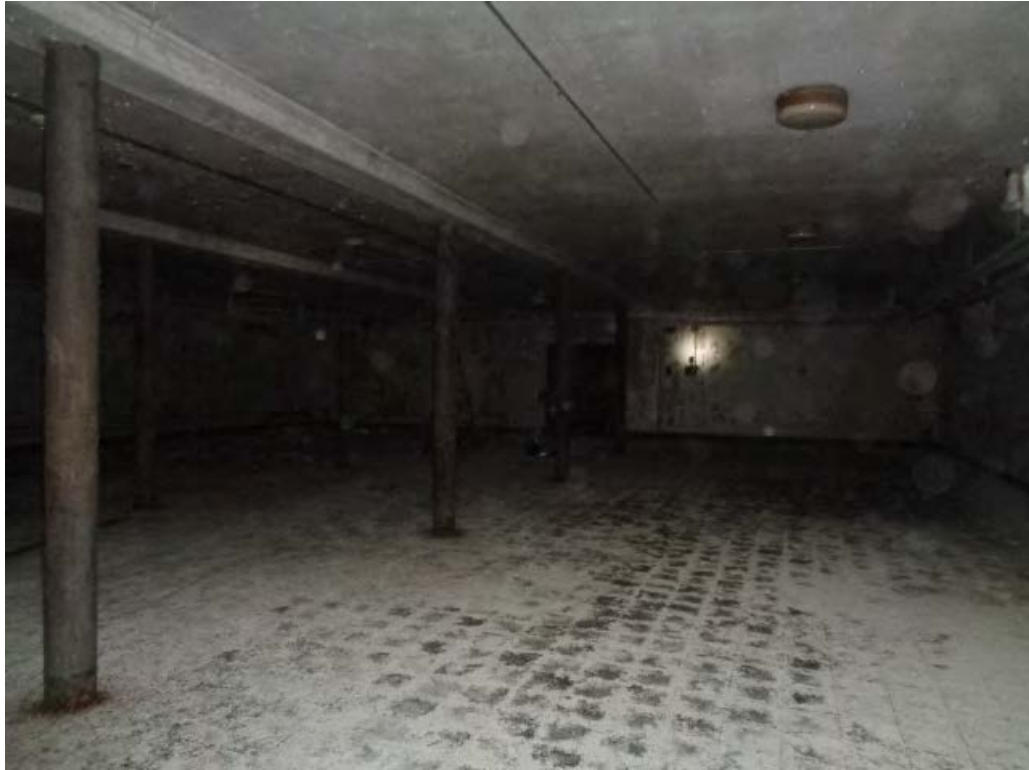
Floor Tile – Multiple types and colors of floor tiles were observed throughout the building at the time of the inspection. Samples of the suspect floor tiles were not collected to identify asbestos content; the floor tiles are considered asbestos-contaminated by the inseparable asbestos-containing black floor mastic attached beneath the tiles. Therefore, all floor tiles must be removed and disposed as ACM prior to building renovation.

Asbestos-Containing Flooring

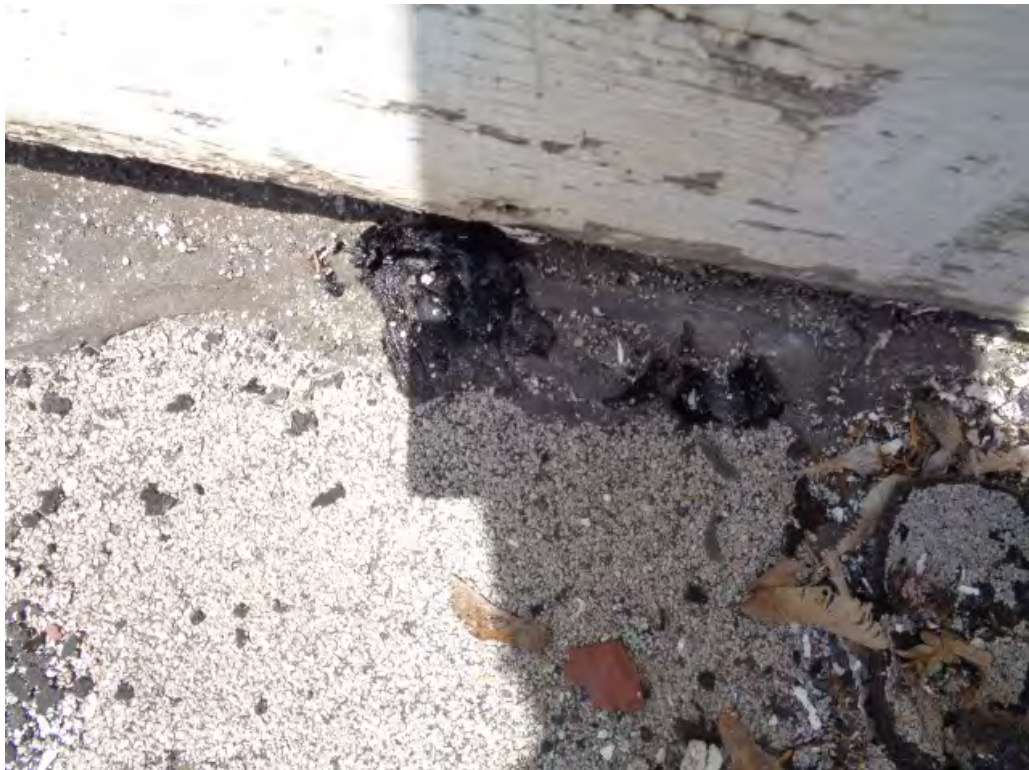
Asbestos-Containing Porch Perimeter Black Flashing/Tar

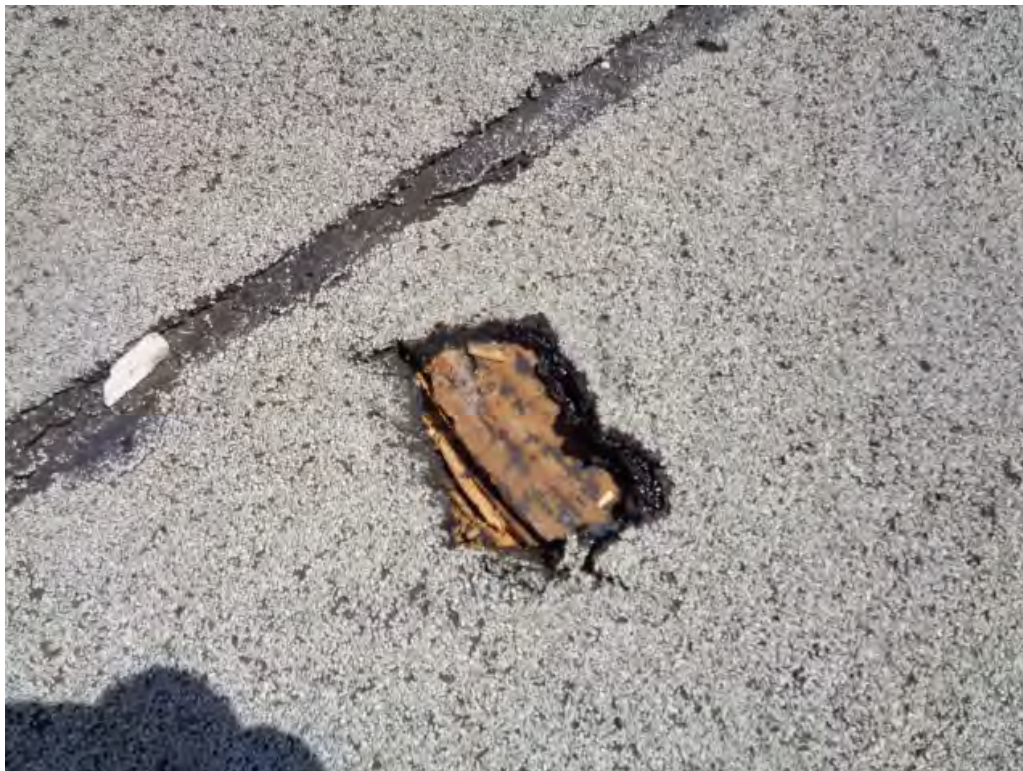
Porch Asbestos-Containing Roofing (field)

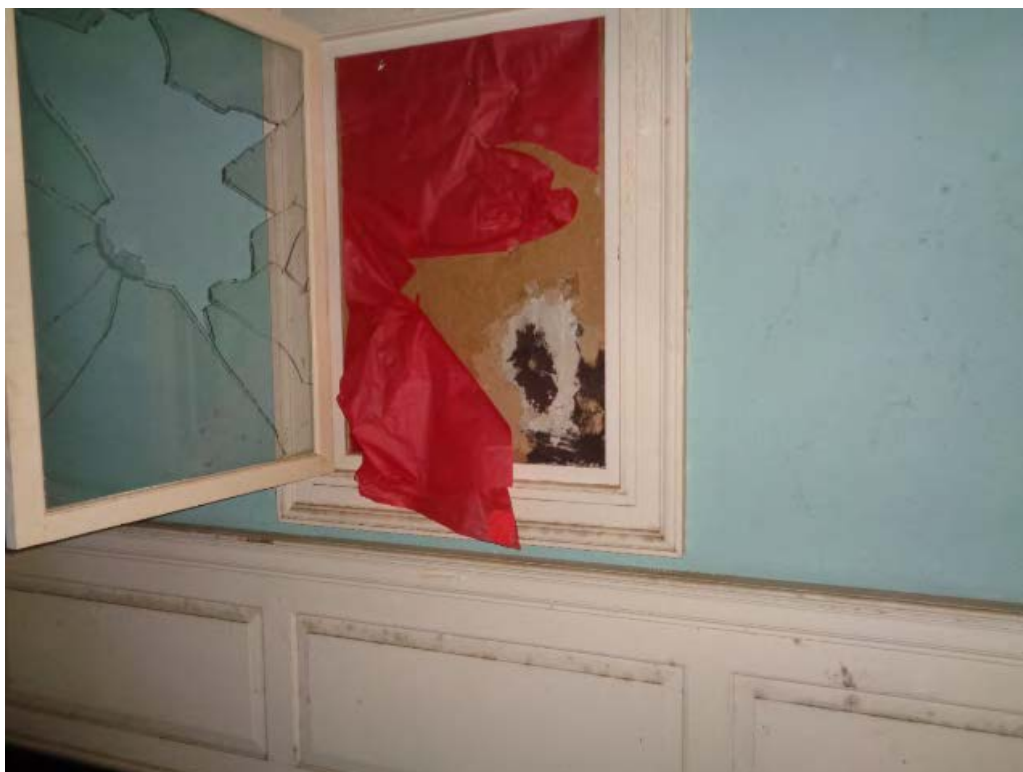
Asbestos-containing Dark Brown Glue Daub on Lounge Room on Bullecion Board

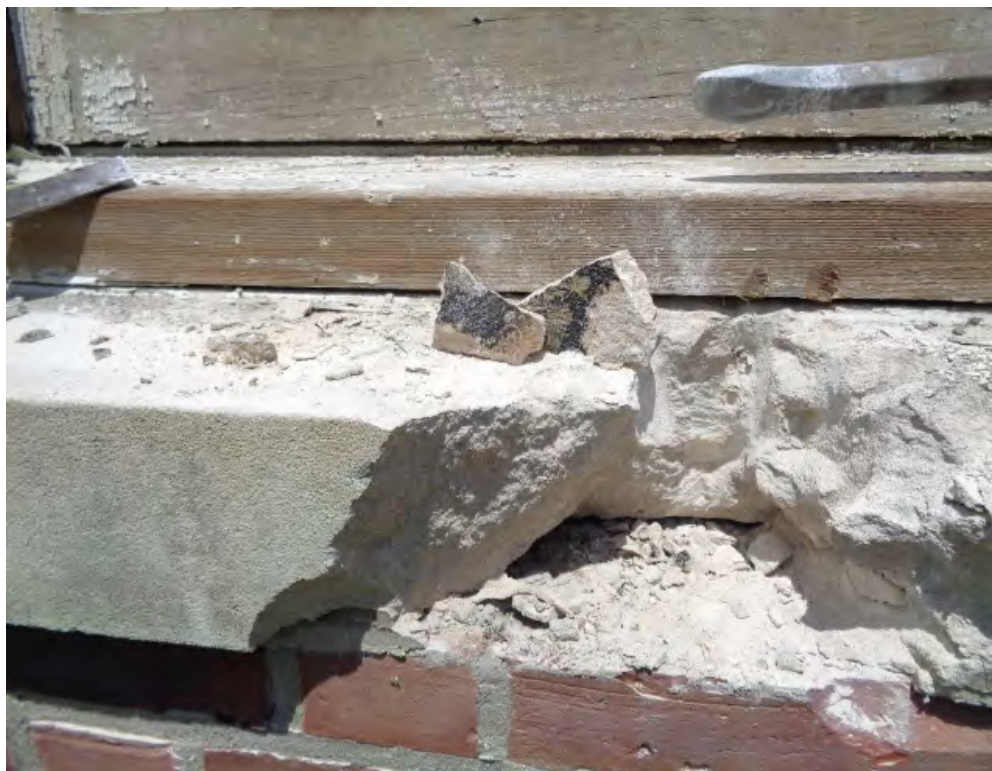
Asbestos-Containing Black Damproofing under Concrete Window Sill

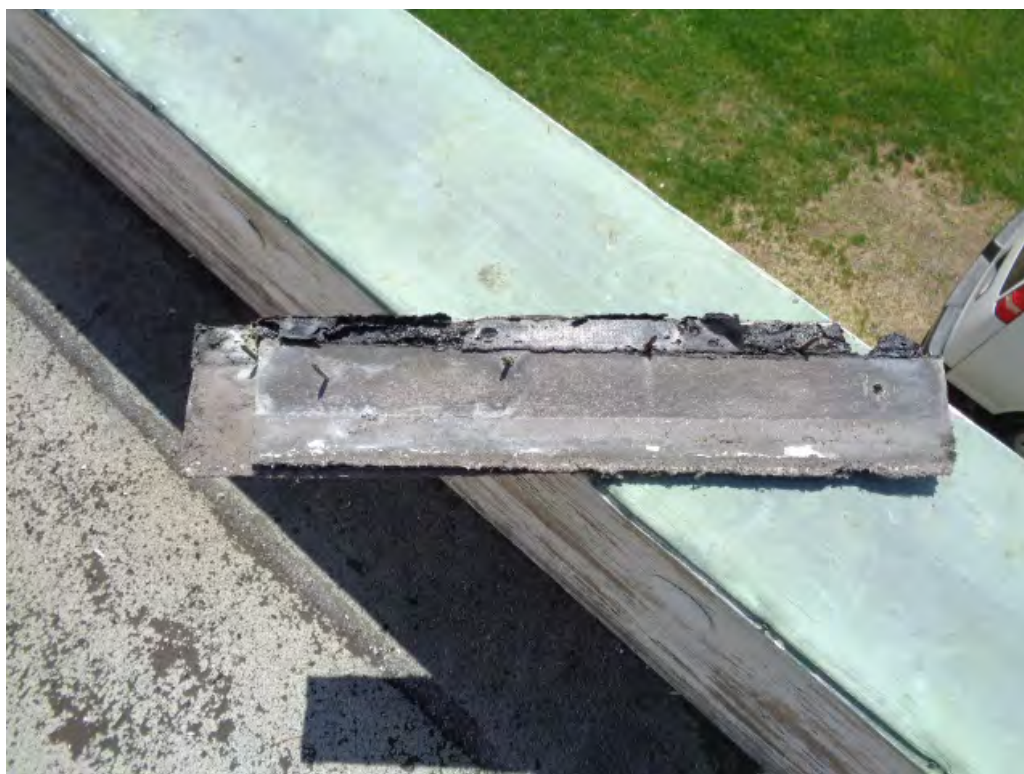
Asbestos-Containing Cementitious Roof Shingle and Flashing/Tar
