Hazardous Building Materials Inspection

**Stamford Hall
Fairfield Hills Campus
Newtown, Connecticut**

Town of Newtown

August 2015
Revised December 28, 2016

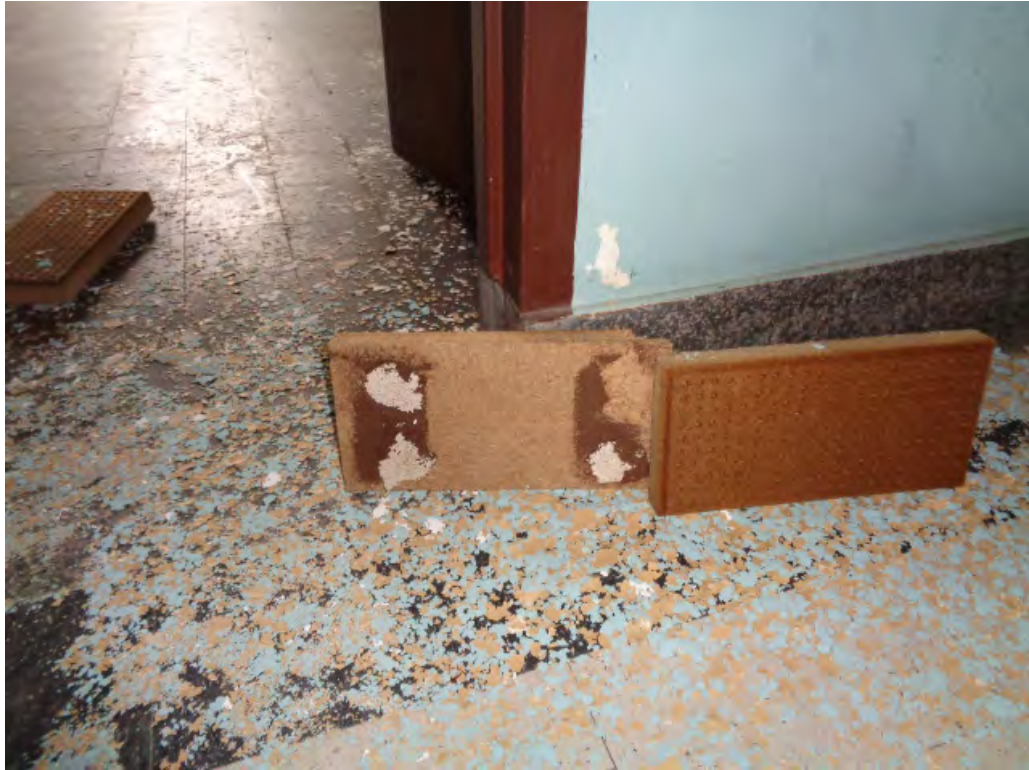
Asbestos-Containing Brown Glue Daubs on Rectangular (6"x4") Ceiling Tiles
