## **TOWN HALL SOUTH AKA THE POLICE HEADQUARTERS**

*Existing Conditions  
of the  
Newtown Municipal Facilities  
Newtown, Connecticut  
KB# 97056*

*May 1, 1999*

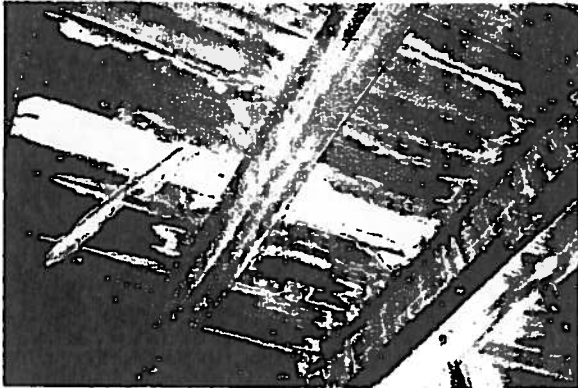
The most noticeable condition is located at the Parking Deck. The concrete deck is exhibiting signs of delamination (separation) of the concrete slab. The metal deck supporting the concrete slab is severely corroded, and portions of it are falling down. In addition, there is serious rusting of the steel beams and columns, which support the deck. At many locations, the connections have been affected by the corrosion, and delamination of the beam flanges is occurring.

The Parking Deck structure must not be used under any circumstances, including the space below on the Basement Level. This portion of the building must be removed because of the extent of deterioration to the structure.

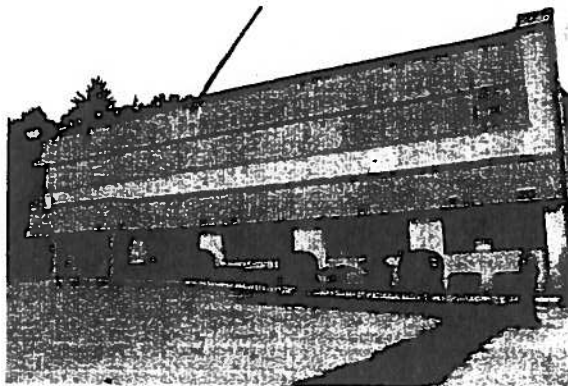
The exterior walls of the lower section are nonbearing steel stud and concrete foundation walls, which are furred out on the interior and clad in a painted gypsum board. In the lower level, the exterior texture 1-11 has demonstrated some difficulties from constant moisture. Rotting does appear. The concrete foundation wall has cracks on the eastern side where the entire floor is under-grade. The access to the building is on this side is on the upper level.

The estimated remaining useful life of these systems would be 15 years for the stud wall, which is experiencing some stress from moisture, and 30 years for the concrete wall. Recommendations include repair of the rot and patching of the cracks, since they may well be a source of water leaks.

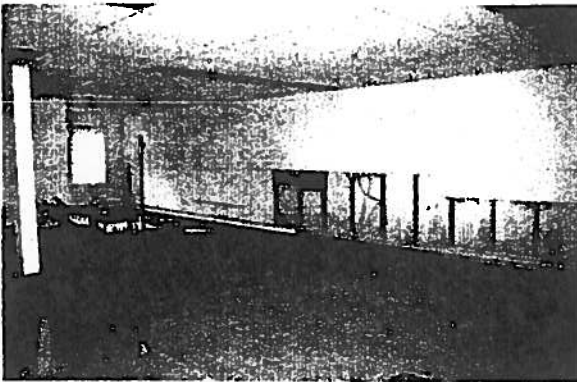
The condition of the finishes varies from very poor to good depending on the location in the building. Notable failures include a serious deterioration due to moisture intrusion in the lower level. Some walls have actually been totally destroyed, floor tile has been lifted, and fungus and mold has wreaked havoc with the finishes in spaces throughout these areas.

The estimated remaining useful life of these finishes varies from zero to 15 years depending on the type and location. Recommendations are that lower level gypsum board finishes be replaced, that the lower level carpeting

be replaced, and the VCT, which may contain asbestos, be replaced. Upstairs, the carpet should be replaced as necessary over the next seven years. It is also recommended that the gypsum board be repainted over the next 8 years. The VCT flooring, while its condition is fair, could remain in use as it does not represent a hazard since it is properly adhered and does not exhibit the difficulties that are apparent downstairs.

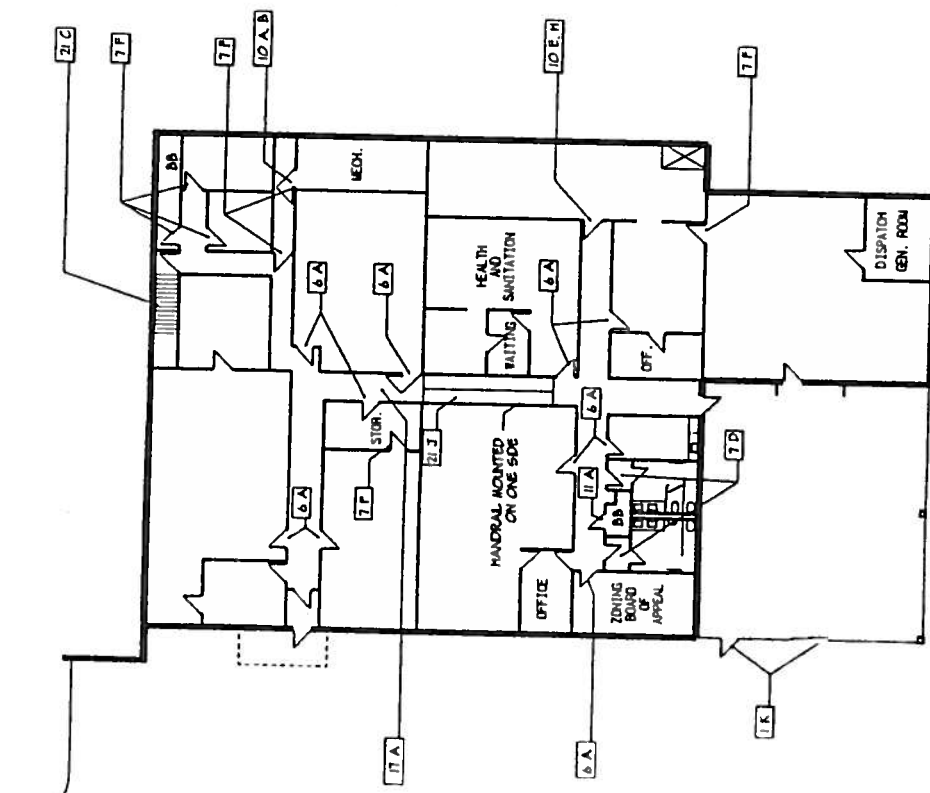
**LOWER FLOOR PLAN**

KEYNOTE: (BOXED NUMBERS AND COMMENTS ARE CODE VIOLATIONS)	
1 K	DEAD BOLT LOCKED AGAINST EGRESS
6 A	CORRIDOR WALLS DO NOT PROVIDE RATING AND SMOKE RESISTANCE
7 F	DOOR AND FRAME ARE NOT RATED
10 A	POSITIVE LOCKSETS OR LATCHSETS ARE REQUIRED
10 B	CLOSURES ARE REQUIRED
11 A	WALL PENETRATIONS REQUIRE FIRE STOPPING
17 A	EMERGENCY LIGHTS ARE REQUIRED
21 C	STAR HANDRAILS DO NOT COMPLY
21 D	RAMP HANDRAILS DO NOT COMPLY
21 E	BARRE BULBS

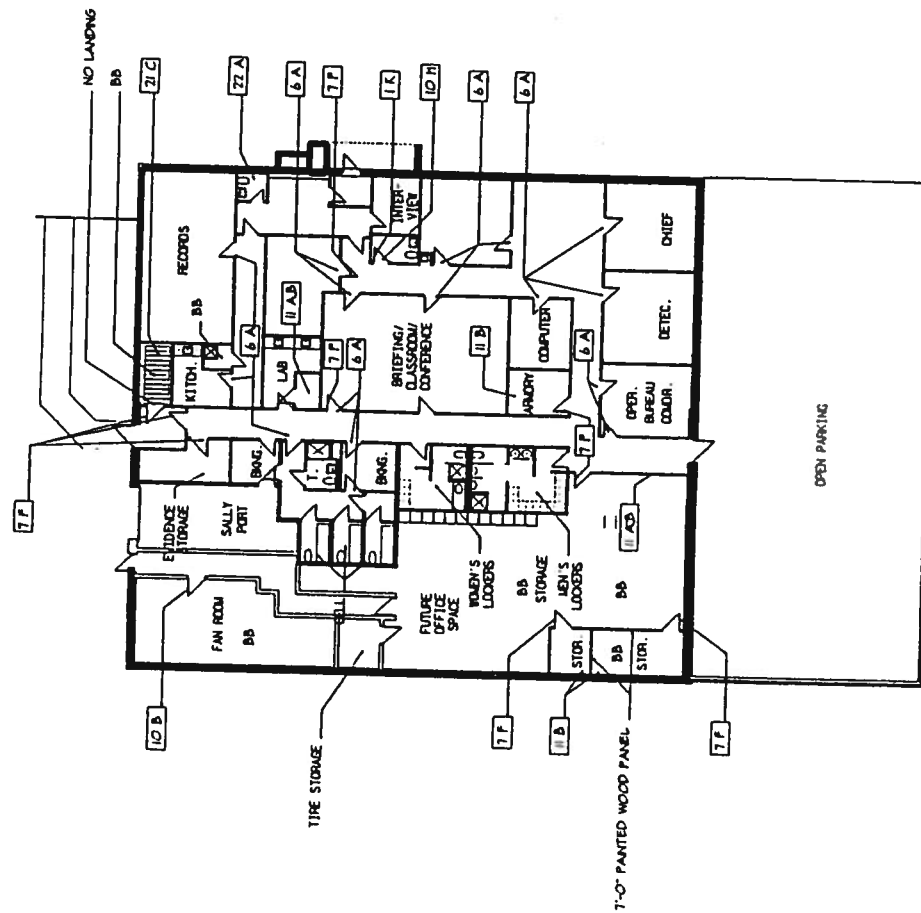
KEYNOTE: (BOLDED NUMBERS AND COMMENTS ARE CODE VIOLATIONS)

1 K	DEADBOLT LOCKED AGAINST EGRESS
6 A	CORRIDOR WALLS DO NOT PROVIDE RATING AND SMOKE RESISTANCE.
7 F	DOOR AND FRAME ARE NOT RATED
10 B	CLOSERS ARE REQUIRED
10 H	MULTIPLE OPERATIONS HARDWARE
11 A	WALL PENETRATIONS REQUIRE FREE STOPPING
11 B	SPACE REQUIRES ONE-HOUR ENCLOSURE OR SPRINKLER
21 C	STAR HANDRAILS DO NOT COMPLY
22 A	ACCESSIBLE TOILET ROOMS ARE REQUIRED
BB	BALE BULBS
