Description of Existing Conditions

Fairfield Hills Campus

Newtown, Connecticut

JUNE 3, 2002

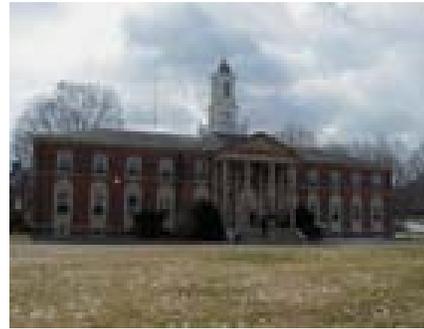
Newtown Hall
Fairfield Hills Park
Mile Hill Road
Newtown, Connecticut

Constructed in 1933, Newtown Hall remains one of the finest buildings on the Fairfield Hills campus. Originally used as an administration building. Newtown Hall is in excellent condition and could house a use of approximately 16,500 square feet within its two stories. This building also houses an attic and a basement. The simple, yet handsome brick structure, is capped by a symmetrical hipped roof. A large cupola reinforces the symmetry along with a large, ornamental pre-cast entry colonnade and pediment. Although simply organized, the interior of Newtown Hall is very tastefully detailed. The main entry is adorned with plaster and wood moldings and proportioned comfortably. Most remaining office spaces are still fitted out with the original wood doors, transoms, and trim, all in excellent condition.

Much of the exterior remains in good condition with the exception of some miscellaneous re-pointing and concrete restoration at the main entrance

Currently a steam heating system is in place but is not served by a boiler plant. The building is not heated, and is not fitted out for air-conditioning. Further analysis of these systems including plumbing, electrical, telephone, etc. is required to determine the extent of renovation required relative to the re-use of the existing structure.

Newtown Hall, lends itself as an existing structure, to a very straight forward reuse as a leaseable office building. Its layout, condition, quality of architecture and construction clearly lead to this use. Although an elevator will need to be added to this building, many of the existing rooms are the appropriate size and proportion for new offices.

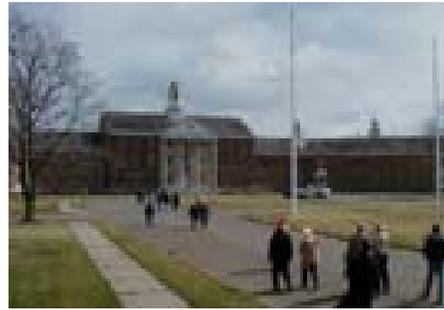
The Shelton House was built in 1933 and houses approximately 89,000 square feet of space on 2 ½ stories. Primarily used for patient housing and some administration, the Shelton House is the entry structure of the complex and serves as the front of the campus. The structure also includes a full basement and attic. The existing brick building is capped with sloping asbestos shingle roofs and cupolas and is recognized by its monumental pre-cast concrete pediment and colonnade at the entrance. The condition of the building is fair and in general need of significant restoration.

Most steel lintels show signs of corrosion with spalling masonry above and alongside window openings. Years of water penetration and cyclical freeze/ thaw damage have deteriorated many areas of masonry. Re-pointing of the masonry and the replacement of the steel lintels are required at all of these locations.

All areas of exterior woodwork, particularly at the sunrooms, cupolas, and cornices, there is significant signs of peeling and rot, much of which will need replacement. All the original windows will need replacement.

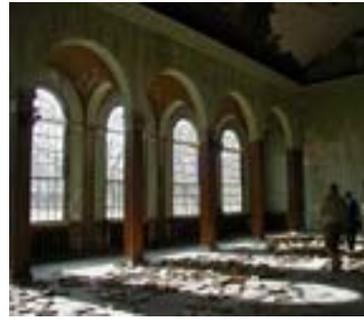
Stratford Hall
Fairfield Hills Park
Washington Avenue
Newtown, Connecticut

Stratford Hall, constructed in 1933 was formally used as a dining hall and library. This structure contains about 9,000 square feet including its basement. The quaint yet stately brick structure opens gracefully to the outdoors with five large round top windows. Inside, an impressive vaulted ceiling defines the main space and is bordered on each side by arcades of a similar vocabulary. Intricate plaster detailing, wood panels, and molding richly articulate this grand interior space.

Although the exterior of this structure is sound, a prolonged steam leak on the interior has damaged much of the interior finishes and will need repair for the ultimate reuse of the building.

Much of the exterior remains in good condition with the exception of some miscellaneous re-pointing and concrete restoration. Steel lintels at flat window arches will need replacement and repainting of the existing trim and banding is also required.

Although damaged, a steam heating system is in place and is not served by a boiler plant. The building is not heated, and is not equipped for air-conditioning Further analysis of these systems including plumbing, electrical, telephone, etc. is required to determine the extent of renovation required relative to the re-use of the existing structure.

Stratford's dramatic space clearly lends itself to a fine restaurant. Part of this space could become a bar and lounge area with the remainder dining. To accommodate this change of use a new kitchen and service area would need to be constructed. Site area is also available to develop a south facing outdoor dining area. Another use could be for a single user office space or small convenience retail/service use.

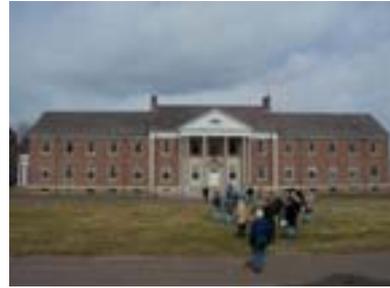
Woodbury Hall
Fairfield Hills Park
Mile Hill Road
Newtown, Connecticut

Woodbury Hall was constructed in 1933 and was primarily used for nursing staff residency. This structure contains about 30,000 square feet on 2 stories and includes a basement and an attic. Similar to the massing and street presence of Newtown, Woodbury is also very symmetrical. Its symmetry is reinforced by a large entrance pediment and balanced by gabled roof ends. The organization of the plan is simple and signature spaces are fitted out with raised panel woodwork and tastefully articulated plasterwork.

The sloping asbestos shingle roofing sits on a 2x12 wood rafter structure, supported by a steel frame. The floor slabs are cast-in-place ribbed concrete bearing on concrete encased steel beams at interior locations, and a load bearing brick wall at the exterior. Steel columns carry much of the interior structural loads from the roof and floors down to the basement. The interior partitions are plaster over terra-cotta clay tile. Although these walls are not load bearing many may be bracing the exterior walls and would need to be assessed if any demolition is required. Current conditions in the basement suggest a significant drainage problem around the perimeter of the building. Heavy flooding and moisture infiltration over time has perpetuated into mildew problems and must be dealt with.

Much of the exterior remains in good condition with the exception of some miscellaneous re-pointing and concrete restoration at the main entrance and other masonry areas. Small built-up roofing sections at the ends of the building show signs of wear and moisture, and are in need of replacement.

Currently a steam heating system is in place, but is not served by a boiler plant. The building is not heated, and is not fitted out for air-conditioning. Further analysis of these systems including plumbing, electrical, telephone, etc. is required to determine the extent of renovation required relative to the re-use of the existing structure.
