**INLAND WETLANDS COMMISSION
MINUTES
Regular Meeting of April 24, 2019 at 7:30 p.m.
Council Chambers, Newtown Municipal Center
3 Primrose Street, Newtown, CT**

POOTATUCK RIVER STREAM
BANK RESTORATION
NEWTOWN
FAIRFIELD COUNTY, CONNECTICUT

PROJECT DESIGN

Pootatuck River Stream Restoration

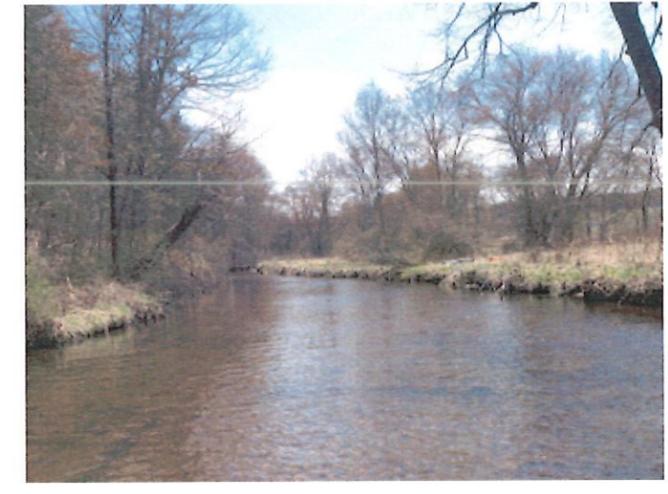
Site 1: Facing Upstream
January 13, 2017

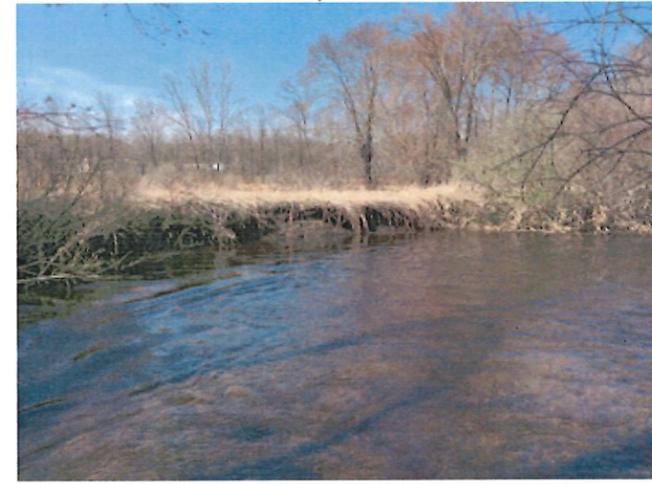
Site 2: Facing Downstream
January 13, 2017

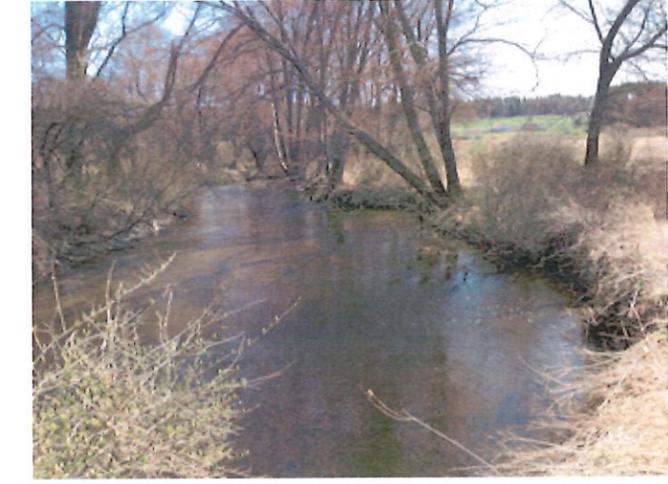
Site 2: Facing Upstream
January 13, 2017

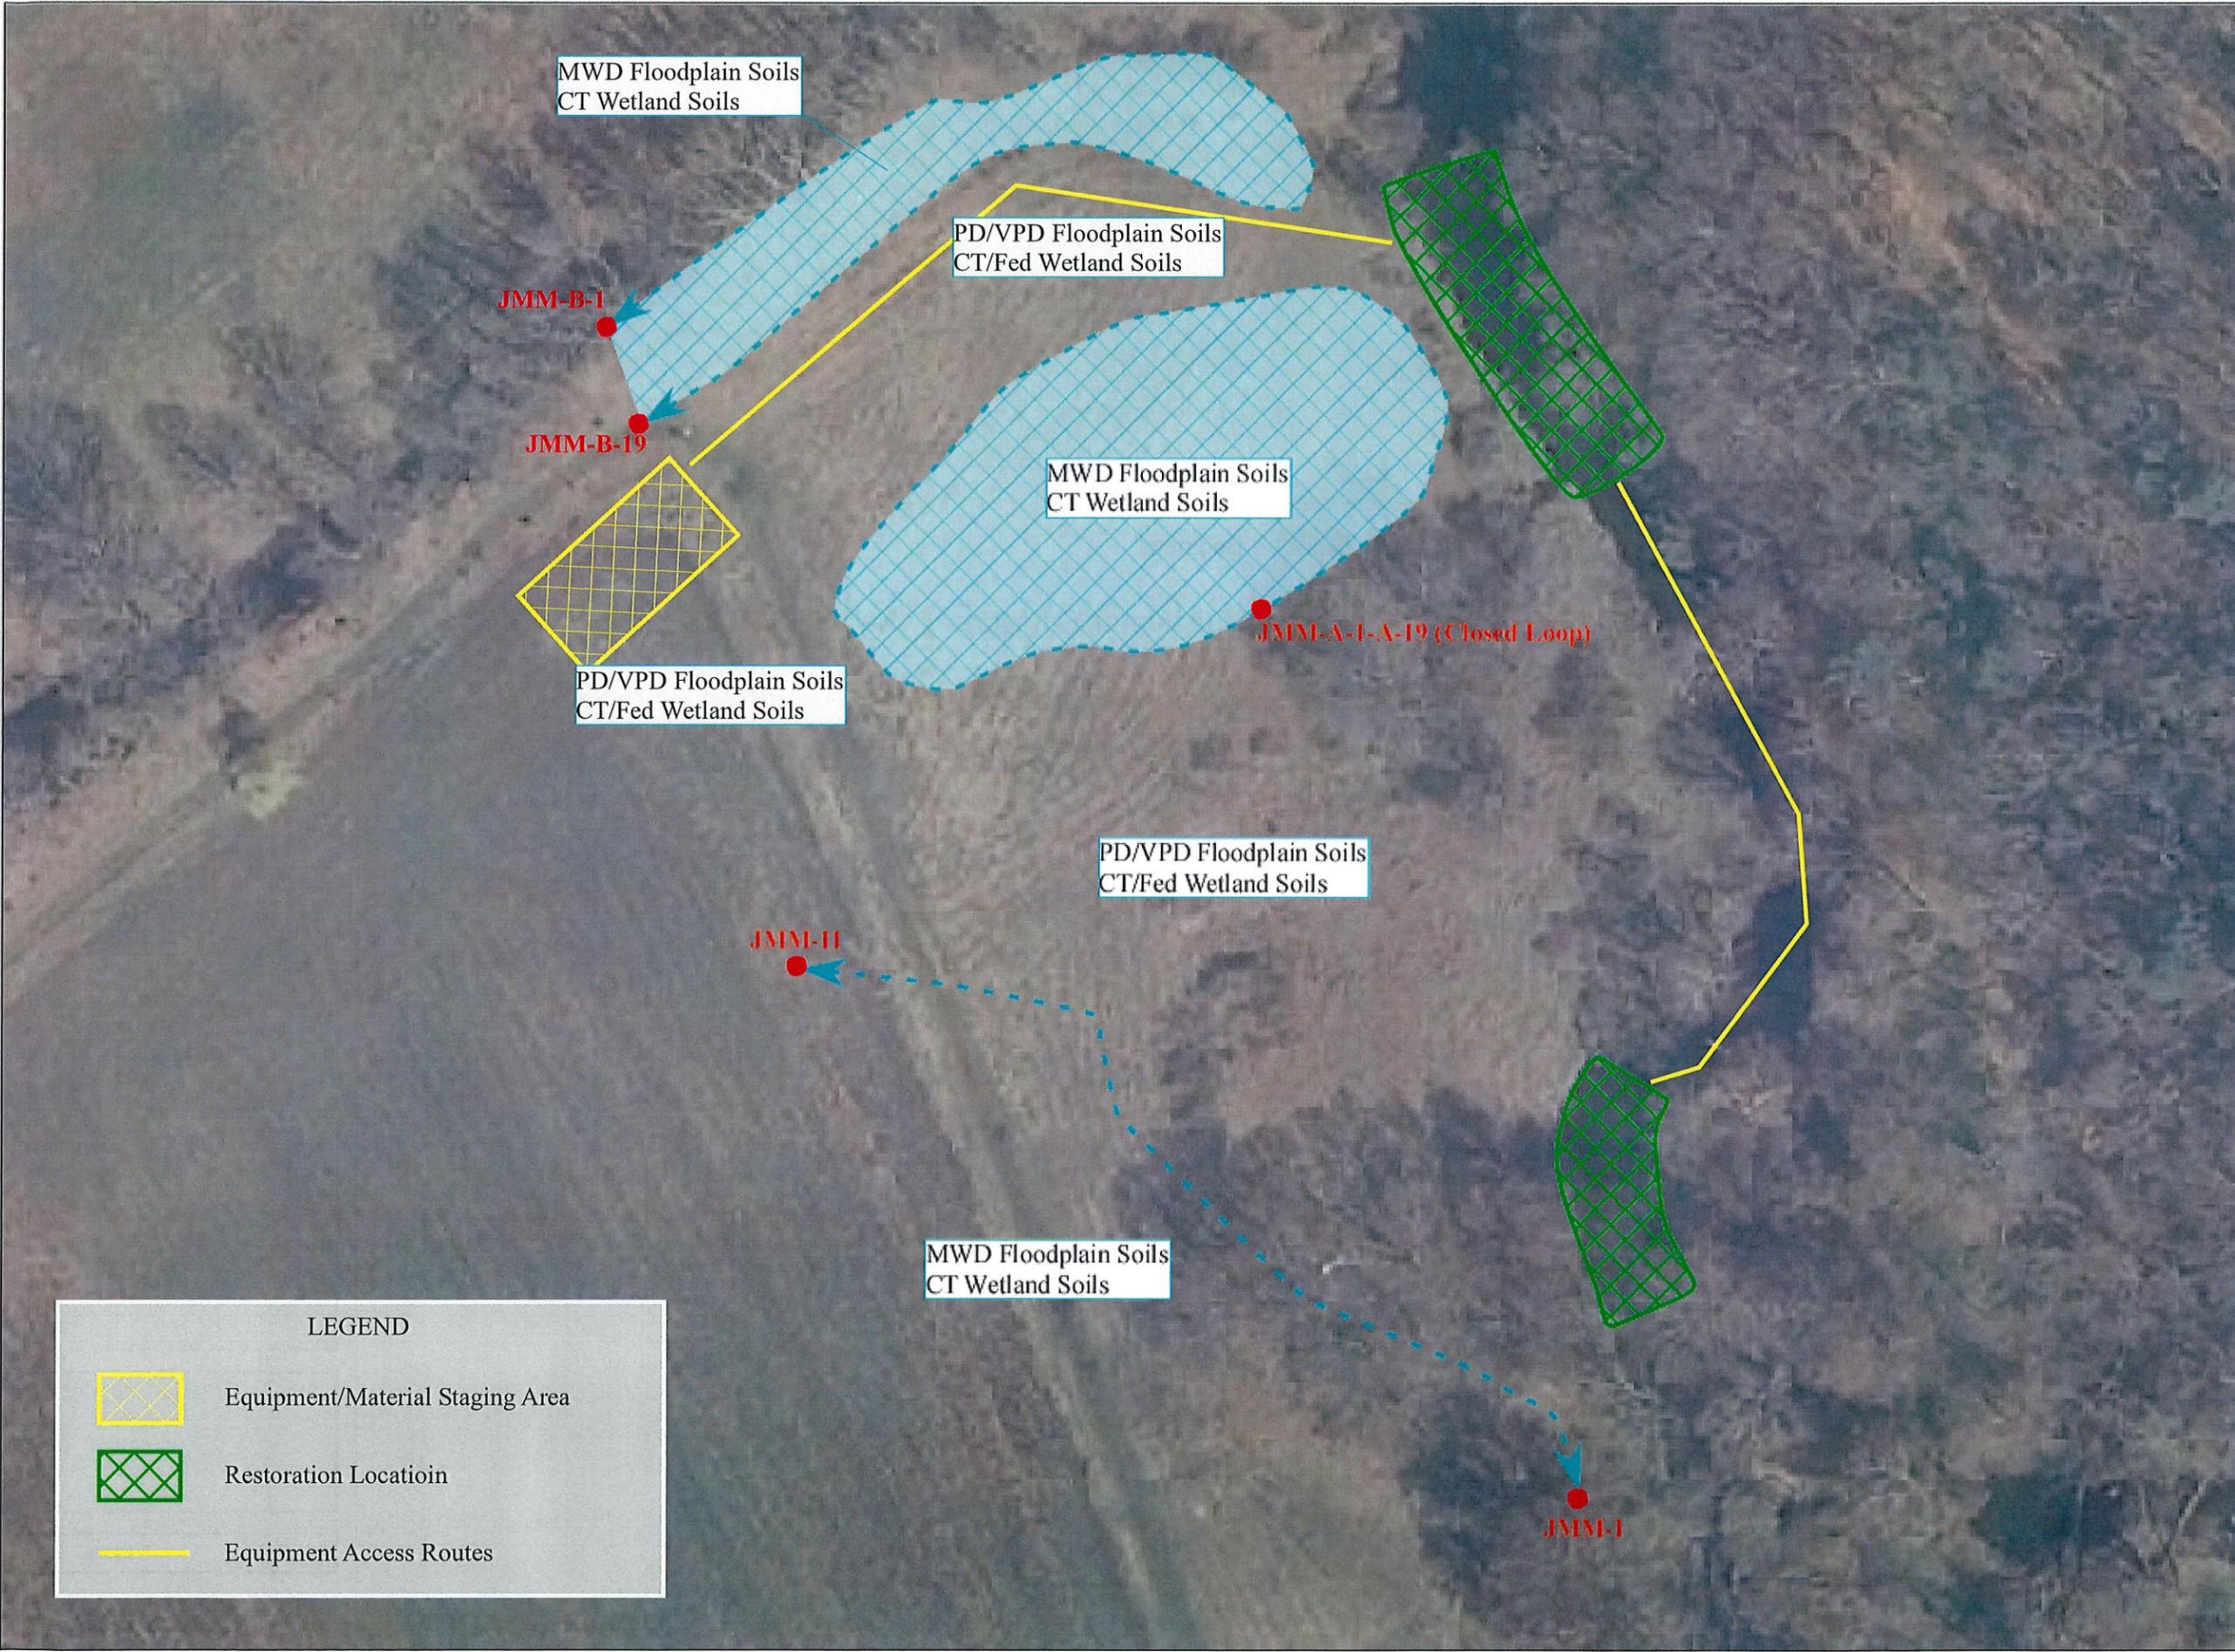
**ADDENDUM A:
EQUIPMENT ACCESS
AND WETLAND
DELINEATION**

- Equipment/Material Staging Area
- Restoration Location
- Equipment Access Routes

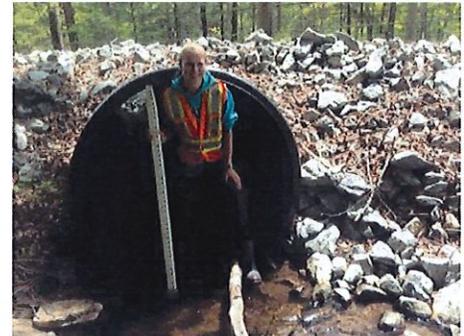
Initial results of an ongoing study conducted by the Housatonic Valley Association (HVA) indicate that approximately 56% of the non-bridge road-stream crossings evaluated to date in the Housatonic watershed are considered moderate or worse **barriers to fish and wildlife movement** (n = 976). Furthermore, modeling by project partners at the University of Connecticut indicates that approximately 18% of non-bridge structures evaluated fail (i.e., water over the road) in a 25-year recurrence interval flood or less (n=594). Given the sheer number of problem structures, a strategic approach to **restoring habitat connectivity** and **reducing flood risk** at road-stream crossings is necessary.

Barrier Evaluation	Number of Culverts	Percentage
Severe barrier	225	23%
Significant barrier	97	10%
Moderate barrier	225	23%
Minor barrier	337	35%
Insignificant barrier	92	9%
No barrier (full passage)	0	0%

Recurrence of Interval Failure	Number of Culverts	Percentage
2-Year	14	2%
5-Year	10	2%
10-Year	23	4%
25-Year	61	10%
50-Year	45	8%
100-Year	50	8%
200-Year	57	10%
Passing	334	56%

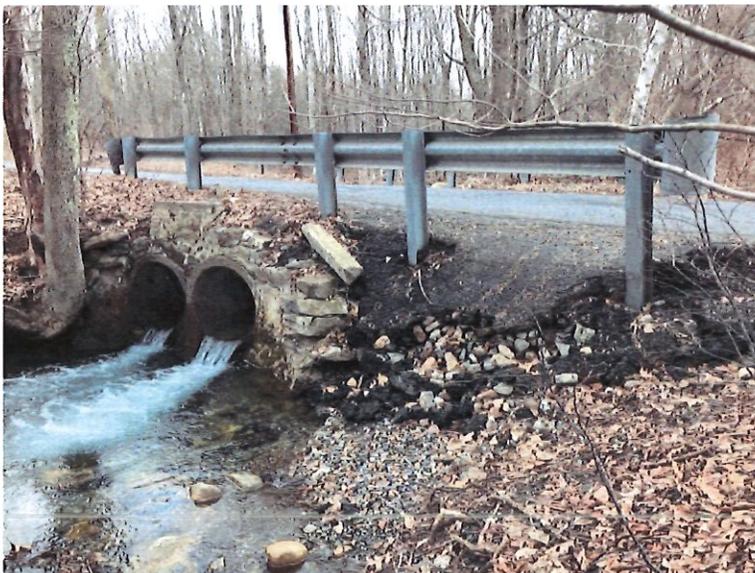
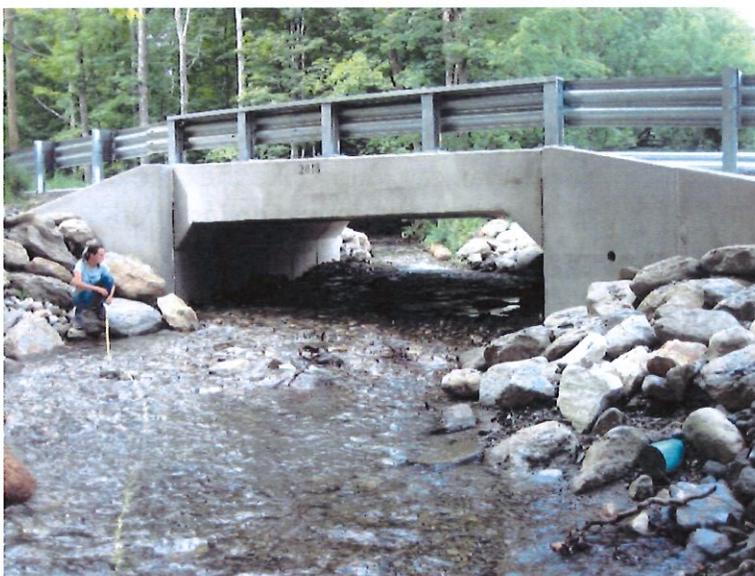
Figure 2 Before (top) and after (bottom) photo of a culvert replacement project on Churchill Brook in Pittsfield, MA. The bottom structures is an-bottomed culvert that was designed with the natural stream channel in mind.
