**FACILITIES CONDITIONS ASSESSMENT
AND
SPACE NEEDS ASSESSMENT**

**MULTIPURPOSE BUILDING
HOOK AND LADDER HEADQUARTERS
TOWN HALL SOUTH**

January 2016

NEWTOWN FACILITIES ASSESSMENT REPORT

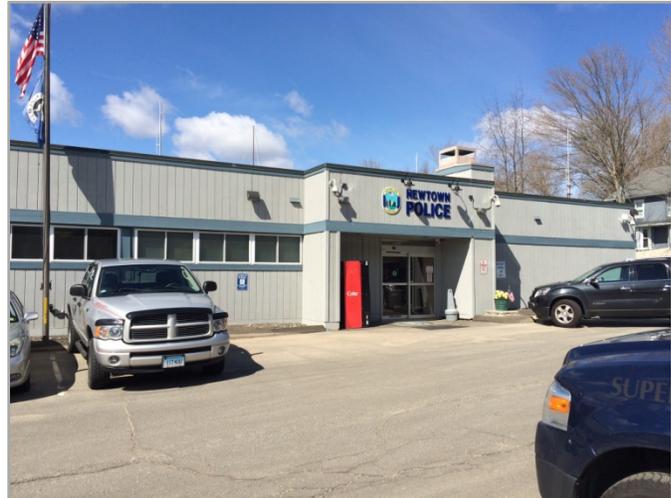
3 Main Street

Year Constructed: 1950
Year of Renovation/Addition: 1990
Building Type: B/S-2/R-2
Construction Type: IIIB
Fire sprinklers: No
Total Floor Area: 18,528 SF
Floors: Basement and First Floors
Parking: 53

GENERAL: Originally constructed as a tractor sales building the building was repurposed to serve Town functions including the Police Department. The exterior of the building is suffering from many years of being clad with "Texture 1-11" siding, a product that is basically scored plywood intended to provide an appearance of vertical wood siding. Windows have needed to be replaced due to air and water leakage. In contrast the interiors are in much better condition. It is very difficult to find parking spaces on the site which we consider to be undersized for its current uses.

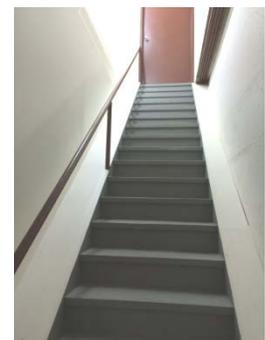
2 Stair between Lower and Upper Levels has projecting nosings and only one handrail. There is also insufficient landing space at the bottom and top of the stair. This stair appears to be a service stair that is not used by other than the custodial staff but it does serve as an egress from what would otherwise be a dead end corridor. As such the stair needs to be upgraded to remove the projecting nosings by using beveled siding to create a gradual slope from the treads to the nosings. ADA compliant handrails need to be added on both sides. The bottom landing will need to be increased in size to allow for clearance space at the door. Similarly, the door at the top of the stair needs to be removed

2 Add a new fire rated partition and ceiling in the Janitor's Closet to separate it from the Storage Area.

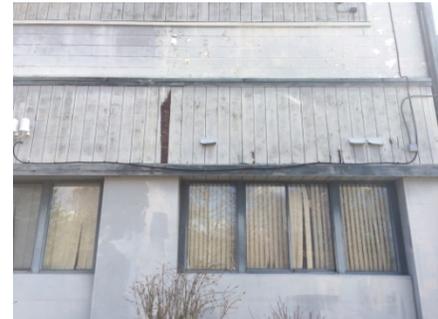
- 2 Exterior siding is deteriorating and is in need of replacement. The north and east sides of Texture 1-11 siding has been redone but the remaining two sides need to be replaced and painted.

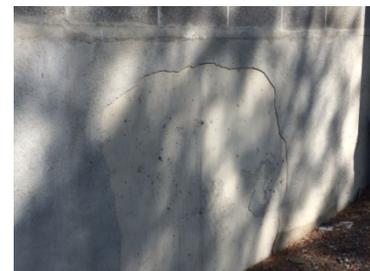
- 3 Parging is delaminating from concrete foundation wall. Remove loose material, apply bonding agent and re-parge exposed concrete areas.

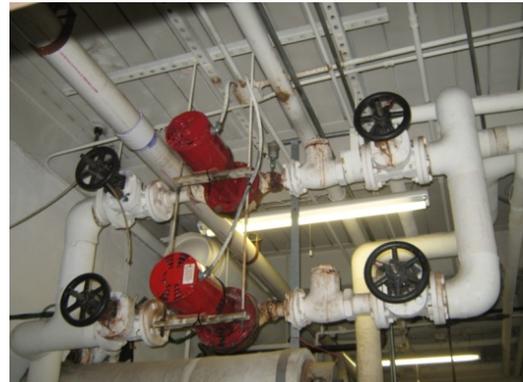
2 Boiler Plant: The building is heated by one Eighty Eight Series hot water boiler. The boiler is gas fired and reaching the end of its useful life. There are two pumps which provide redundancy in case one pump fails. The hot water system serves fin tube radiation and duct mound hot water coils. The hot water pumps are controlled by six temperature zones via electric relays. Recommend replacing the boiler with two high efficiency condensing boilers to provide redundancy and higher levels of energy efficiency (up to 95% versus current boilers with nominal efficiency of probably 75% to 80%). Replace hot water distribution and controls to provide more zones for energy efficiency and update controls to DDC type system.

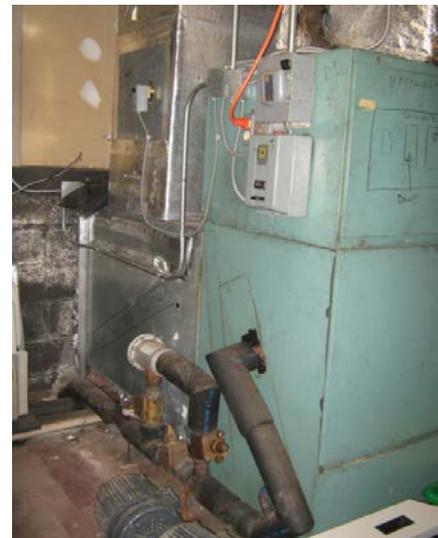
3 Most of the building is served by indoor mounted air handling units with remote compressor / condensers and duct mounted hot water coils. Most of the units are old are in fair to poor condition. Ductwork distribution to spaces below includes single zone hot water coils. "Local" air conditioning is also provided at specific areas with ductless split units. Temperature control system is via electric relays with electric actuated valves and dampers. Computer Operations Room needs improved air conditioning and ventilation. Recommend replacing air handling systems and replace and upgrade controls to web based DDC type system.

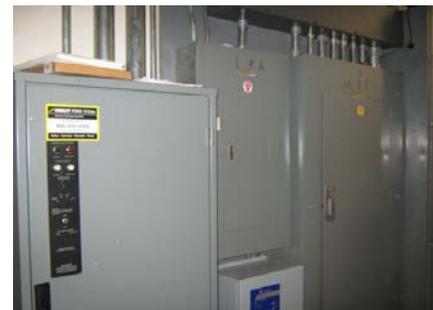
3 The building is served by a Square D distribution panel, rated at 400 amperes, 208Y/120 volts, 3-phase. The service equipment and main distribution panels are in good condition.

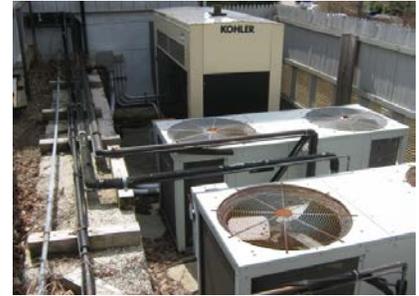
Emergency Generator: The generator is a 80 KW Kohler; gas fired generator and automatic transfer switch located inside; both are in good condition. Recommend upgrading electrical power distribution throughout the building with new local panels, new receptacles and wiring.

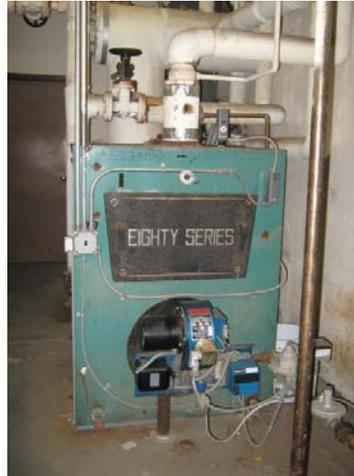
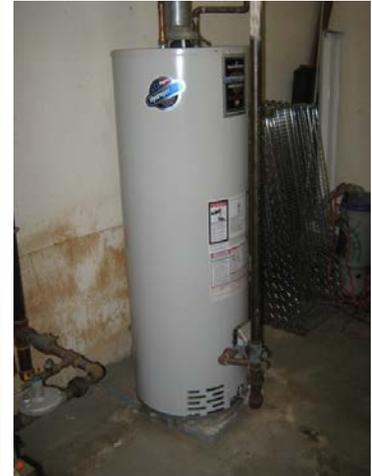
- Existing Domestic Hot Water System: The domestic hot water is generated by a Bradford White gas fired water heater with 50 gallon storage. The water heater is in good condition, but does not incorporate a mixing valve at the hot water supply. Recommend adding mixing valve to water heater.

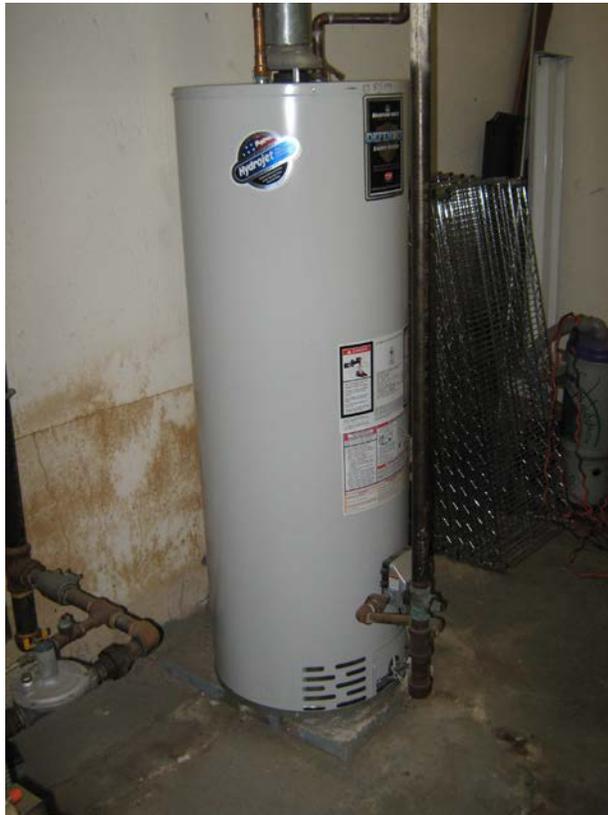
1. Existing Domestic Hot Water System: The domestic hot water is generated by a Bradford White gas fired water heater with 50 gallon storage. The water heater is in good condition, but does not incorporate a mixing valve at the hot water supply.

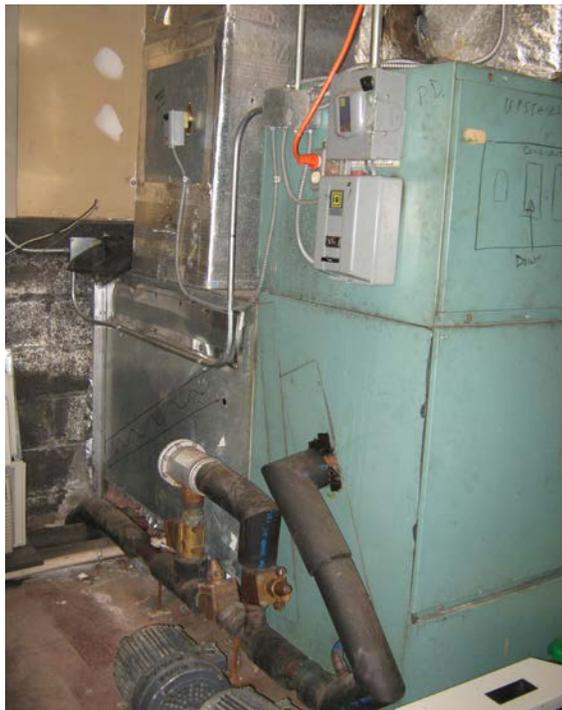
EXISTING AIR HANDLING SYSTEMS

1. Most of the building is served by indoor mounted air handling units with remote compressor / condensers and duct mounted hot water coils. Most of the units are old and in fair to poor condition.

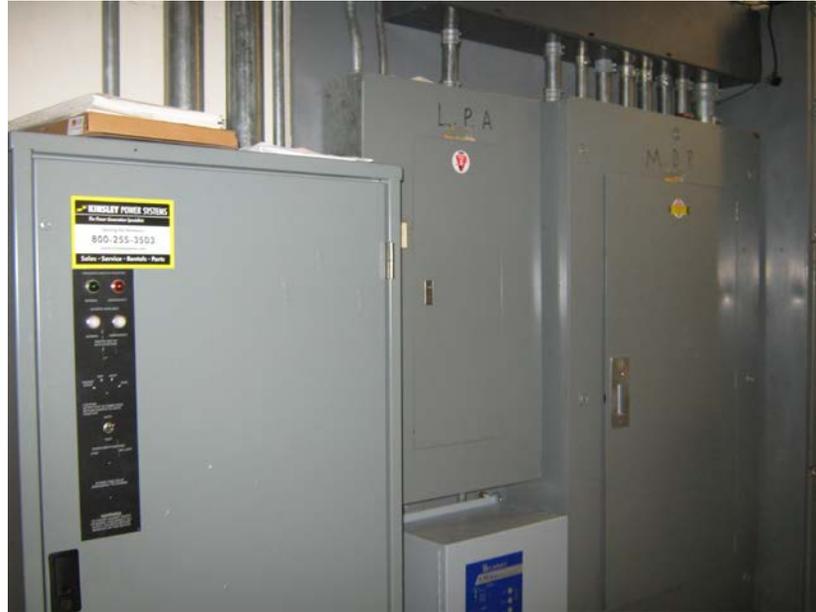
1. The building is served by a Square D distribution panel, rated at 400 amperes, 208Y/120 volts, 3-phase. The service equipment and main distribution panels are in good condition.

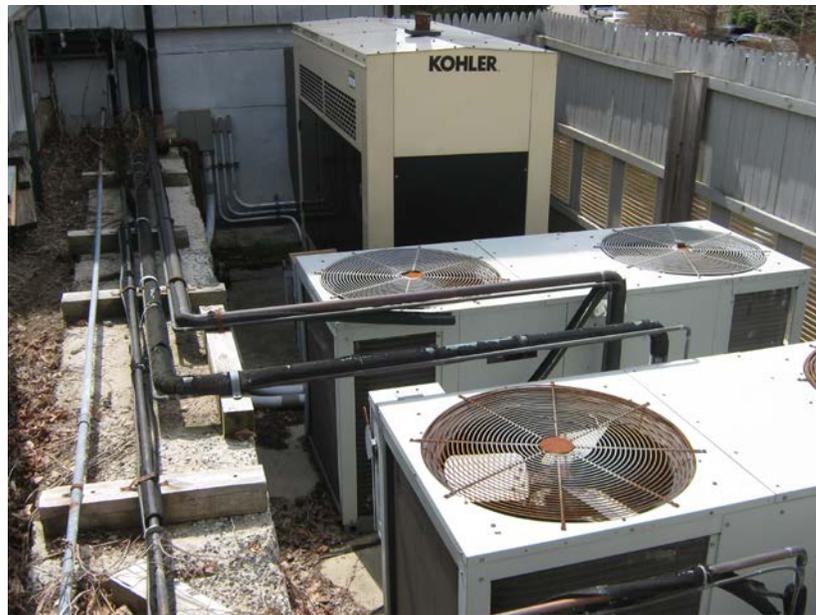
2. Emergency Generator: The generator is a 80 KW Kohler; gas fired generator and automatic transfer switch located inside; both are in good condition.

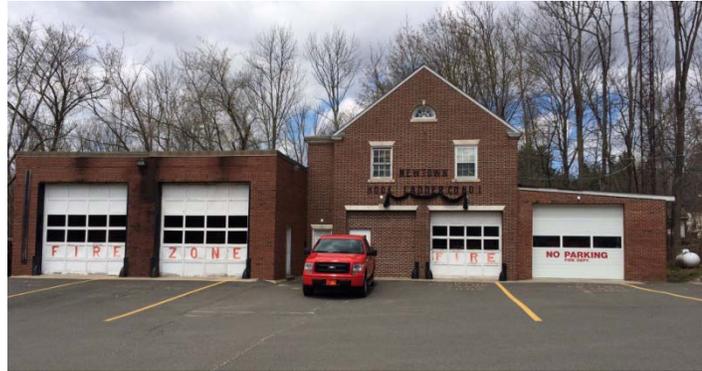
45 Main Street

Year Constructed: 1931
North Addition:
South Addition: 1969
Building Type: B/S-2
Construction Type: IIIB
Fire sprinklers: No
Total Floor Area: 6227 SF
Floors: Basement (2 levels), First Floor and Second Floor.
Parking: Shared

GENERAL: This building is badly worn and due to the instability of the soils beneath, and despite stabilizing improvements, it is in poor condition. The Fire Department will be relocated to a new building so this report does not address specific needs of a fire department. The current building is overloaded by the trucks and support structure located in the basement has been added to prevent collapse of the floors. Space conditions for the Staff are very poor.

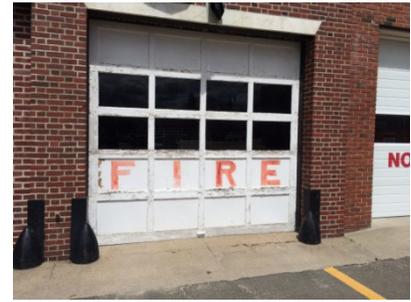
3 All wood windows, doors, overhead doors, plywood panels and wood trim have areas of peeling paint and bare wood is visible. Scrape paint down to solid material, and feather edges. Fill wood splits and holes. Repaint with a primer and two coats. Verify proper operation of all windows and doors and make necessary adjustments.

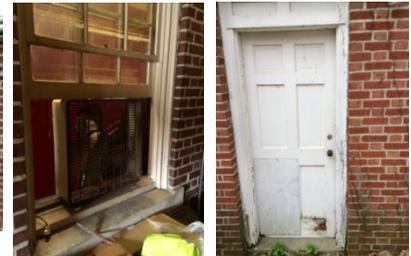
3 Replace exterior door from north addition.

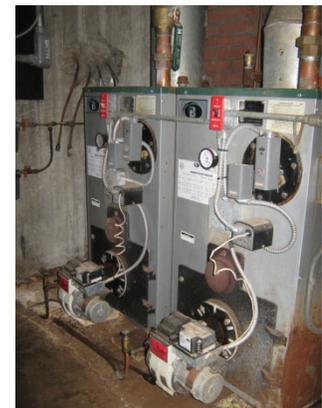
Boiler Plant: The building is heated by two (2) Peerless hot water boilers; each with nominal 350 MBH capacity. The boilers are fuel fired fed from a buried fuel oil tank outside the building. The buried fuel oil piping does not appear to be double wall. The boilers are in good condition. There are four (4) hot water pump zones controlled by local electric thermostats.

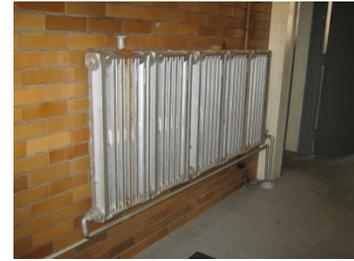
- 3 The hot water system serves unit heaters and cast iron radiators. The unit heaters are in good condition, the cast iron radiators are most original to the building and nearing the end of their useful life.

Recommend replacing cast iron radiators with fin tube radiation, Install air handling systems to provide mechanical ventilation. Install central air condition systems through new ducted units and/or ductless split AC units. Replace and upgrade controls to web based DDC type system.

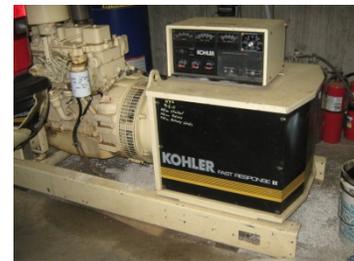
- 3 The building is served by General Electric distribution panels, service rated at 200 amperes, 208Y/120 volts, 3-phase. The service equipment and main distribution panels are in good condition. Emergency Generator: The generator is a 30 KW Kohler; fuel fired generator with day tank / pump set located inside the garage bay. The system is in fair condition.

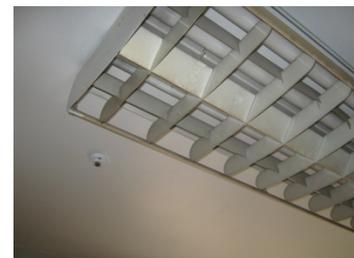
- 3 Lighting, in general, consists primarily of fixtures with T12 fluorescent lamps. Most of the fixtures are in poor condition and should be updated to more energy effacement lighting and controls. Emergency lighting is handled by an emergency generator. The fire alarm system is a FCI zoned system which is in fair condition.

Recommend upgrading Upgrade some of the electrical power distribution throughout the building with new local panels, new receptacles and wiring. Replace lighting with new energy efficient fixtures and controls such as occupancy sensors and daylight harvesting.

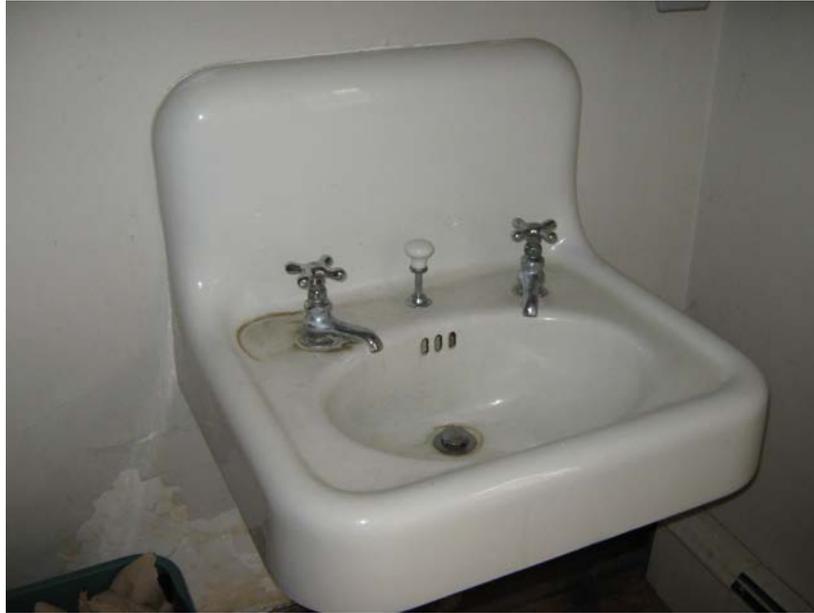
1. Existing plumbing fixtures are as follows:
 - a. In general, there are a variety of fixtures of different age and condition. Most of the fixtures are in need of replacement due to age and also to benefit from sensor mounted controls and water conserving features.
 - b. Water closets are floor mounted; tank type, vitreous china
 - c. Urinals are wall mounted with manual flush valves.

- d. Lavatories are wall hung with outdated faucets.

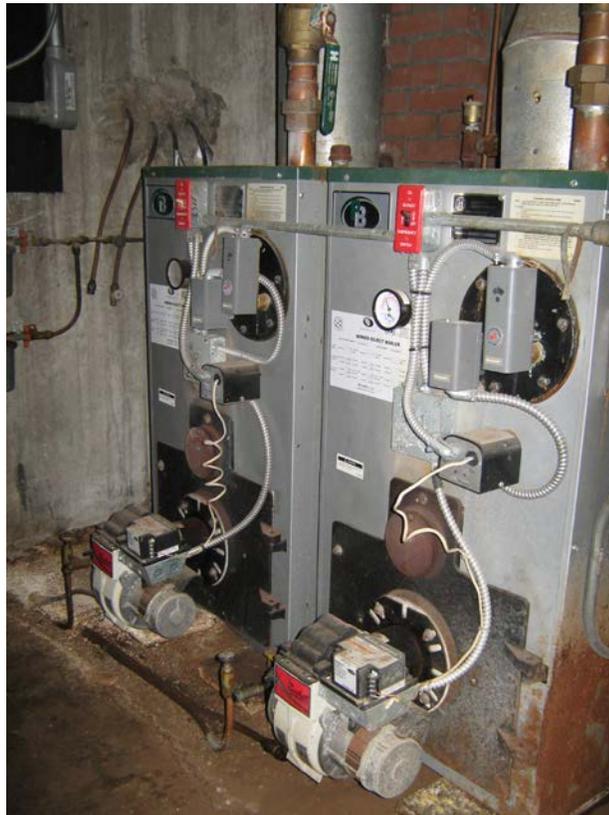
1. Boiler Plant: The building is heated by two (2) Peerless hot water boilers; each with nominal 350 MBH capacity. The boilers are fuel fired fed from a buried fuel oil tank outside the building. The buried fuel oil piping does not appear to be double wall. The boilers are in good condition.
2. There are four (4) hot water pump zones controlled by local electric thermostats.

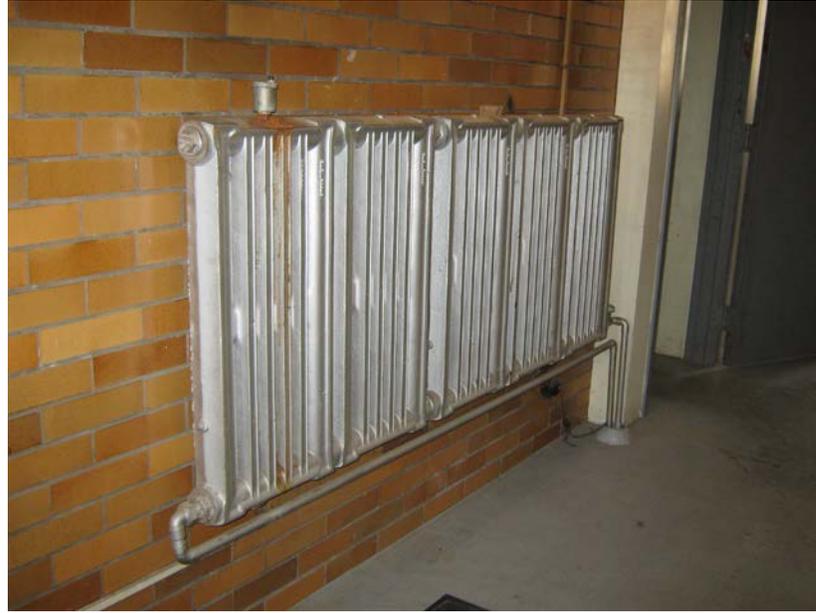
CAST IRON RADIATOR

3. The hot water system serves unit heaters and cast iron radiators. The unit heaters are in good condition, the cast iron radiators are most original to the building and nearing the end of their useful life.

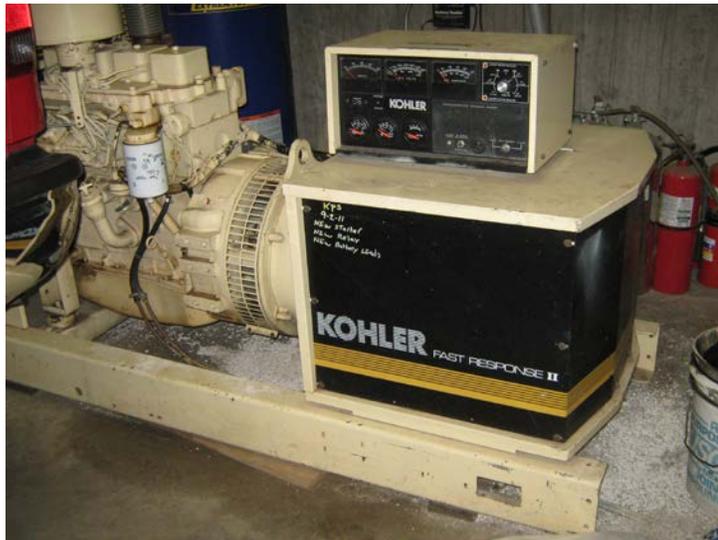
1. The building is served by General Electric distribution panels, service rated at 200 amperes, 208Y/120 volts, 3-phase. The service equipment and main distribution panels are in good condition.
2. Emergency Generator: The generator is a 30 KW Kohler; fuel fired generator with day tank / pump set located inside the garage bay. The system is in fair condition.

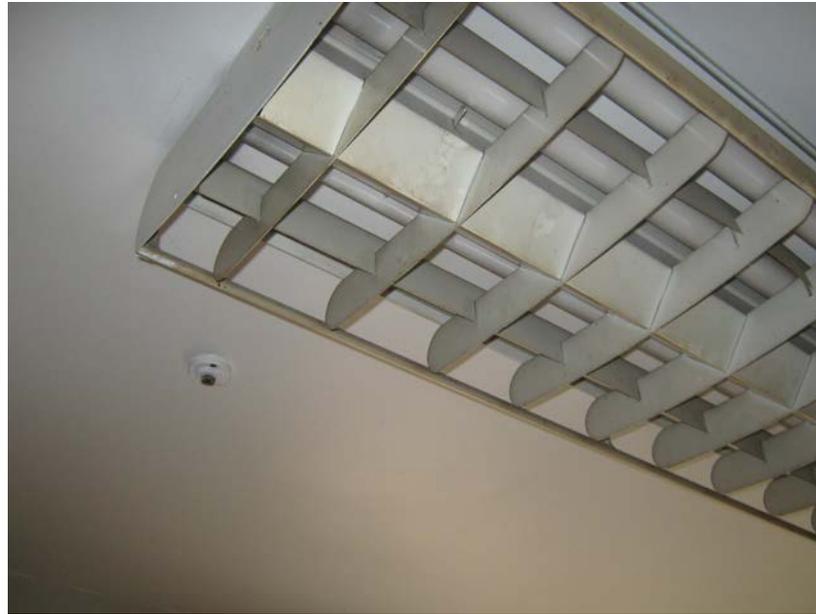
3. Lighting, in general, consists primarily of fixtures with T12 fluorescent lamps. Most of the fixtures are in poor condition and should be updated to more energy efficient lighting and controls. .

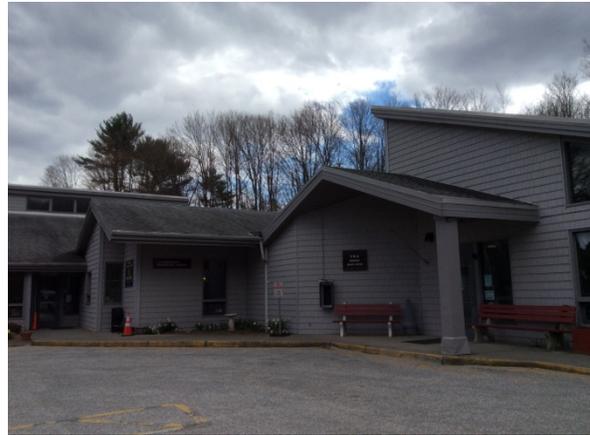
14 Riverside Road

Year Constructed: 1972
Additions: 1978, 1989, 2010
Building Type: A-3/
Construction Type: V
Fire sprinklers: No
Total Floor Area: 9650 SF
Floors: First Floor and Mezzanine
Parking: 36

GENERAL: This building has had multiple additions to satisfy the occupants growing needs. It is generally in good condition but has some roof leak issues that have resulted in some interior damage. The mechanical systems are in need of replacement.

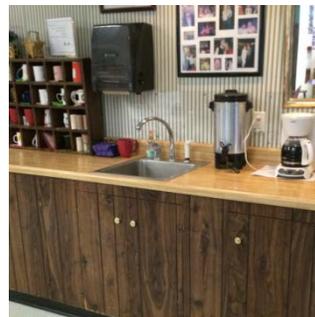
3 Sink and counter in Clinic and VNA Exam room (used for storage) are not ADA compliant. Change cabinets to provide knee space and replace sink.

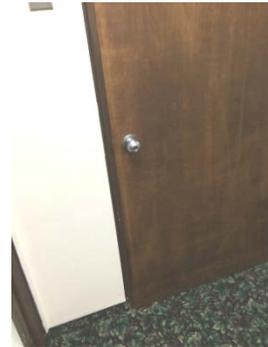
- 3 Doors throughout Senior Center building and Pre-school Area with the exception of the most recent 2010 additions (Sunroom, Workout Room and ADA restrooms) have knob sets but require lever sets for accessibility. Replace all knobsets with lever sets.

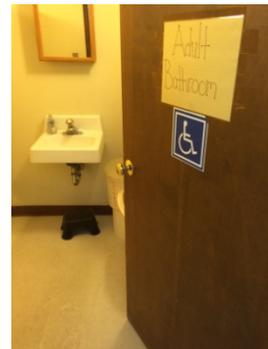
- 3 No ADA compliant restrooms. Neither the adult or the children's restrooms comply with ADA codes. Modify restroom to comply with all ADA codes.

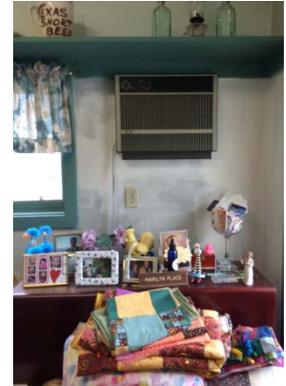
3 Walls in Directors office are in need of repainting. Repaint all walls.

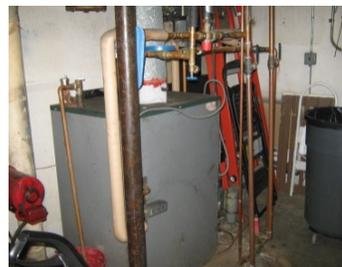
2 Boiler Plant: Overall, the building is heated by two separate boilers which are not interconnected. Both boilers are fuel oil fired. The boiler at the original building is a Peerless Model STC-07 hot water boiler with nominal capacity of 400 MBH. This boiler, its pumps and related hydronic piping system is reaching the end of its useful life.

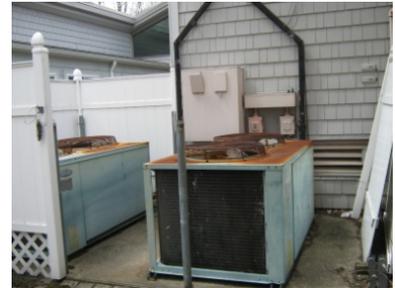
Existing Air Handling Systems: The buildings area served by indoor mounted air handling units with remote compressor / condensers located outside at grade. The two units at the original building are in fair to poor condition. The unit at the new building addition is in good conditions. The systems are fully ducted on the supply air and return air. "Local" air conditioning is also provided at specific areas with ductless split units. Temperature control is via local 7 day programmable thermostats.

Replace the air handling units and compressor / condensers serving the original building. The indoor units are located in mechanical rooms above the main floor and replacement of these units will be difficult. Also, the refrigerant piping may need to be replaced to accommodate newer types of refrigerant. Upgrade the temperature controls to provide off site monitoring through a web based program.

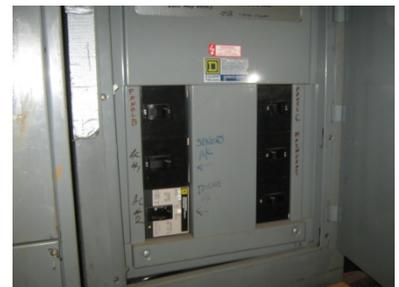
The building is served by a Square D distribution panel, rated at 400 amperes, 208Y/120 volts, 3-phase. The service equipment and main distribution panels are in good to fair condition. Recommend upgrading electrical service, local panels, receptacles and wiring at the original building.

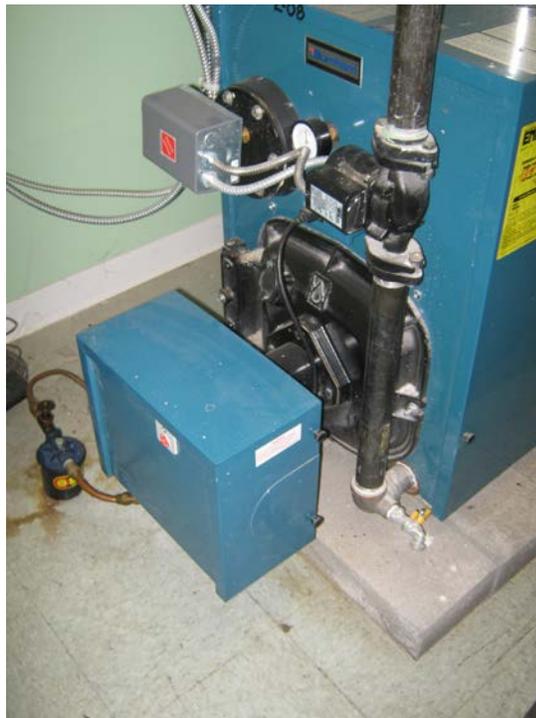
HOT WATER BOILER @ NEW BUILDING ADDITION

2. Boiler Plant: The boiler at the building addition is a Burnham Model PV85 hot water boiler with nominal capacity of 196 MBH. This boiler is in good condition

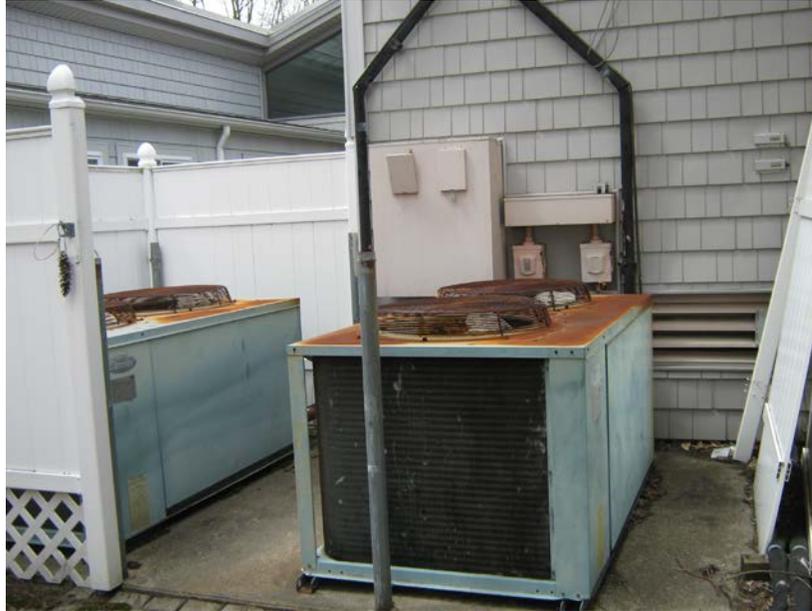
COMPRESSOR / CONDENSER @ ORIGINAL BUILDING

1. The buildings area served by indoor mounted air handling units with remote compressor / condensers located outside at grade. The two units at the original building are in fair to poor condition. The unit at the new building addition is in good conditions.

2. The systems are fully ducted on the supply air and return air.
3. “Local” air conditioning is also provided at specific areas with ductless split units.
4. Temperature control is via local 7 day programmable thermostats.

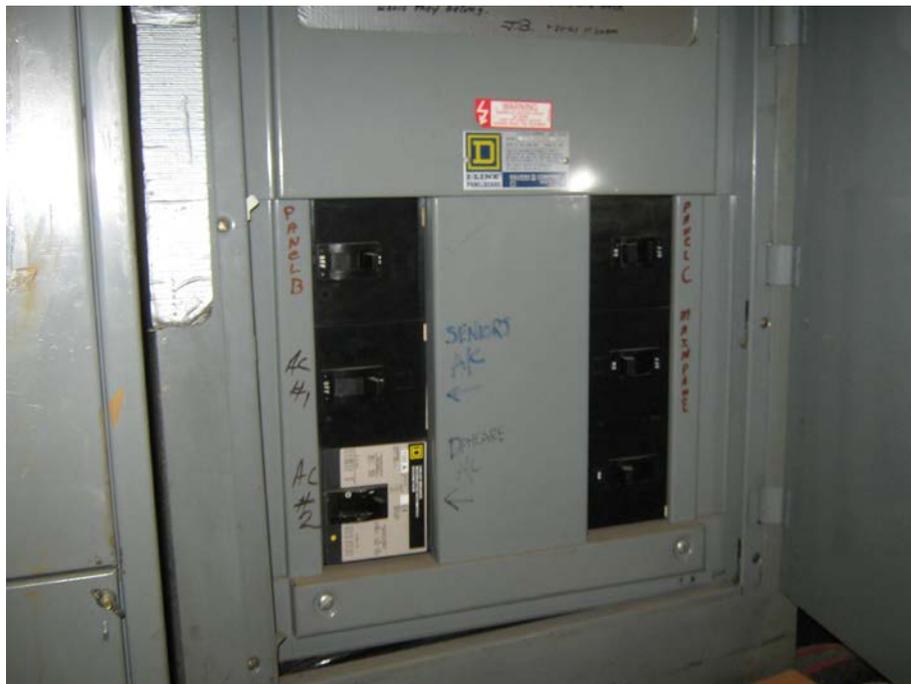
1. The building is served by a Square D distribution panel, rated at 400 amperes, 208Y/120 volts, 3-phase. The service equipment and main distribution panels are in good to fair condition.

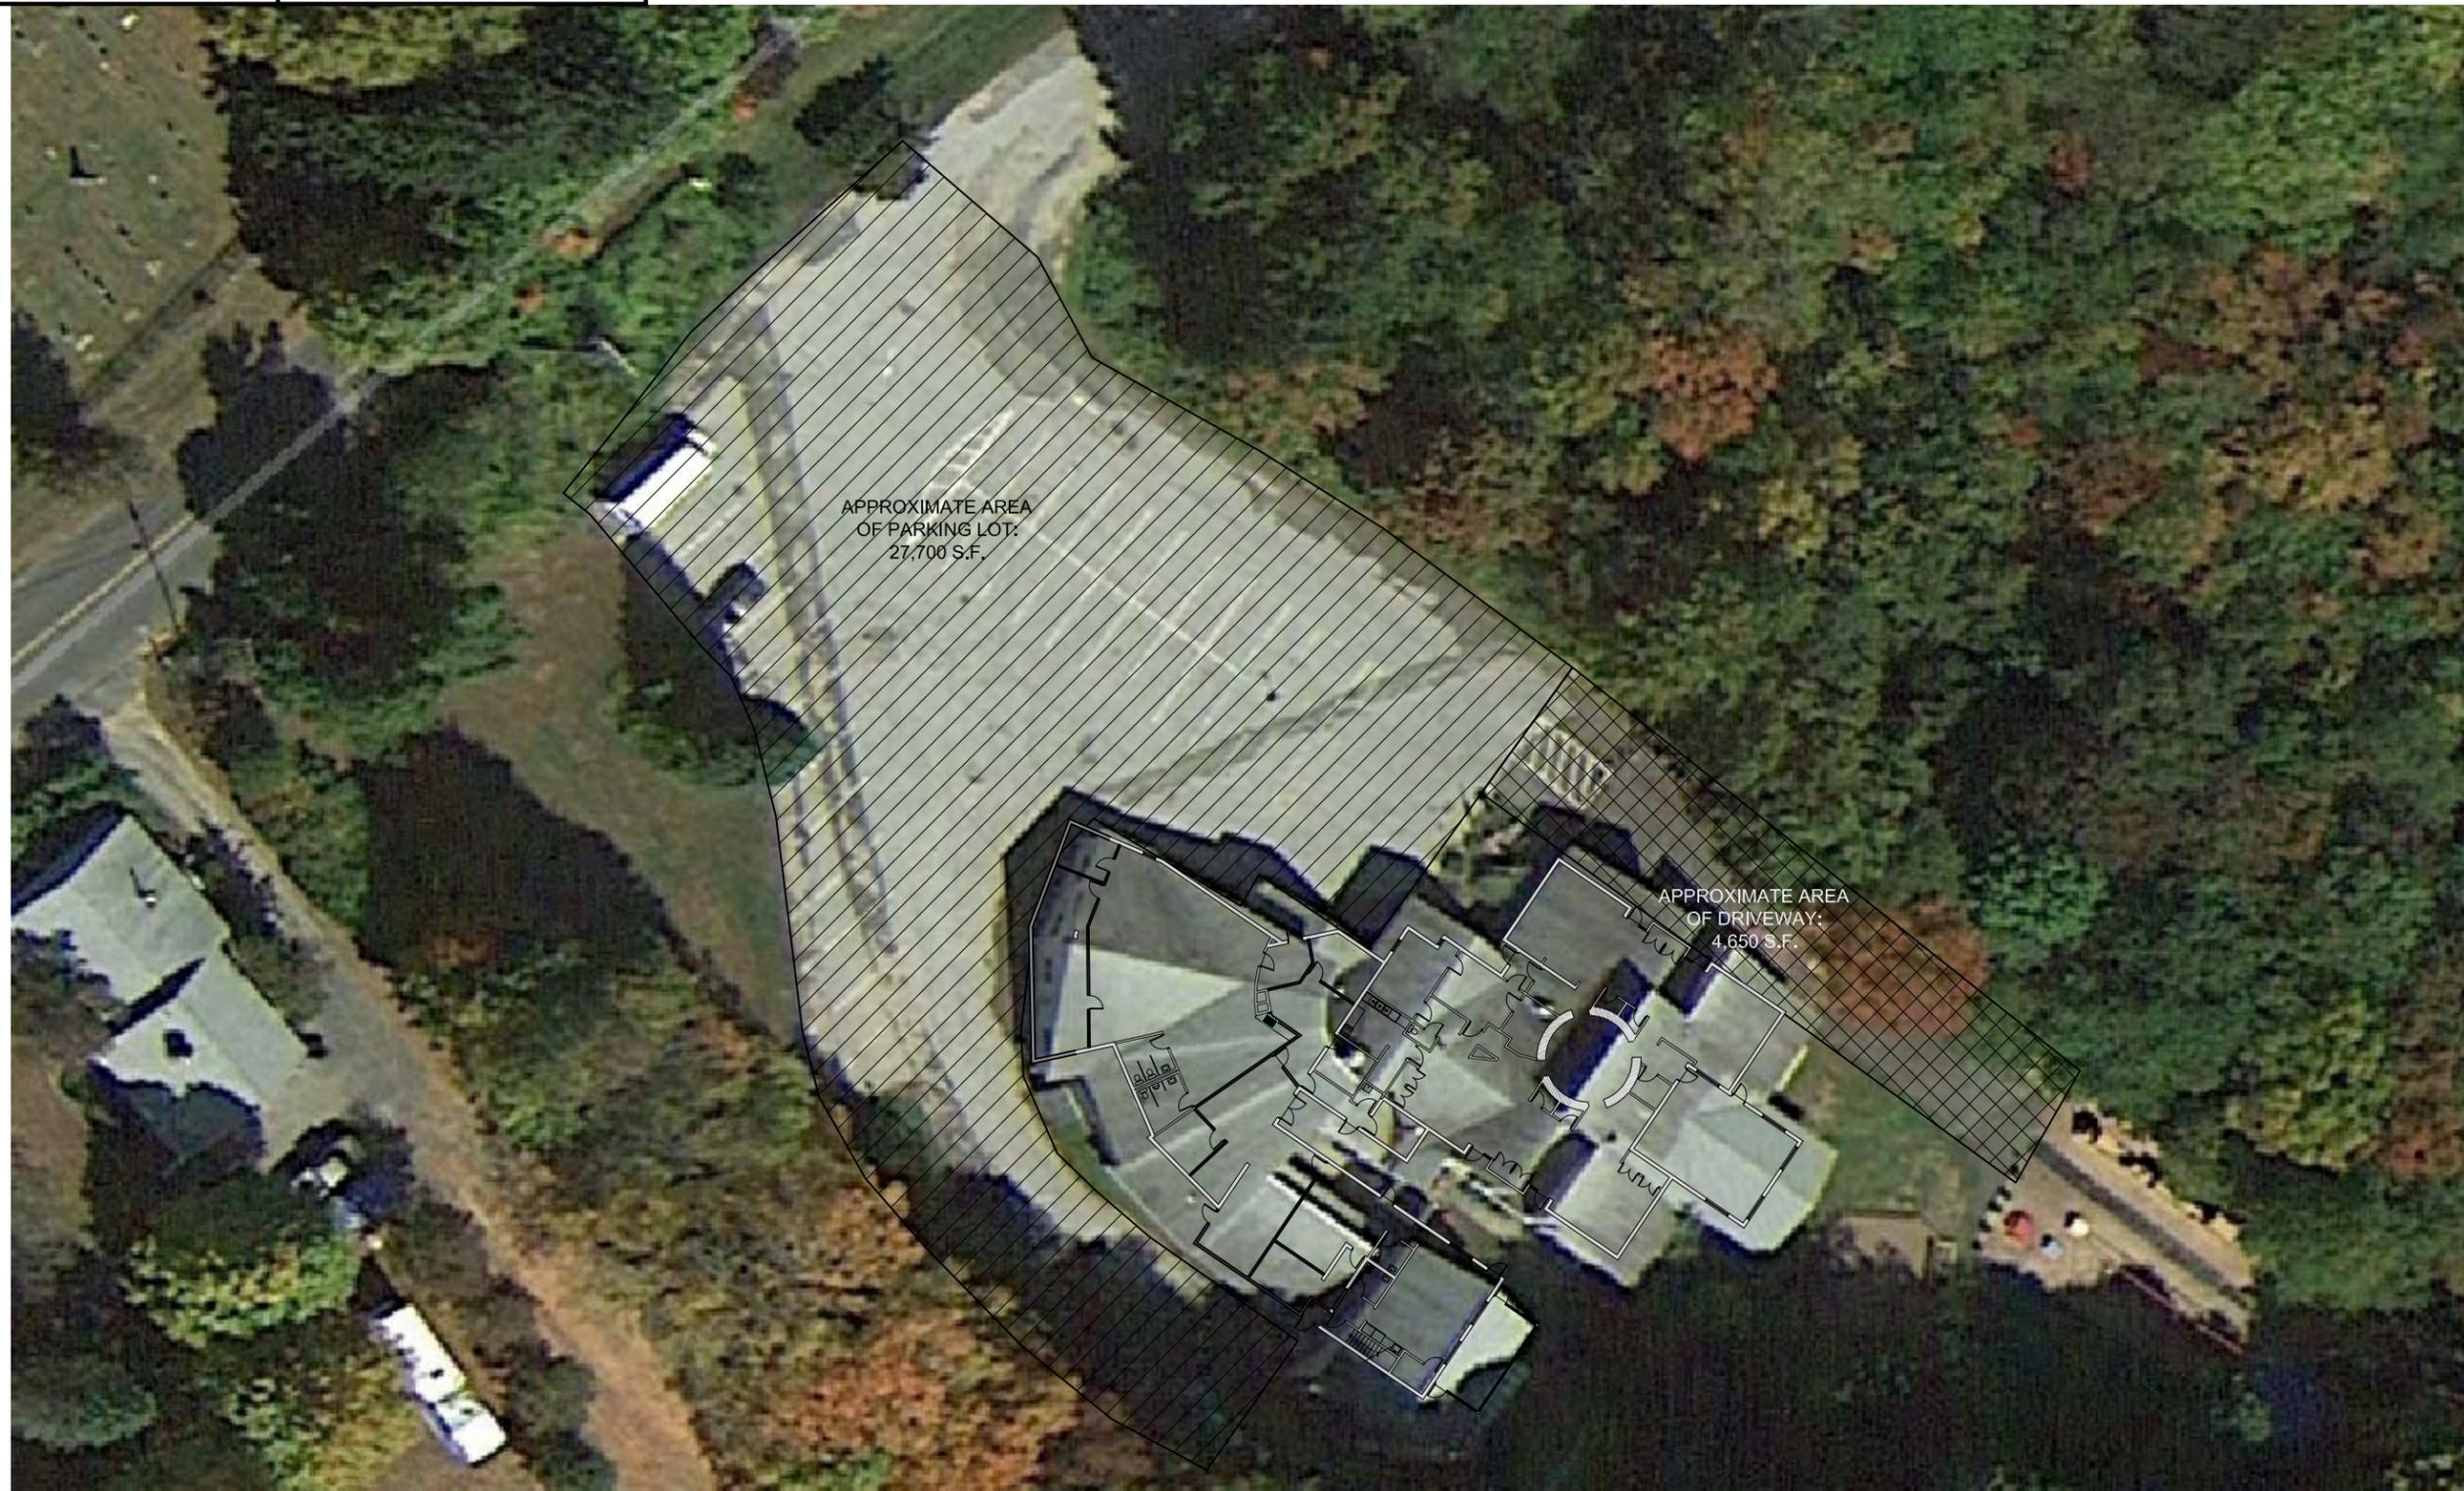
1 NEWTOWN MULTI-PURPOSE BUILDING - SITE PLAN
1" = 40'-0"
Drumme Rosane Anderson, Inc.

MP-A-2
FLOOR PLANS
EXISTING SITE
Newtown Facilities Assessment Report
