Hazardous Building Materials Inspection

**Kent House
Fairfield Hills Campus
Newtown, Connecticut**

Town of Newtown

August 2015

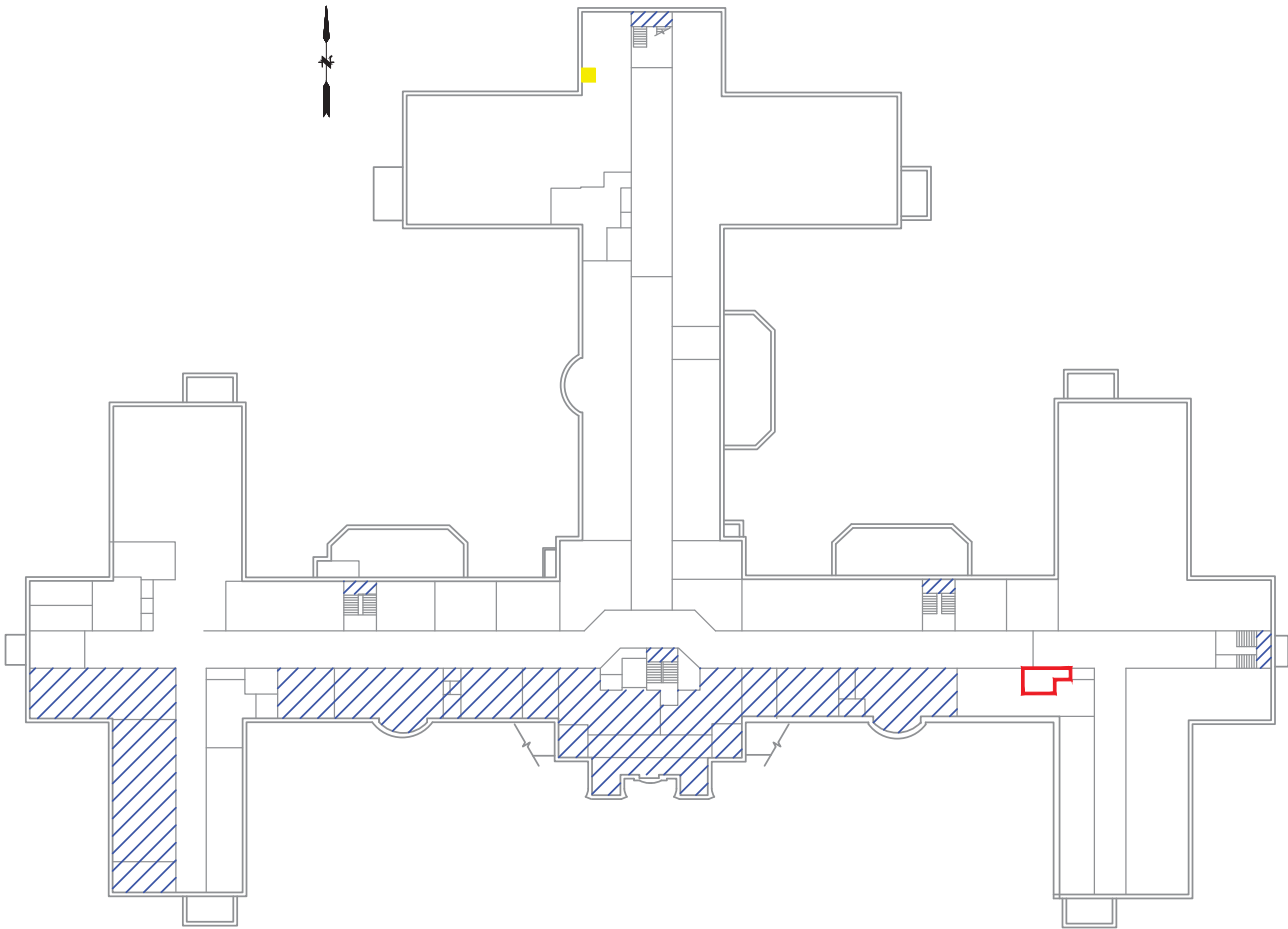
1 ASBESTOS CONTAINING MISCELLANEOUS MATERIAL LOCATION
BASEMENT – KENT HOUSE
SCALE: N.T.S.

- FLOOR TILE & MASTIC
- BLACK TAR/WRAP ON ELECTRICAL WIRE IN METAL DRINKING FOUNTAIN
- BLACK PATCH GLUE ON CERAMIC WALL TILE

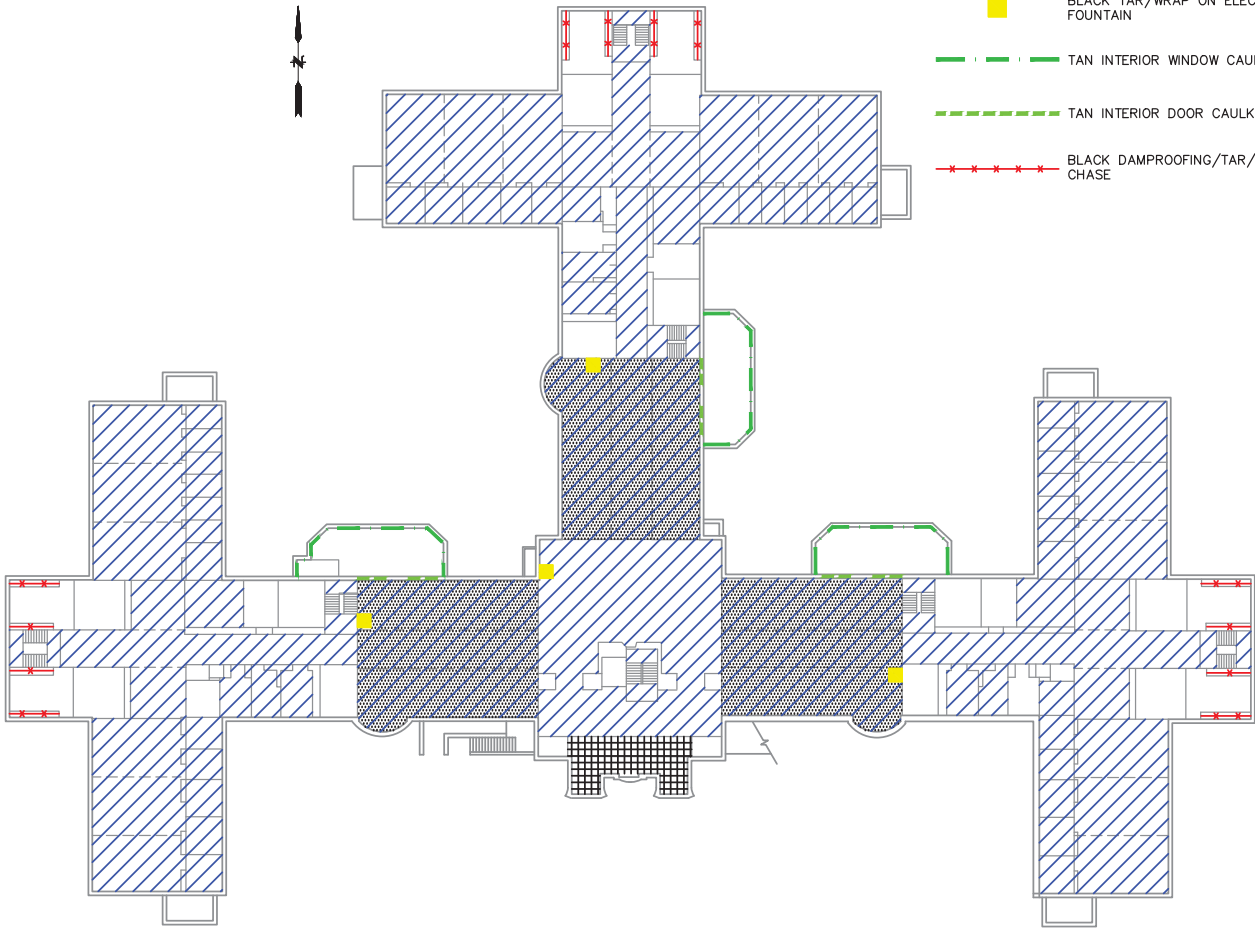
2 ASBESTOS CONTAINING MISCELLANEOUS MATERIAL LOCATION
FIRST FLOOR – KENT HOUSE
SCALE: N.T.S.

- FLOOR TILE & BLACK MASTIC
- GRAY STATE FLOORING AND STEPS
- GRAY FELT PAPER ON INSULATION ASSOCIATED WITH 1'x2' METAL CEILING TILES
- BLACK TAR/WRAP ON ELECTRICAL WIRE IN METAL DRINKING FOUNTAIN
- TAN INTERIOR WINDOW CAULKING COMPOUNDS
- TAN INTERIOR DOOR CAULKING COMPOUNDS
- BLACK DAMPROOFING/TAR/PAPR ON BRICK IN PIPE WALL CHASE

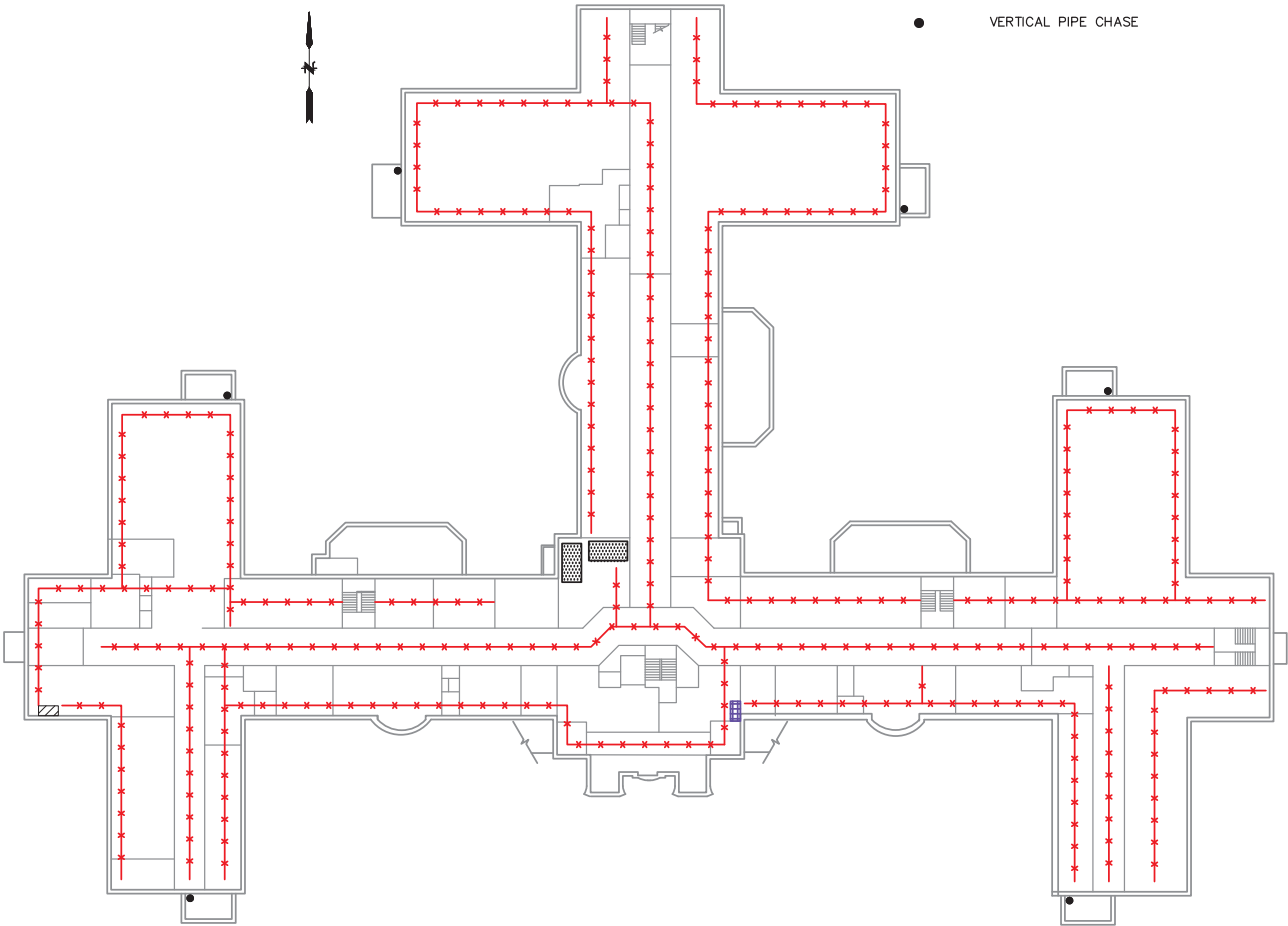
1 ASBESTOS CONTAINING THERMAL SYSTEM INSULATION MATERIAL LOCATION BASEMENT – KENT HOUSE
SCALE: N.T.S.

- TANK INSULATION
- HVAC DUCT INSULATION
- VIBRATION ISOLATION CLOTH CONNECTOR
- PIPE INSULATION AND MUDDIED PIPE FITTING INSULATION
- VERTICAL PIPE CHASE

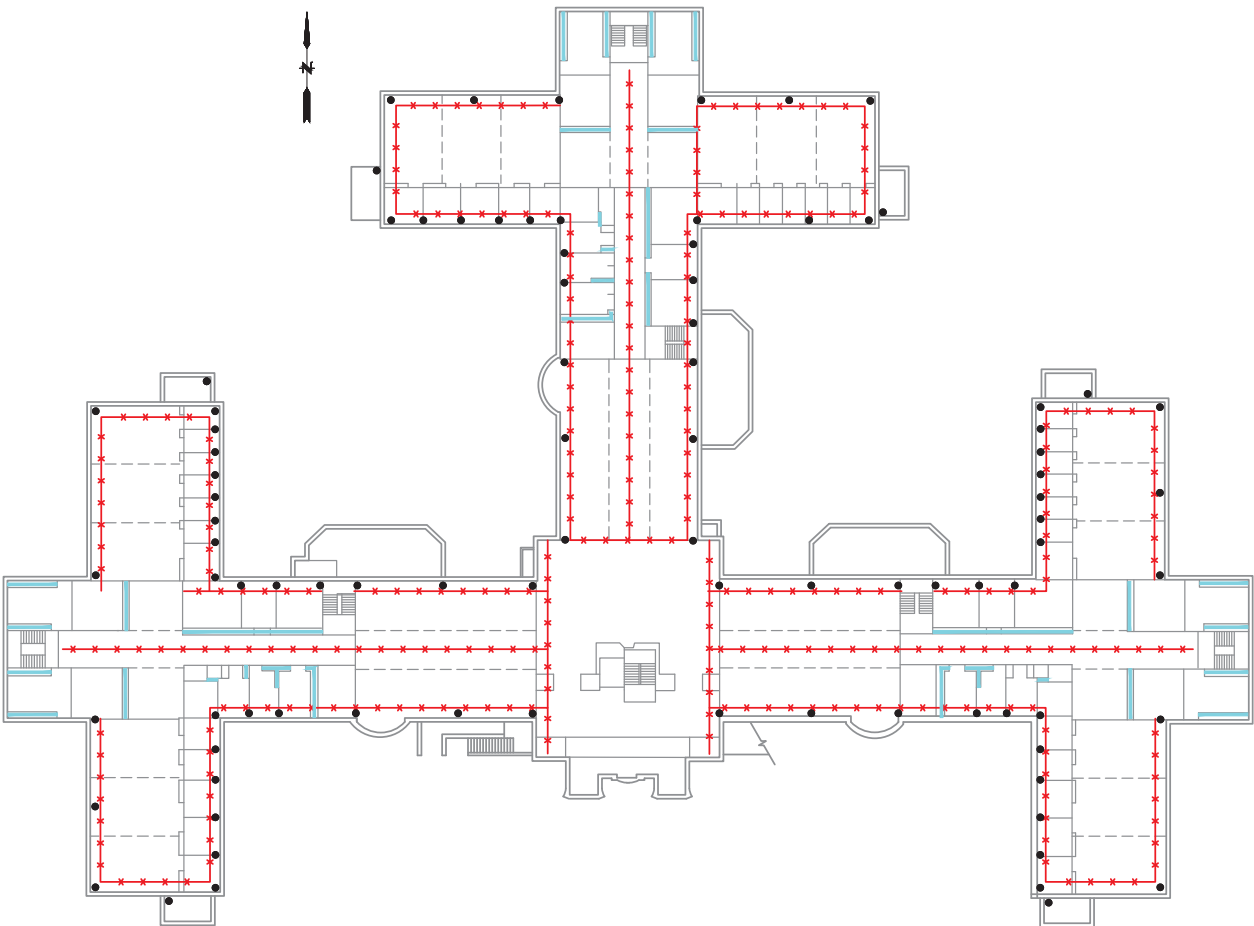
2 ASBESTOS CONTAINING THERMAL SYSTEM INSULATION MATERIAL LOCATION FIRST FLOOR – KENT HOUSE
SCALE: N.T.S.

- PIPE INSULATION AND MUDDIED PIPE FITTING INSULATION
- PIPE WALL CHASE
- PIPE CHASE VERTICAL

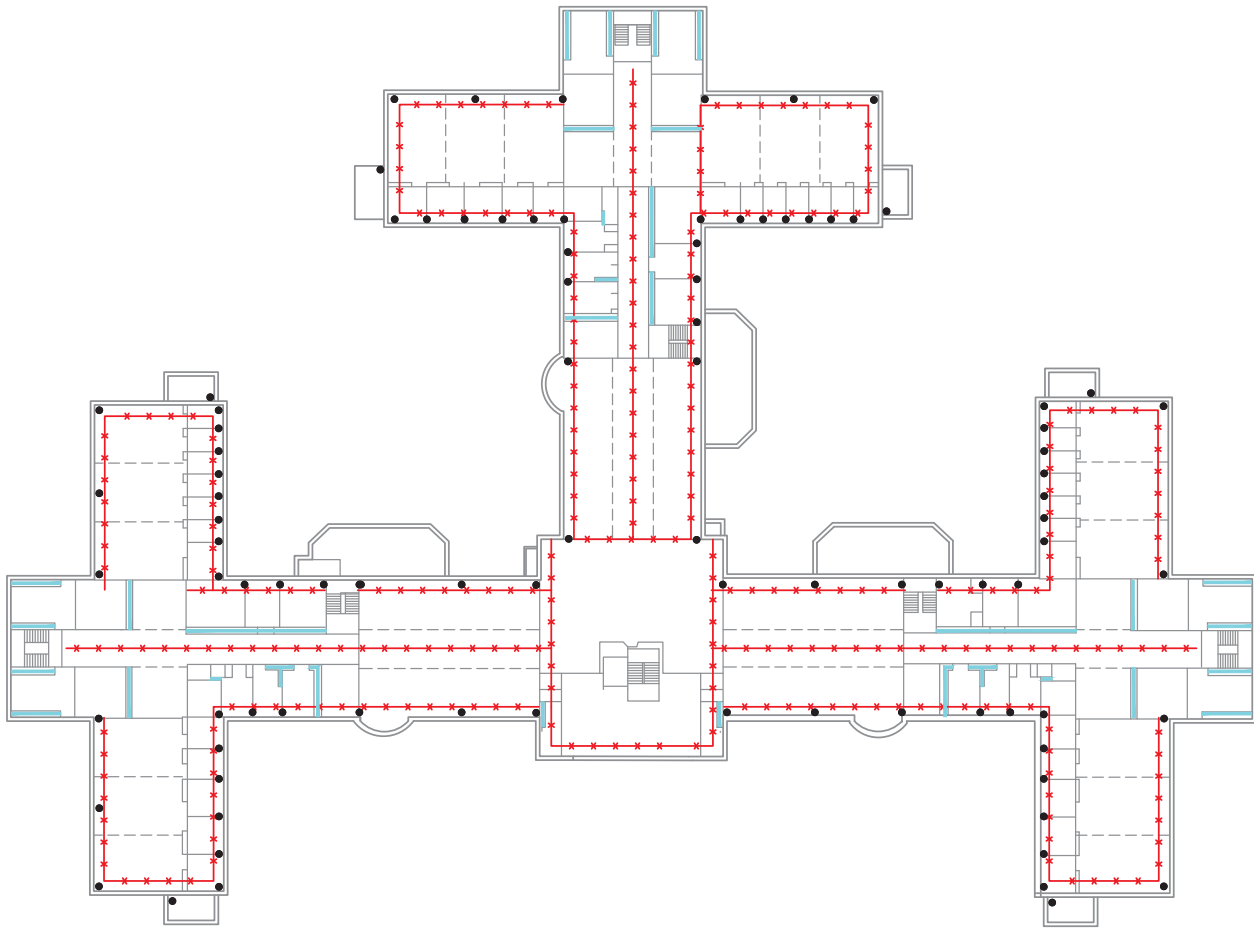
1 ASBESTOS CONTAINING THERMAL SYSTEM INSULATION MATERIAL LOCATION SECOND FLOOR – KENT HOUSE SCALE: N.T.S.

- PIPE INSULATION AND MUDDIED PIPE FITTING INSULATION
- PIPE WALL CHASE
- PIPE CHASE VERTICAL

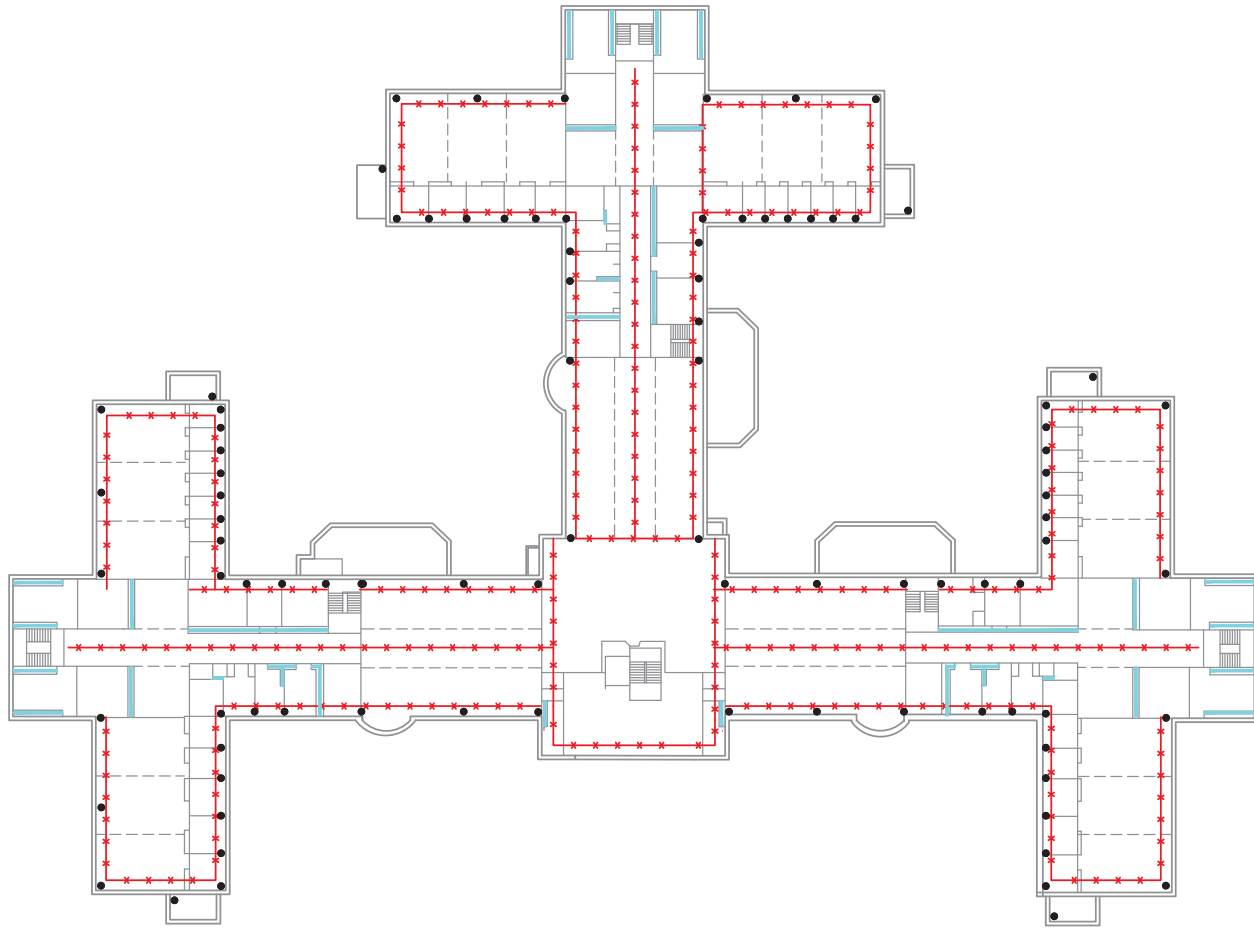
1 ASBESTOS CONTAINING THERMAL SYSTEM INSULATION MATERIAL LOCATION THIRD FLOOR – KENT HOUSE SCALE: N.T.S.

- PIPE INSULATION AND MUDDIED PIPE FITTING INSULATION
- PIPE WALL CHASE
- PIPE CHASE VERTICAL

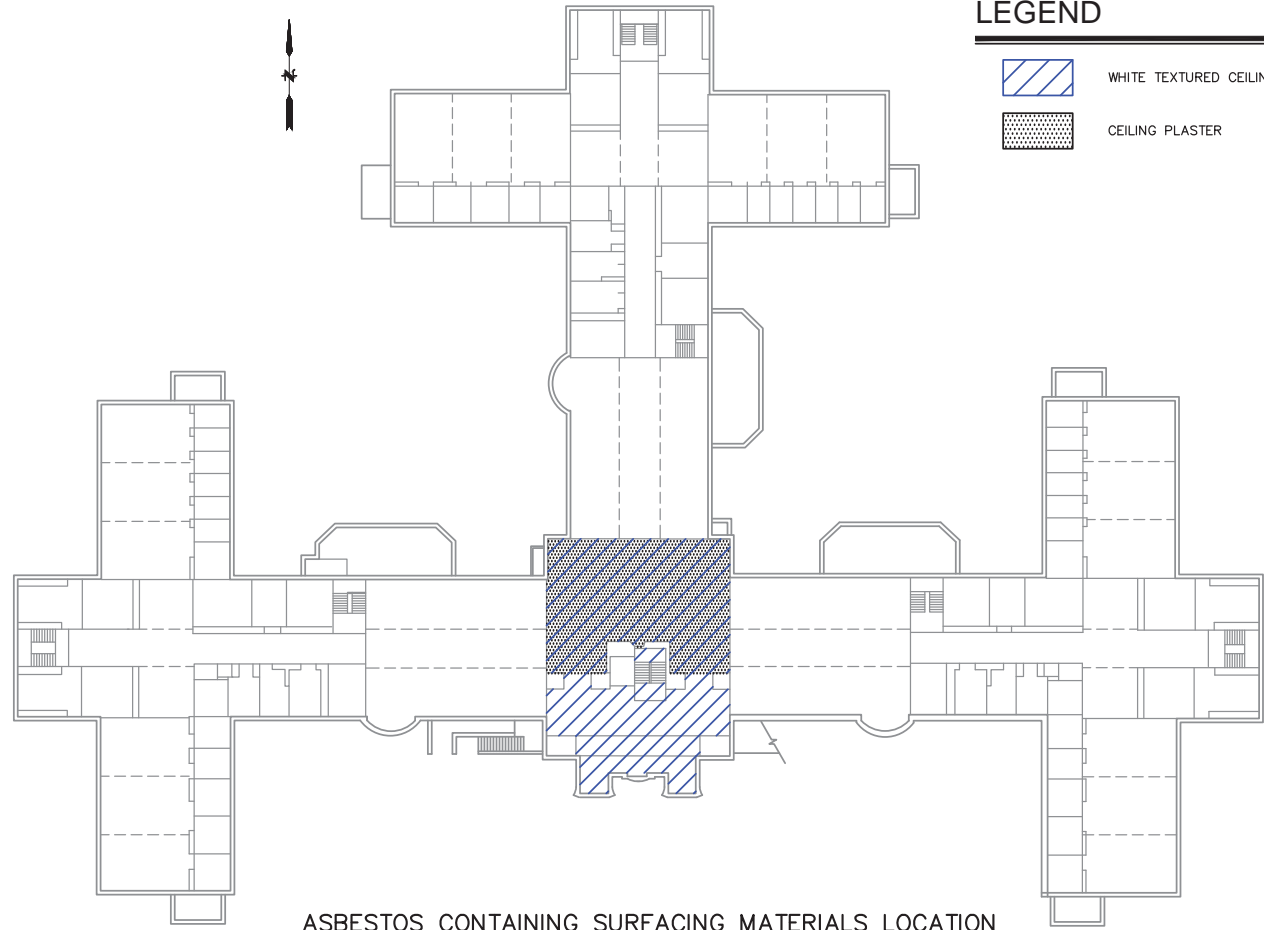
1 ASBESTOS CONTAINING SURFACING MATERIALS LOCATION
FIRST FLOOR – KENT HOUSE
SCALE: N.T.S.

WHITE TEXTURED CEILING PAINT

CEILING PLASTER

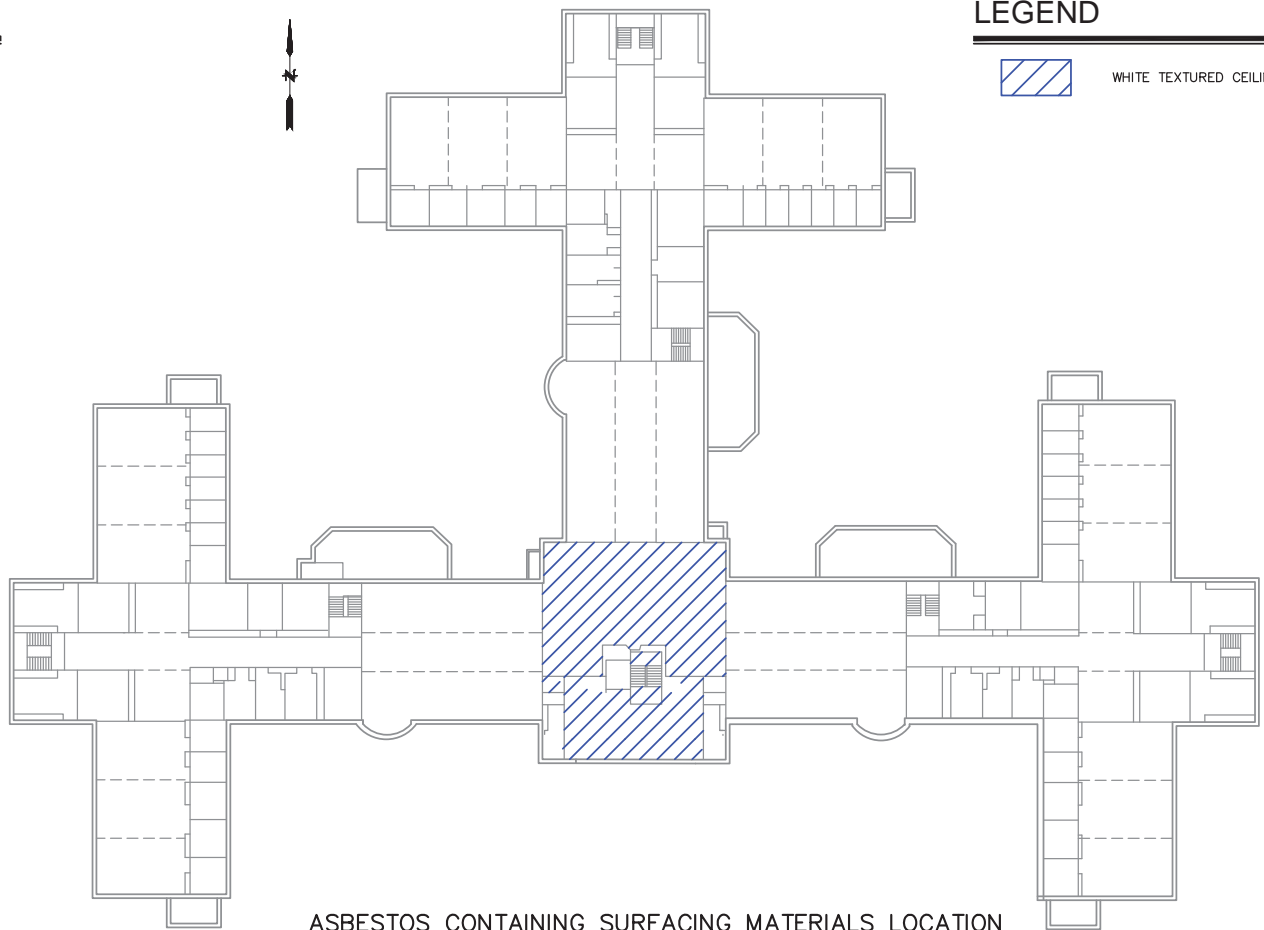
2 ASBESTOS CONTAINING SURFACING MATERIALS LOCATION
SECOND FLOOR – KENT HOUSE
SCALE: N.T.S.

WHITE TEXTURED CEILING PAINT

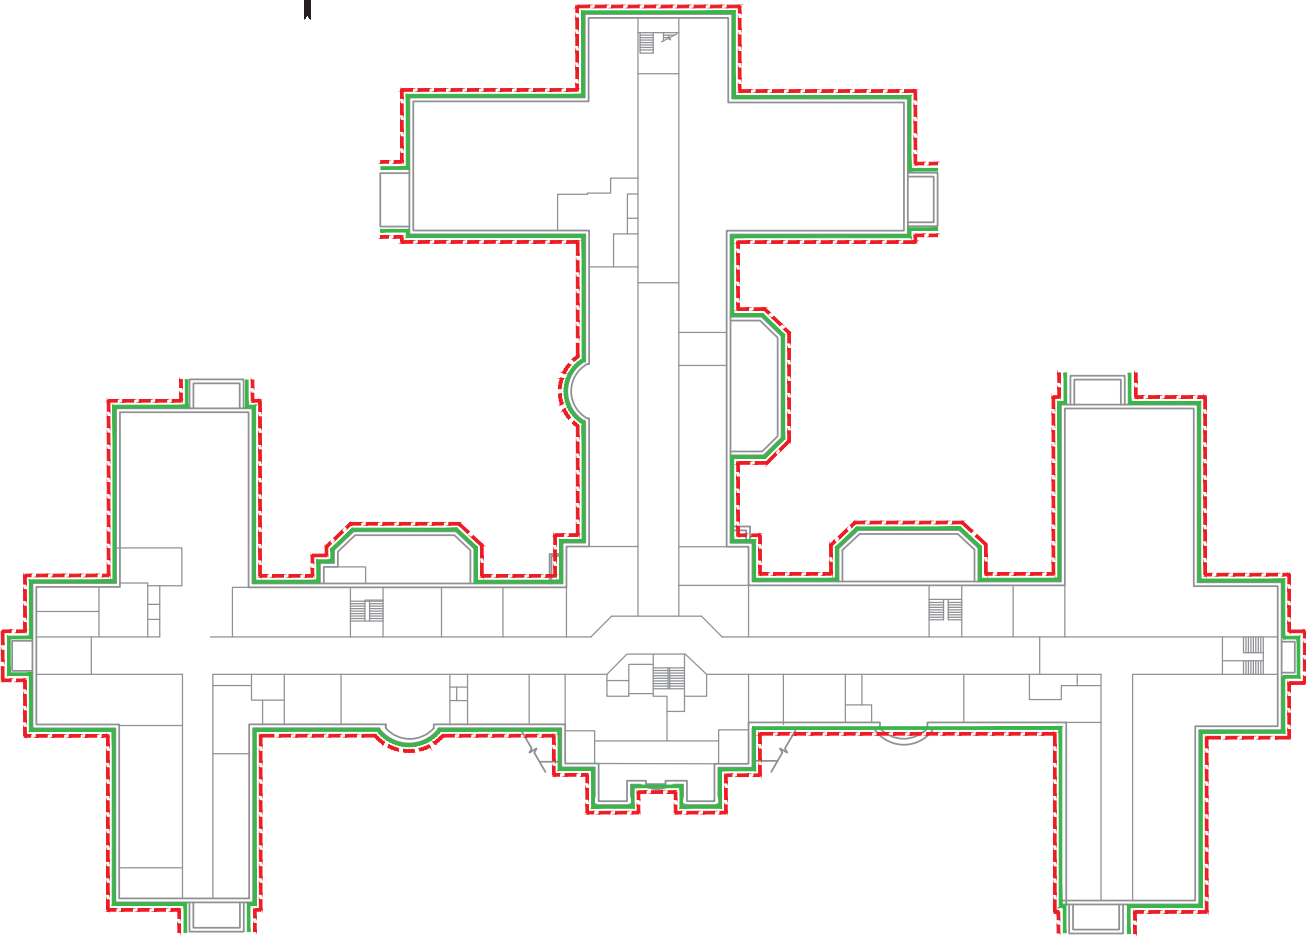
1 ASBESTOS CONTAINING EXTERIOR MATERIALS LOCATION
BASEMENT – KENT HOUSE
SCALE: N.T.S.

- EXTERIOR WINDOW CAULKING AND GLAZING COMPOUNDS
- EXTERIOR BLACK DAMPROOFING/TAR/PAPER UNDER CONCRETE (LIMESTONE) WINDOW SILL

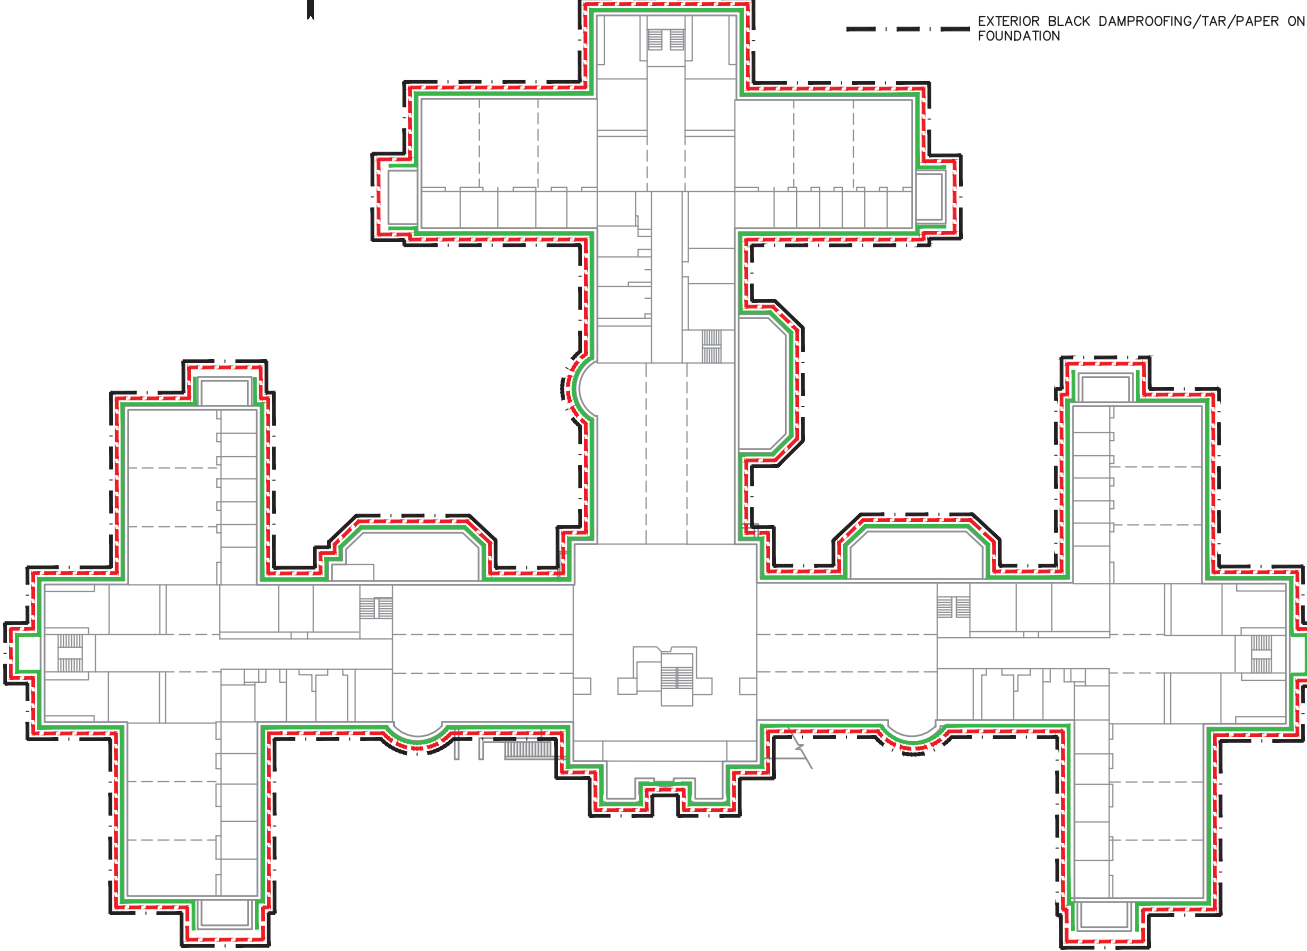
2 ASBESTOS CONTAINING EXTERIOR MATERIALS LOCATION
FIRST FLOOR – KENT HOUSE
SCALE: N.T.S.

- EXTERIOR WINDOW CAULKING AND GLAZING COMPOUNDS
- EXTERIOR BLACK DAMPROOFING/TAR/PAPER ON LOWER CONCRETE TRIM AND CONCRETE WINDOW SILL
- EXTERIOR BLACK DAMPROOFING/TAR/PAPER ON CONCRETE FOUNDATION

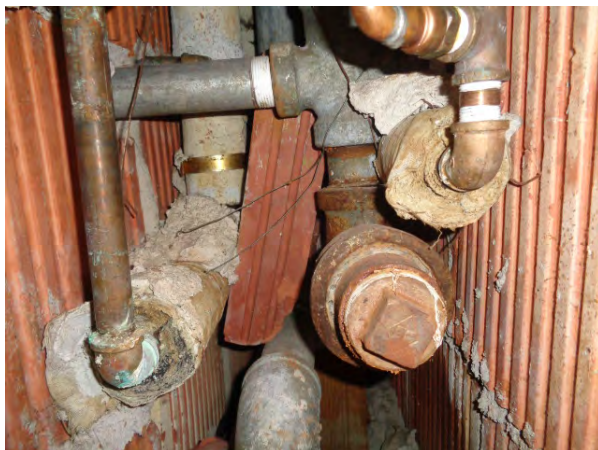
ACM Pipe Insulation in Wall Pipe Chase

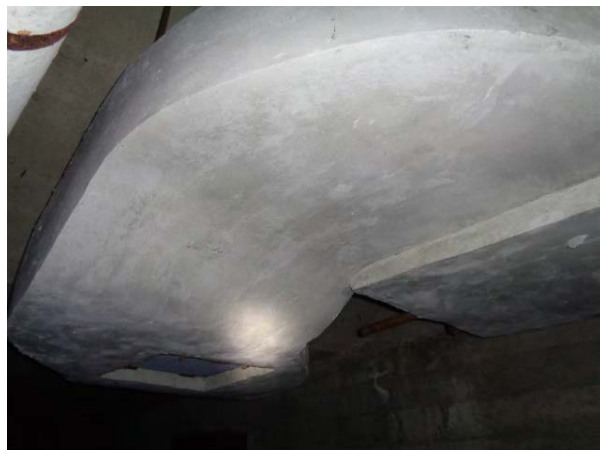
ACM HVAC Duct Insulation

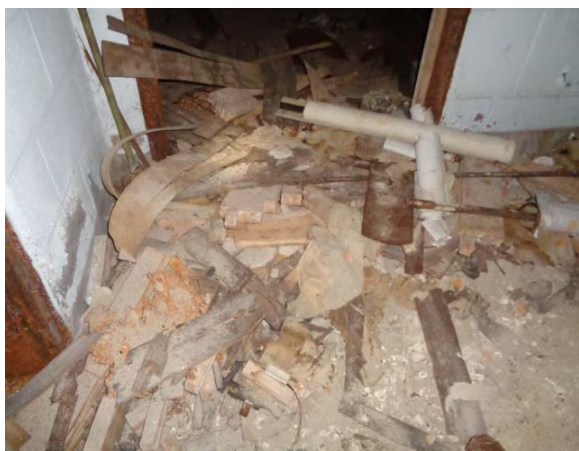
Damaged ACM TSI Debris

EnviroScience recommends that a comprehensive scope of work and technical specification for asbestos abatement be developed as part of Site renovation and/or demolition plans. Due to damaged ACM located throughout the Site, an Alternative Work Practice (AWP) should be developed by a CTDPH-licensed Asbestos Project Designer and submitted to the CTDPH for approval. The AWP should be developed for the construction of critical barriers, a decontamination unit and establishment of negative pressure. Once critical barriers, negative pressure, and a decontamination unit are constructed, the abatement contractor would clean all surfaces, abate all ACM, and encapsulate the work area with lockdown encapsulant.

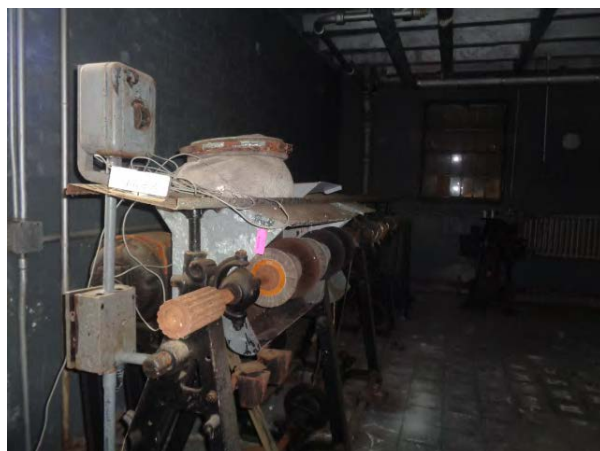
**Basement Mechanical Belt Machine Vibration
Isolation Cloth Connection**

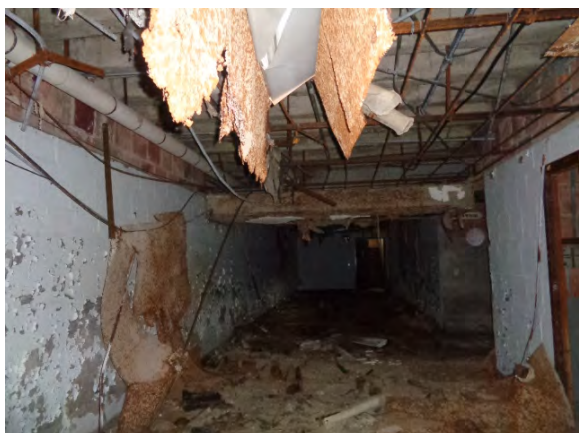
**Damaged ACM Plaster and TSI Debris in
Basement**

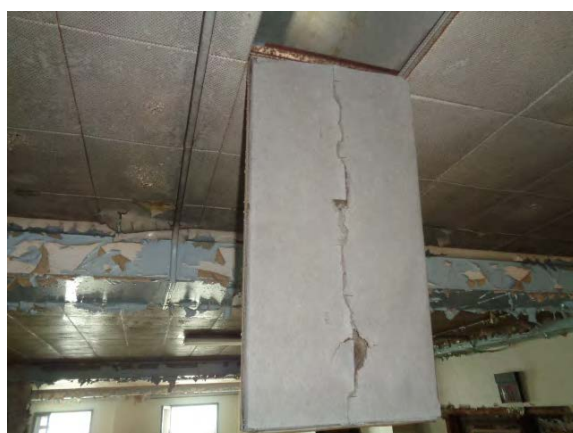
**ACM Gray Paper Wrap on Metal 1' x 2' Ceiling
Tile Insulation**

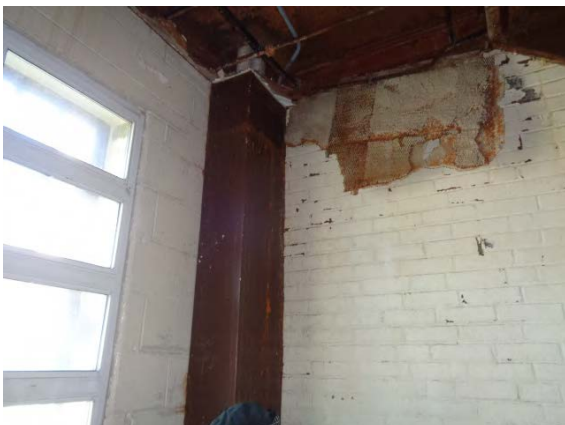
**Vertical Pipe Chase with ACM Pipe Insulation
in Stairwells**

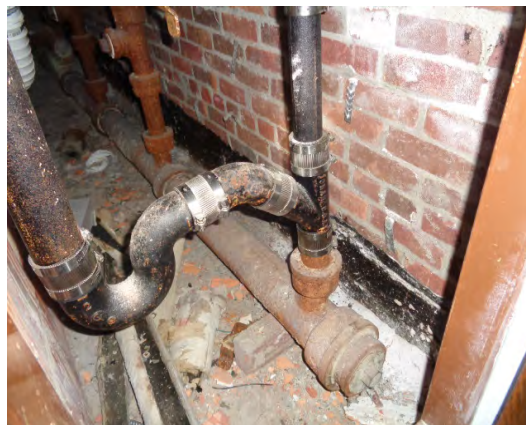
**ACM Black Damproofing/Tar/Paper in
Bathroom Wall Pipe Chase**

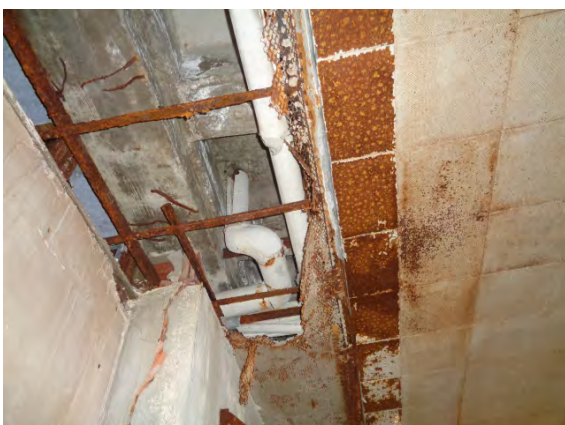
**ACM Pipe Insulation and Mudded Pipe Fitting
Insulation above Ceiling**

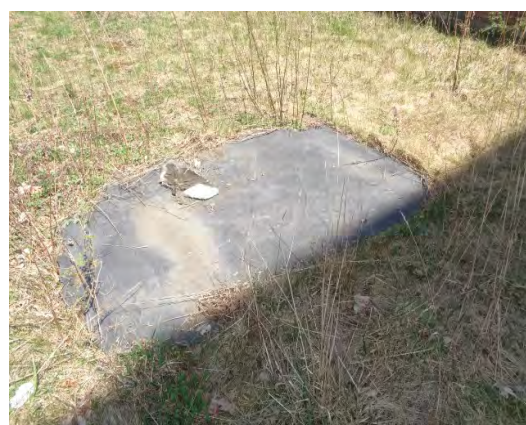
**ACM Black Roofing Debris on Southwest
Grounds**

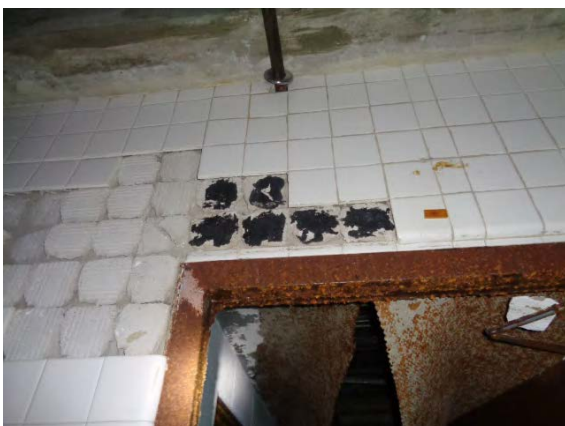
ACM Black Glue on Ceramic Wall Tile

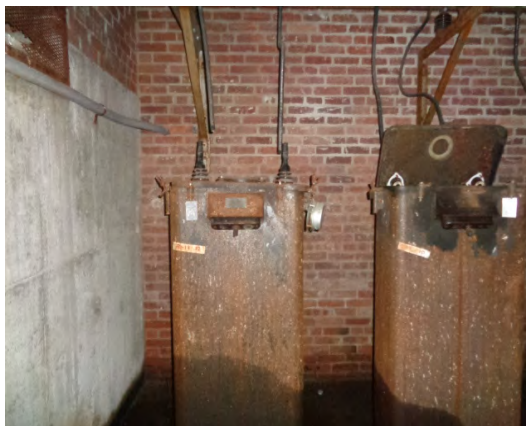
**Universal Waste Transformer Oil Reservoirs in
Basement**
