Hazardous Building Materials Inspection

**Stamford Hall
Fairfield Hills Campus
Newtown, Connecticut**

Town of Newtown

August 2015
Revised December 28, 2016

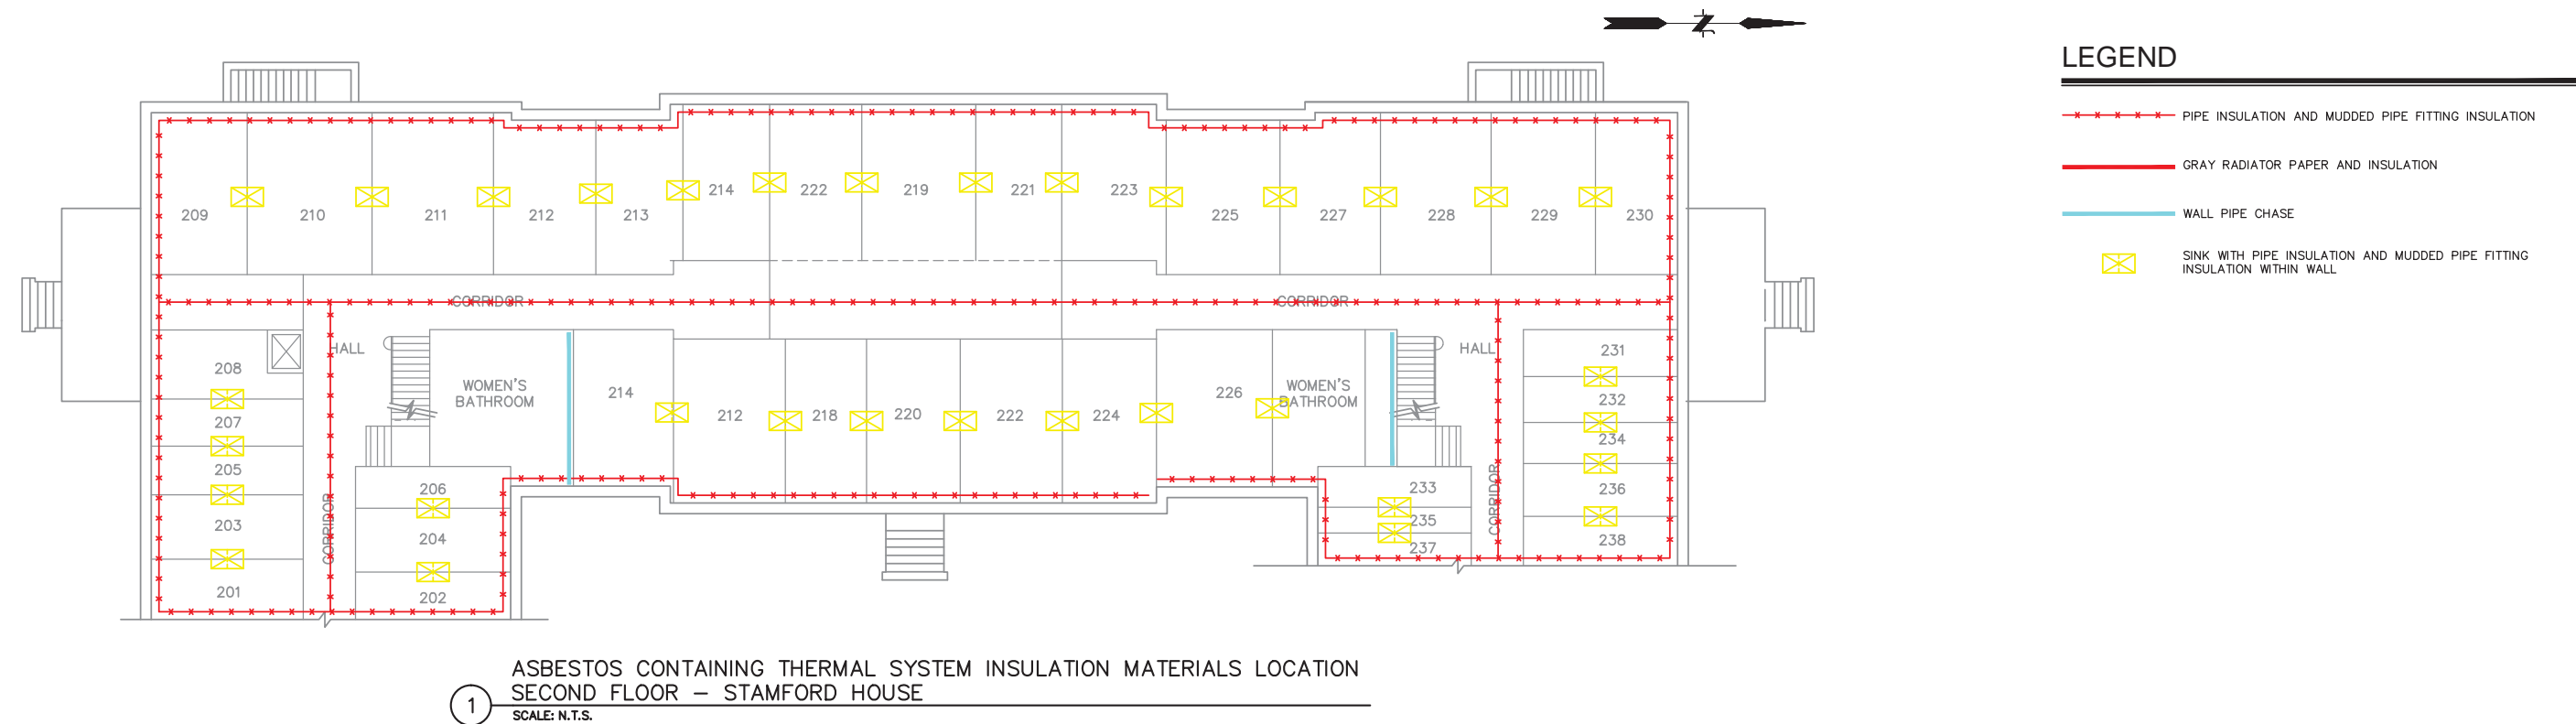
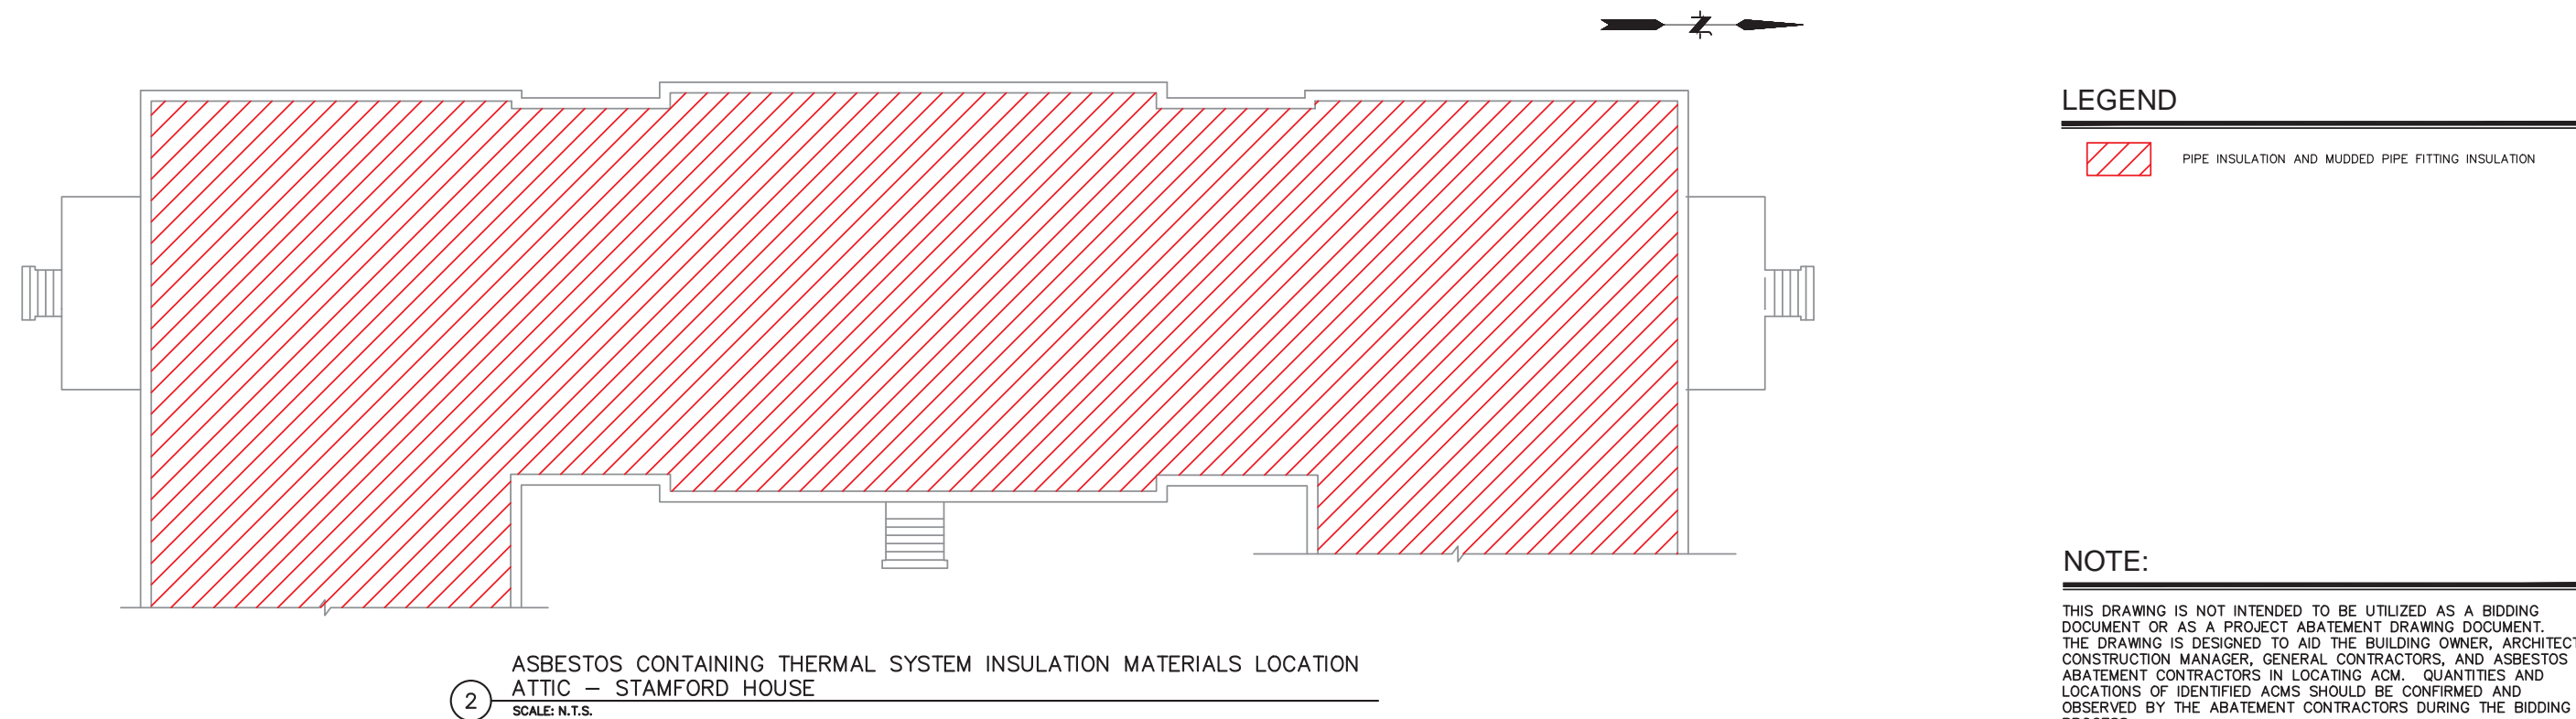
PROJ. No.: 20141268.ASE
DATE: JULY 2015
FIG.2.1

TOWN OF NEWTOWN
ASBESTOS CONTAINING THERMAL SYSTEM
INSULATION MATERIALS LOCATION
FAIRFIELD HILLS - STAMFORD HOUSE
NEWTOWN CONNECTICUT

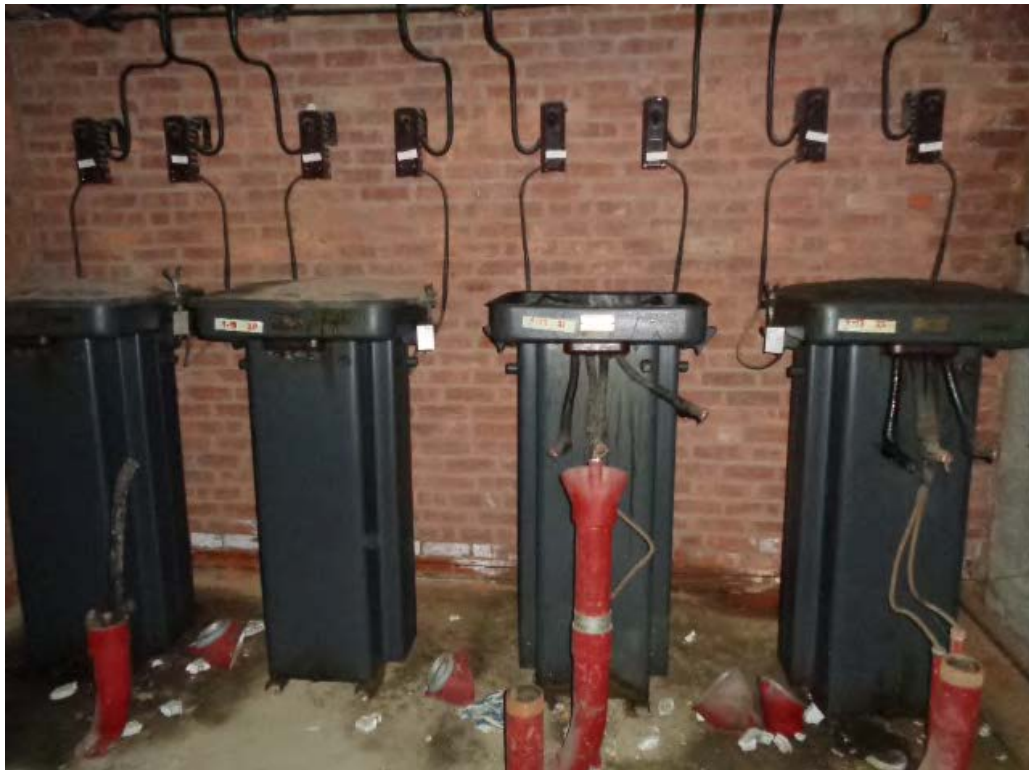
Oil Transformers
