Municipal Buildings Strategic Plan
Advisory Committee
Minutes
Thursday, October 29, 2015
7:00pm
Town Hall South
3 Main Street, Newtown

Presentation to Municipal Buildings Strategic Plan Committee Fairfield Hills

Reuse of Town Hall South as the Police Department

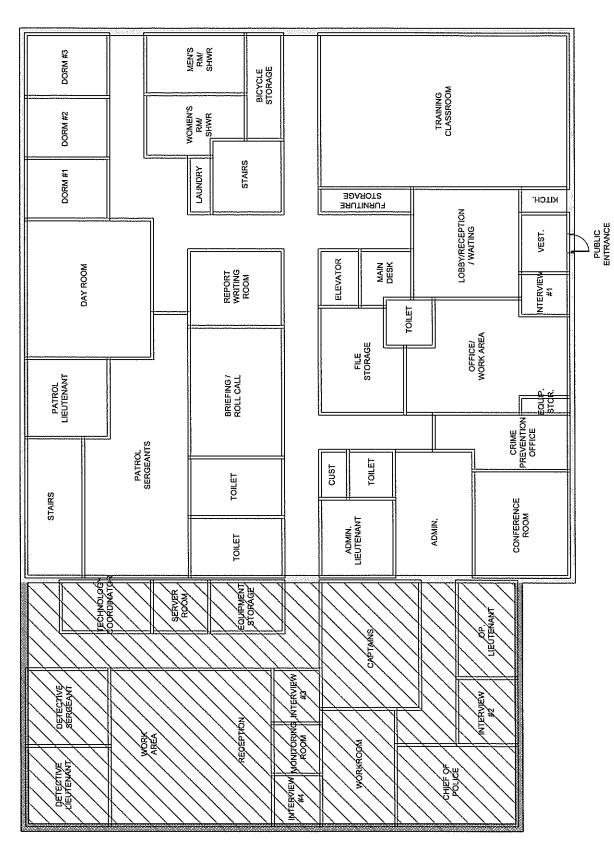
1/16" = 1'-0"

The current Police Department occupies the entire upper level and a small portion of the lower level of Town Hall South. In this option the conversion of the entire building is explored to meet the programmatic needs of the Department but it is known that the current floor area is inadequate.

The east end of the building is not fully developed with two thirds of the Lower Level a fenced in enclosure and the upper level with just a floor slab that has been roofed over. These appear to be the best areas to achieve additional floor area. Walls can be added to replace the fence around the lower level and a complete enclosure provided at the upper level. There is no other opportunity to expand the floor area. (Typically a vertical addition might be an option but will require extensive renovations to transfer the loads from the new 2nd floor to new footings in the basement and to upgrade the building to resist seismic loading. The expense of such a scheme will be prohibitive and may create zoning problems).

With the added floor area the Police space needs can be accommodated at Town Hall South with two exceptions; firstly, the dispatch area will need to be relocated out of the building and secondly, the shooting range cannot be accommodated in the building. Any expansion of the building will extend over the setbacks, but it may be possible to have a lower level expansion, below grade, to accommodate the range. Below grade, it may be possible to obtain a variance to the Zoning By-Laws.

This appears to be a viable option for the Police Department but will require further exploration to determine if compliance with Zoning can be achieved.

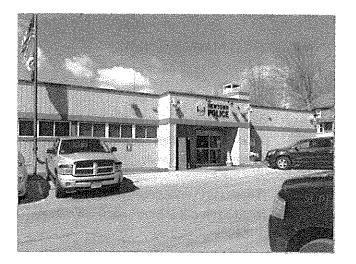
GENERAL: Originally constructed as a tractor sales building the building was repurposed to serve Town functions including the Police Department. The exterior of the building is suffering from many years of being clad with "Texture 1-11" siding, a product that is basically scored plywood intended to provide an appearance of vertical wood siding. Windows have needed to be replaced due to air and water leakage. In contrast the interiors are in much better condition.

It is very difficult to find parking spaces on the site which we consider to be undersized for its current uses.
